Tech Memo

To: Mill Valley StreamKeepers
From: Roger Leventhal, P.E., FarWest Restoration Engineering
Date: November 15, 2004
Re: Preliminary Fish Barrier Culvert Modifications and Flood Assessment, Arroyo
Corte Madera/Old Mill Creek, Mill Valley, California

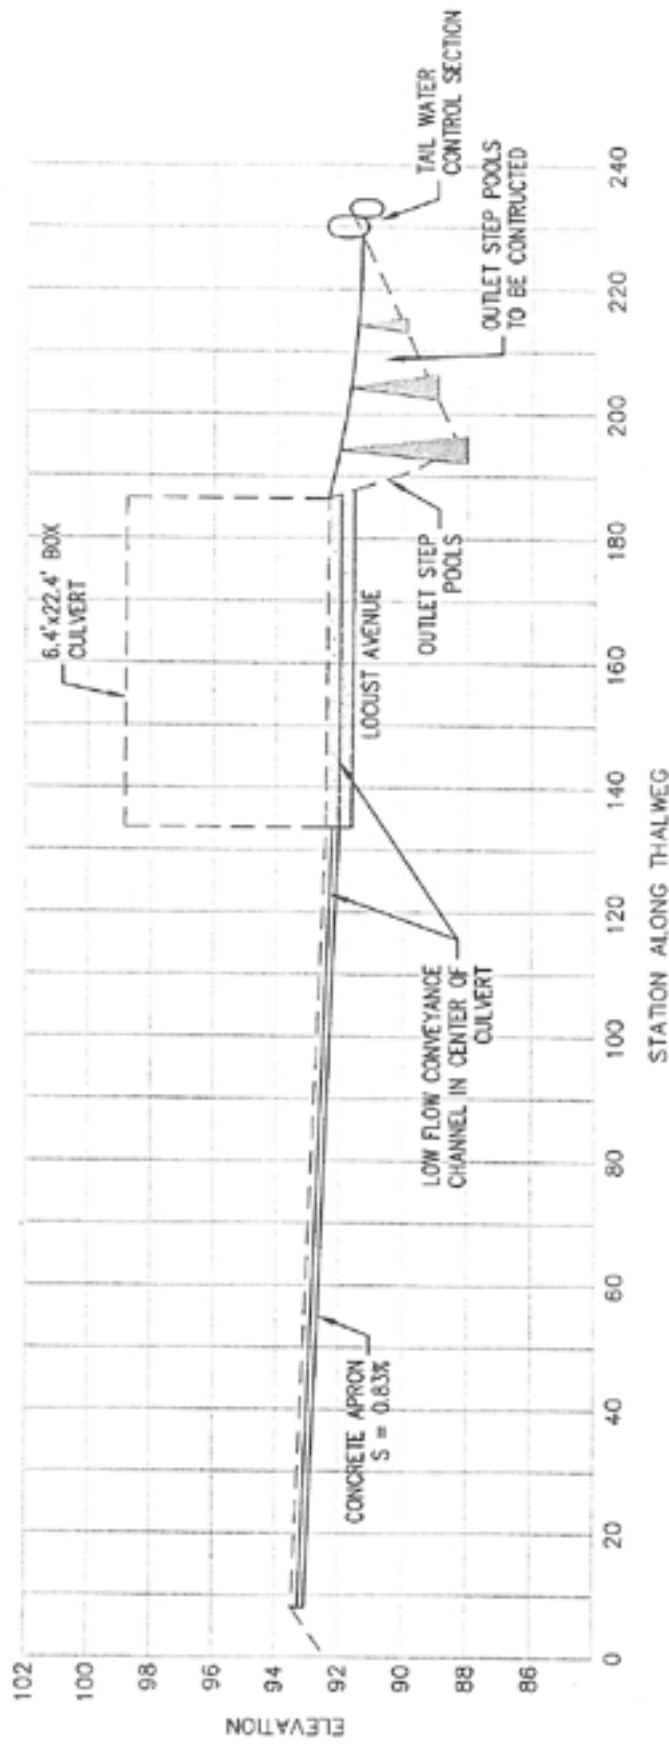
FIGURE 2
MILL VALLEY FISH BARRIER CULVERT MODIFICATIONS
SECTION THROUGH CULVERT MR-068
LOW FLOW FISH CHANNEL ALTERNATIVE

The Arroyo Corte culvert at Locust Avenue is a 6.4 foot high by 22.2 foot wide arch culvert with a concrete bottom that runs under Locust Avenue and also under an apartment building. At the inlet to the culvert, there is also a 125 foot long concrete apron that was included in the fish passage evaluations.

Adult Steelhead: Meets criteria for 23% of range of estimated migration flows; fails to meet depth criteria only for flows below 61 cfs (adult flow range is 3 to 78.4 cfs).

Demolition and removal of concrete and asphalt to a depth of approximately 18 to 24 inches from a 4 to 10 feet wide channel along the bottom of the structure

Reinforcement of the channel side slopes with a concrete reinforcement to an assumed depth of three feet (to be confirmed during final design)

Placement of rock and gravel to provide a natural bottom passageway within the culvert.

Installation of three log weir at the tailwater section to raise tailwater elevation

Removal of portions of the upstream asphalt entranceway.

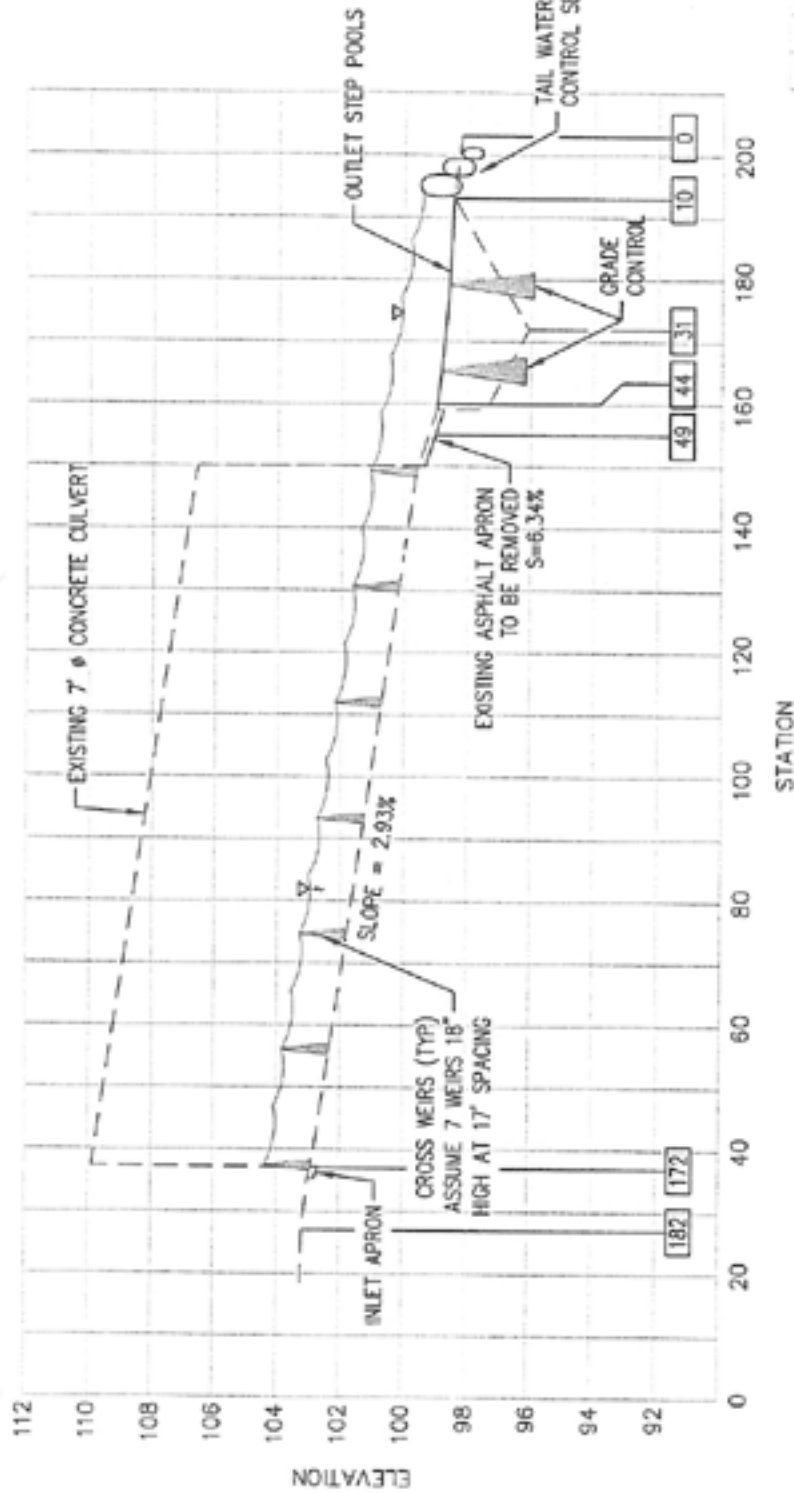
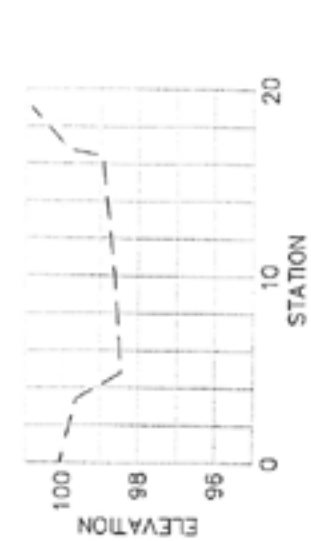
FIGURE 3
MILL VALLEY FISH BARRIER CULVERT MODIFICATIONS
ARROYO CORTE MADERA DEL PRESIDIO #2
UNDER BUILDING (MR-069)

This culvert was mapped as a 7 foot diameter 111 foot long concrete culvert at a slope of approximately 2.93 percent. The outlet pool of the culvert is the confluence of Arroyo Corte and Old Mill Creeks.

Juvenile Steelhead: Fails to meet passage criteria for velocity.

Adult Steelhead: Fails to meet criteria for velocity for flows from 7 cfs to 33.6 cfs (passage flow range of flows is 3 to 33.6 cfs)

In addition, R. Taylor evaluated that the culvert was undersized with an approximate storm capacity of only the 25 year flow event.

This steep slope (approximately 3 percent) and length (111 feet) of this culvert represents a difficult design issue for fish passage. It is very unlikely that corner baffles will produce low enough velocities to meet the requirements of Table 1 above. A quick culvert analysis using 33.6 cfs (the one percent upper passage flow) indicates that the velocity through the culvert will be approximately 12.3 ft/sec, well above the design guidelines of 4 ft/sec described above for adult salmonids in a culvert over 100 feet.

Construction of a downstream tailwater pool steps to raise elevations 1-2 feet.

Install a series of weirs and pool cross-baffles to reduce velocities and increase depths to meet guidelines; or make recommendations for barrier replacement.

Install upstream berms or flood proofing to contain channel breakout flows.

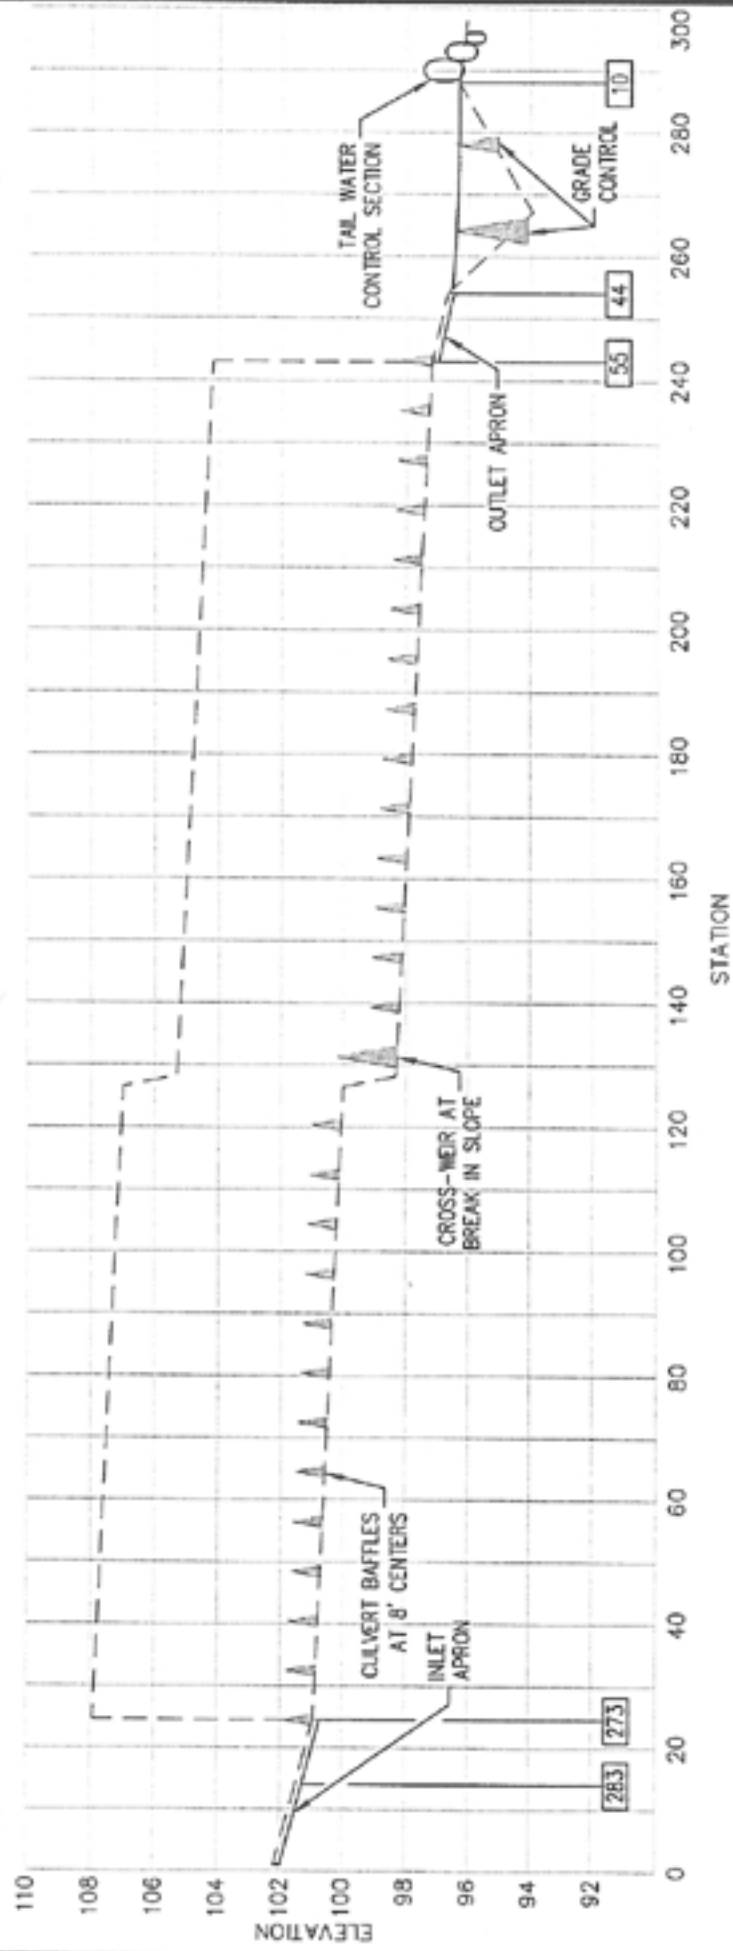
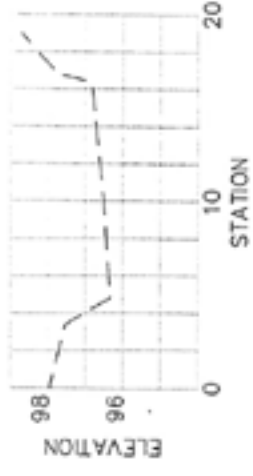
FIGURE 4
MILL VALLEY FISH BARRIER CULVERT MODIFICATIONS
OLD MILL CREEK #1
MILLER AVENUE (MR-075)

The MR-075 culvert is located along Old Mill Creek under Miller Avenue right through downtown Mill Valley. The culvert is 218.5 feet long at a diameter of 7 feet and is laid at an overall slope of 1.72 percent (Figure 4). There is a break in slope halfway through the culvert. The outlet pool of the culvert is the confluence of Arroyo Corte #2 (MR-069).

Juvenile Steelhead: Fails to meet passage criteria for velocity and depth.

Adult Steelhead: Fails to meet criteria for velocity for flows from 5.5 cfs to 20 cfs (passage range of flows is 3 to 40.3 cfs)

In addition, R. Taylor evaluated that the culvert was undersized with an approximate storm capacity (HW/D=1) of only the 14 year flow event. Taylor estimated that Miller Avenue is overtopped on a 02-year storm event.

A quick culvert analysis using HY-8 shows that at a flow of 40.3 cfs (the one percent upper passage flow) the velocity through the culvert is approximately 11 ft/sec, well above the design guidelines of 3-4 ft/sec described above for adult salmonids in a culvert over 200 feet.

Construction of a downstream tailwater pool steps to raise elevations one to two feet.

Evaluate the effectiveness of installing corner baffles or if required a series of step-pool weirs to reduce velocities to meet guidelines.

Install berms or floodwalls along those areas of the creek identified during final hydraulic analysis as showing overbank flooding.

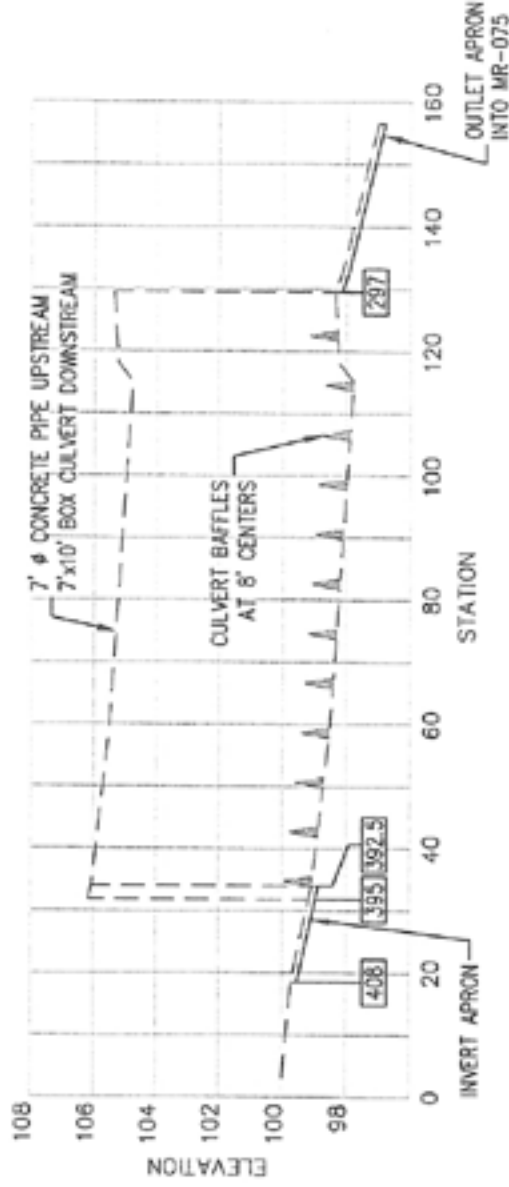
FIGURE 5
MILL VALLEY FISH BARRIER CULVERT MODIFICATIONS
OLD MILL CREEK #2
UNDER POST OFFICE (MR-076)

The Old Mill Creek #2 culvert is a 95.5 foot long culvert at a slope of approximately 0.74% . The culvert is a 7 foot diameter circular culvert at the inlet and a 7 foot by 10 foot box culvert at the outlet. The culvert condition was mapped as fair to poor with exposed rebar at the invert.

Juvenile Steelhead: Fails to meet passage criteria for velocity and depth.

Adult Steelhead: Fails to meet passage criteria for velocity and depth.

In addition, R. Taylor evaluated that the culvert was undersized with an approximate storm capacity (HW/D=1) of only the 14 year flow event. Taylor estimated that Miller Avenue is overtopped on a 74-year storm event.

A preliminary culvert analysis using HY-8 at a upper one percent passage flow of 40.3 cfs indicates that the velocity through the culvert is approximately 8 ft/sec, above the design guidelines of 5 ft/sec described above for adult salmonids in a culvert under 100 feet.

The results indicate overtopping of the culvert for both 100-year flow conditions. The anticipated rise in water level was calculated to be approximately 0.6 to 3 feet from existing water levels under flood conditions.

For flooding analysis purposes, it was assumed that baffles will be constructed in the culvert with step 12 inches high at a spacing of approximately 8 feet for a total number of steps of approximately 13 steps.

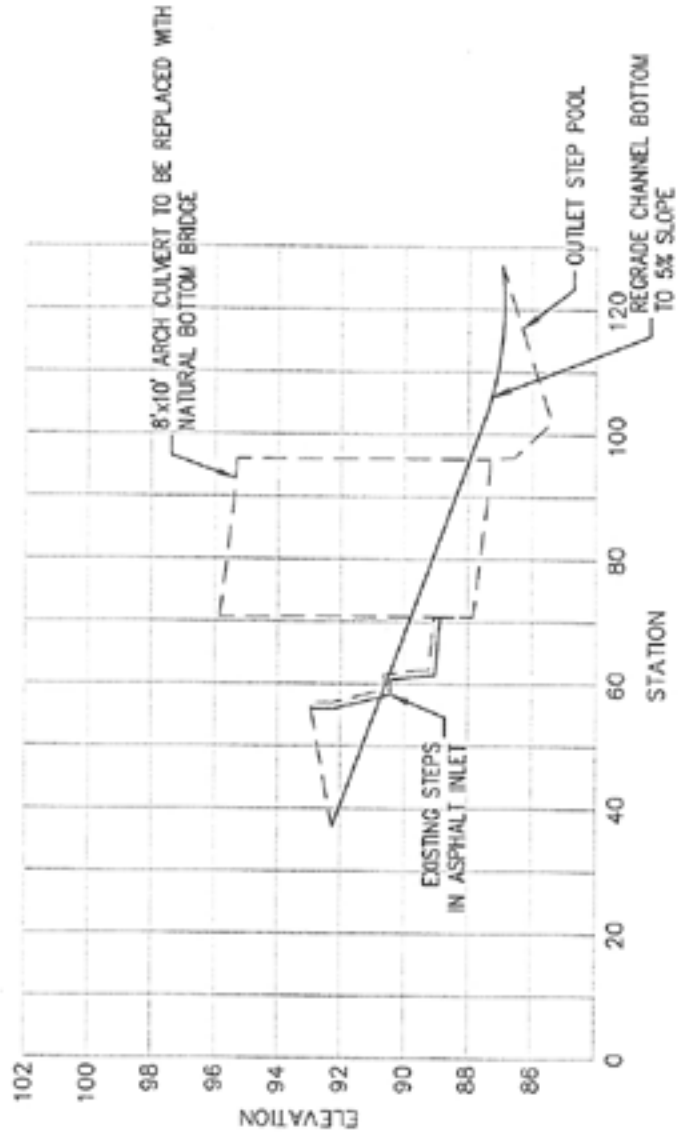
Figure 8: Profile of MR-077

Old Mill Creek #3 is a 8 foot high by 10 foot wide arch culvert 6 ft by 5 ft arch culvert approximately 18 feet in length at a slope of approximately 2.4%. The overall condition is fair to poor with cracking of the culvert floor. The primary barrier for fish passage is a series of steep steps cut into the upstream asphalt apron that is essentially impassible for fish.

Juvenile Steelhead: Fails to meet passage criteria for velocity and depth.

Adult Steelhead: Fails to meet passage criteria for velocity and depth.

Given the short length of the culvert, we propose to replace the culvert with an arch bridge with a natural bottom. The width of the bridge would be designed to meet DFG and NOAA Fisheries guidelines to be approximately 25 percent larger than the active channel width of 18 feet, therefore, the bridge width would be approximately 22 feet at an estimated width of 14 feet (single traffic lane). The series of upstream step would be regraded into a series of steps approximately 0.5 feet in height graded back into the park.
