**RUSSIAN RIVER STREAM CROSSING INVENTORY AND FISH PASSAGE
EVALUATION**

FINAL REPORT

Ross N. Taylor, Thomas D. Grey, Anabel L. Knoche, and Michael Love

March 31, 2003

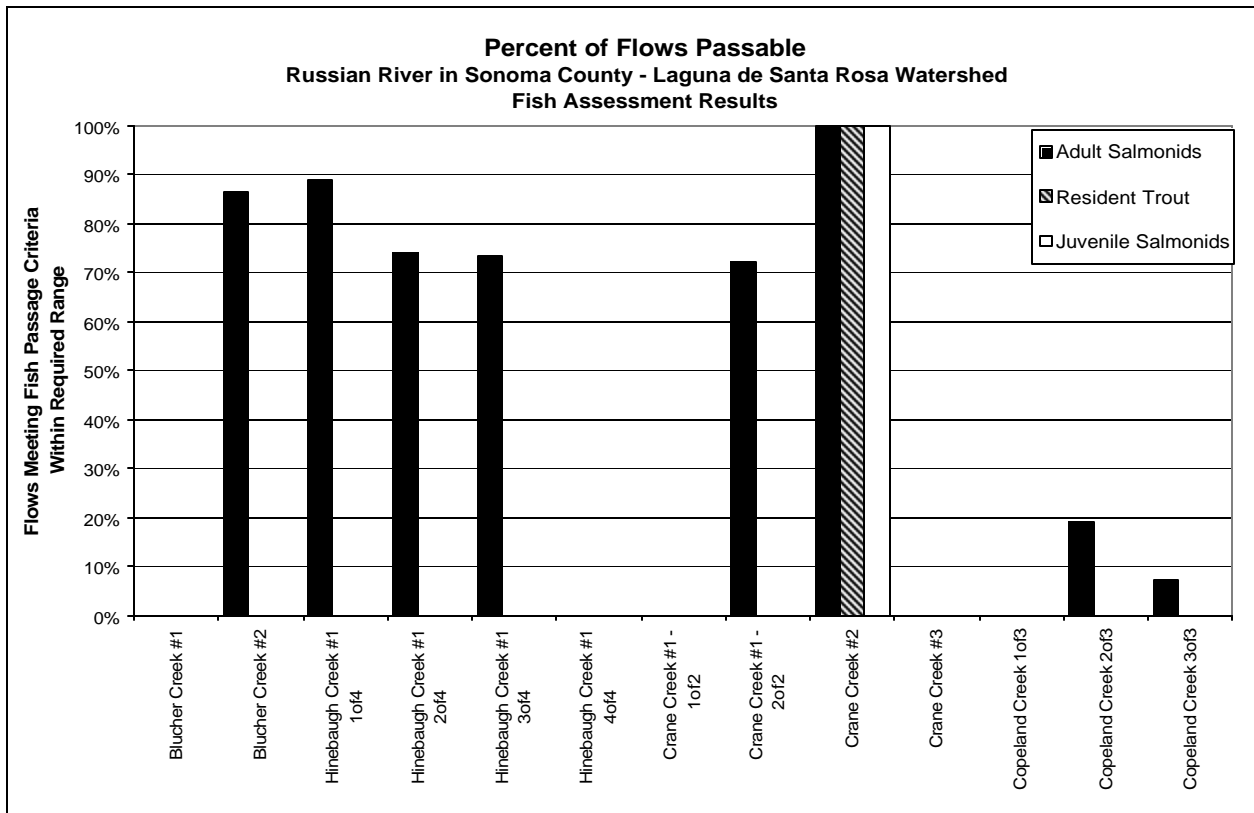
Figure 12. Percent passable as estimated by the Green-Gray-Red evaluation filter and FishXing for seven Sonoma County stream crossings within the Laguna de Santa Rosa sub-basin, by three groups of life-stages.

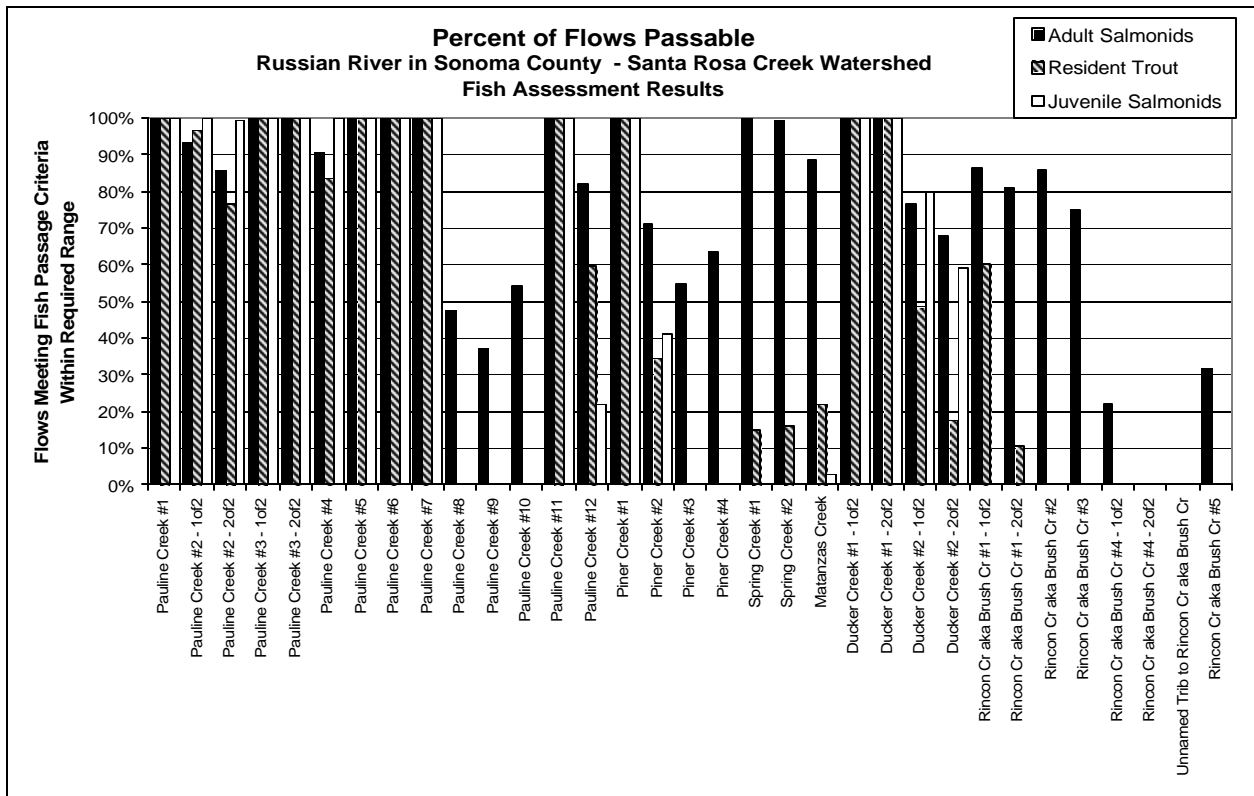
Figure 13. Percent passable as estimated by the Green-Gray-Red evaluation filter and FishXing for 27 Sonoma County stream crossings within the Santa Rosa Creek sub-basin, by three groups of life-stages.
