**Final Report:
1999 East Austin Creek
Watershed Erosion Control and Prevention Project,
SB271 Road Upgrading and Decommissioning Project**

**California Department of Fish and Game, &
California Department of Parks and Recreation,
East Austin Creek State Recreation Area**

Pacific Watershed Associates
Arcata, California,
(707) 839-5130

May 2002

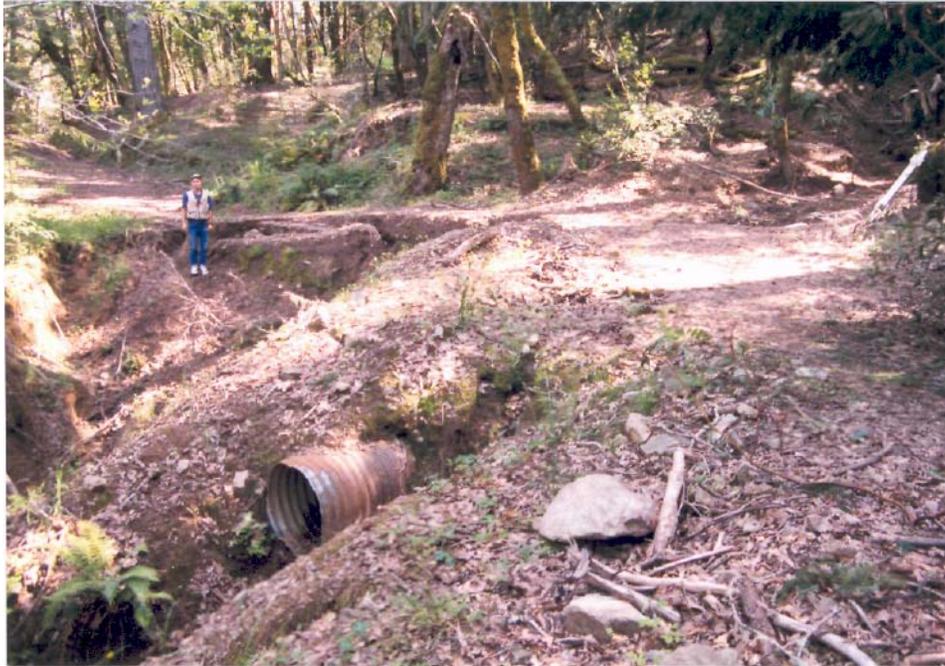
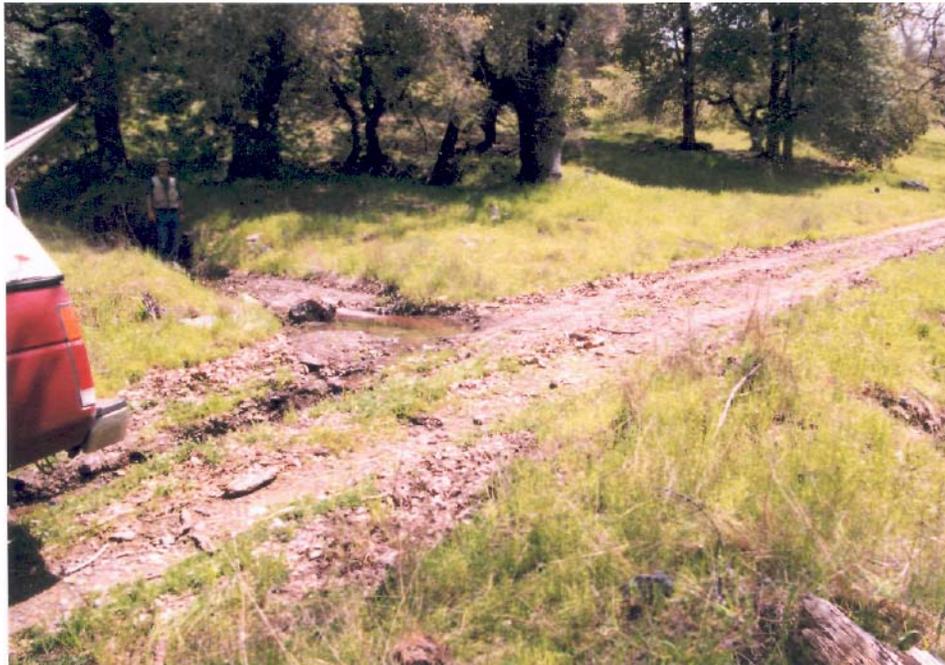
Figure 1A and 1B. Examples of typical erosional problems in Austin Creek State Recreation Area which lead the State Parks and PWA to seek CDF&G funding to protect important aquatic habitat in the East Austin Creek watershed. Failed stream crossings and direct sediment delivery (upper photo), un-culverted diverted streams resulting in hillslope gully erosion and sediment delivery (lower photo).

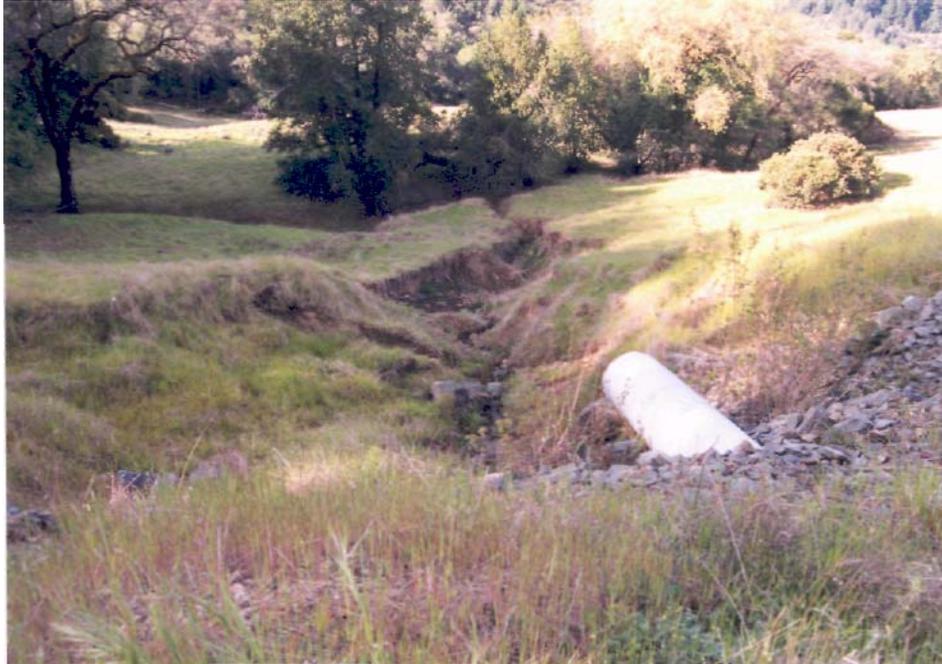
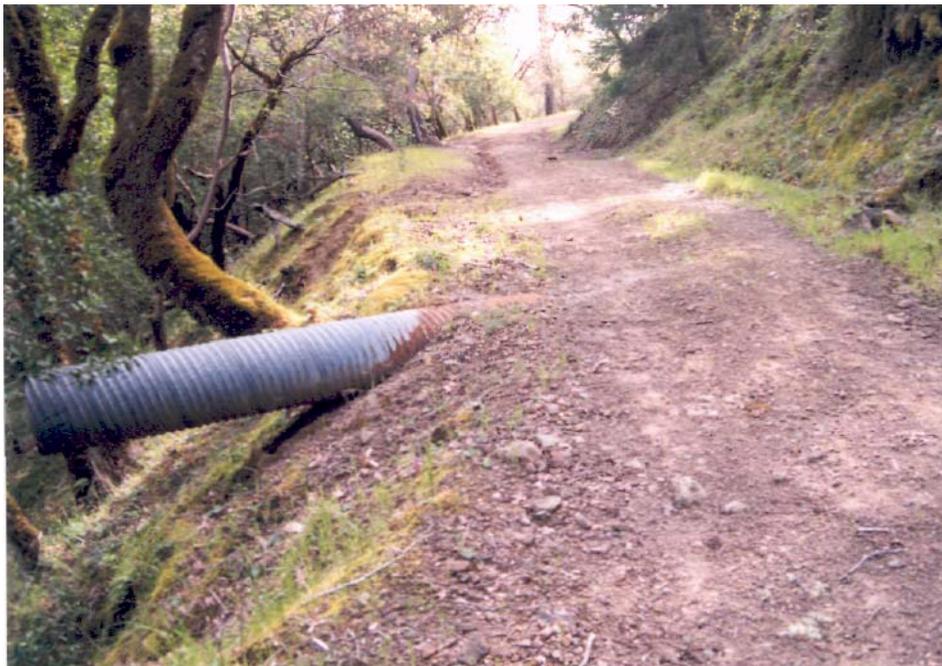
Figure 2A and 2B. Examples of typical erosional problems in Austin Creek State Recreation Area which lead the State Parks and PWA to seek CDF&G funding to protect important aquatic habitat in the East Austin Creek watershed. Large road bed drainage areas between ditch relief culverts resulting in the formation of large man-made channels (hillslope gullies) and direct sediment delivery (upper photo), long lengths of un-controlled or un-planned road drainage resulting in high sediment delivery rates of road bed. surface lowering erosional products (lower photo).

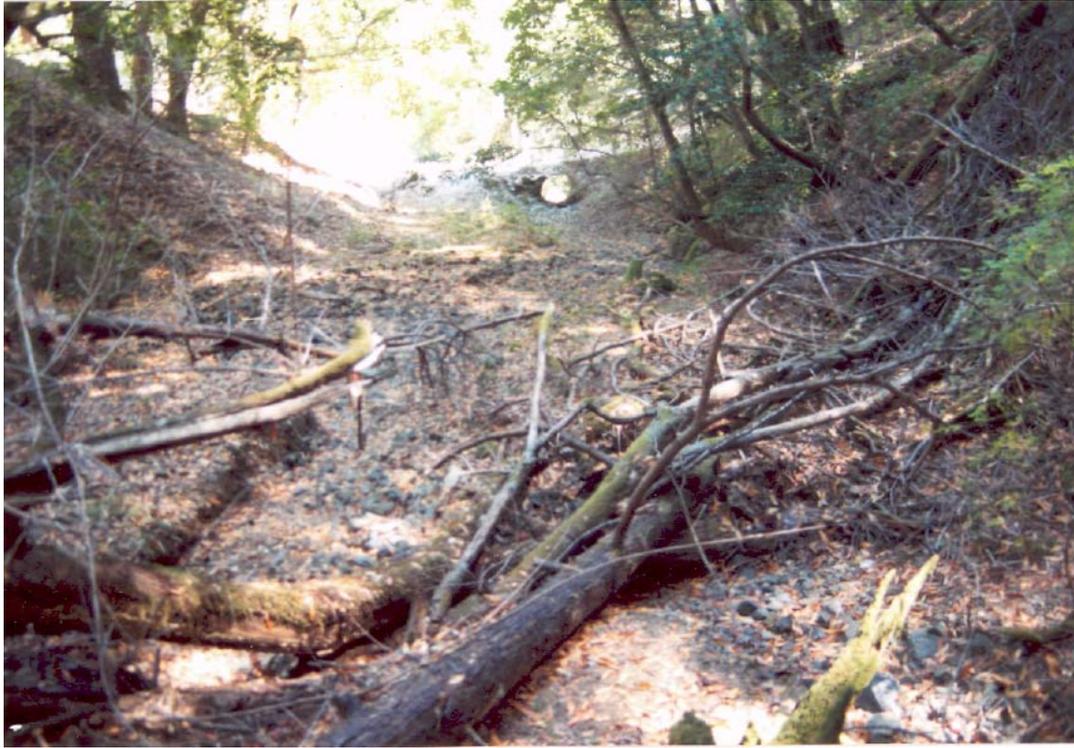
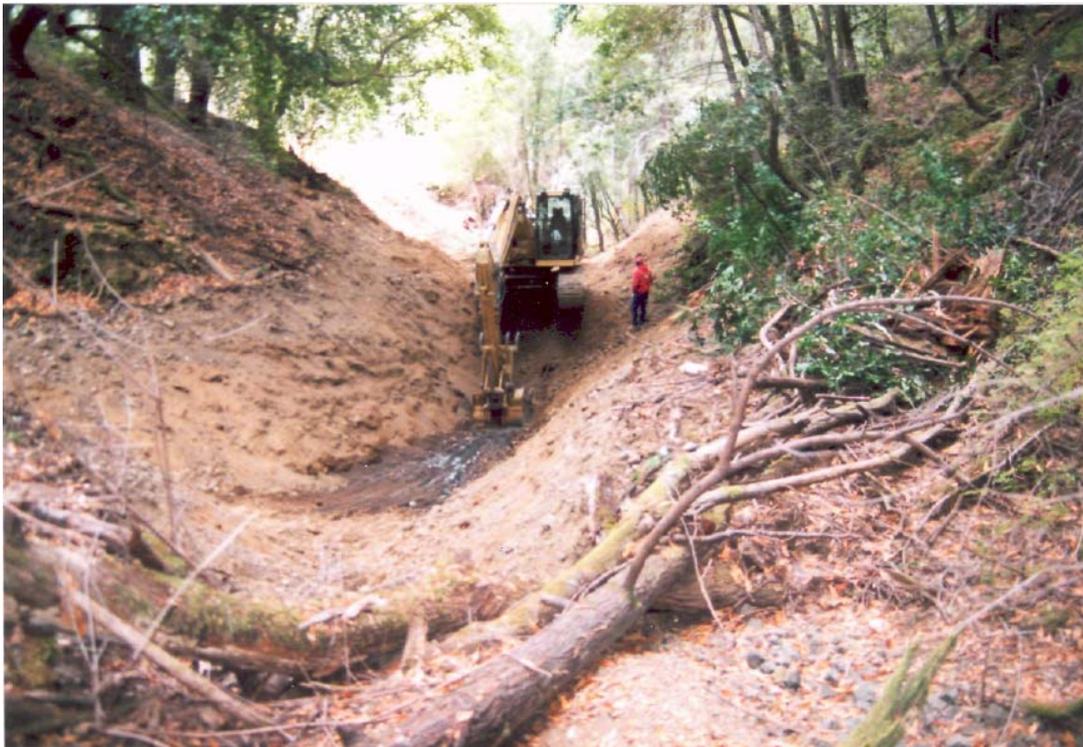
At site #73, the existing culvert was undersized, had a high plug potential, was a fish barrier with a 15 foot vertical culvert outfall to the perennial stream below, and had stored approximately 1500 yds³ of channel stored sediment above the culvert inlet. The assessment had called for excavating the crossing and installing a bridge. However, as the excavation proceeded, it was clear that installing a stable bridge crossing was going to be difficult. Several meetings were held with park personnel to explore options for pedestrian and equestrian access through or around the large excavation. It was agreed that the best option was to construct 500 feet of new trail around the site. The new trail has not yet been built, but we encourage it be constructed this year.

Figure 3A (top) and 3B (bottom). View downstream. Before and during excavation of channel stored sediment above undersized culvert stream crossing at Site #73. The culvert installation was a barrier to upstream fish migration and had also resulted in channel aggradation for 100 feet upstream of the culvert inlet. The stream crossing was properly closed by excavating all road fill and channel stored sediment upstream from the culvert.

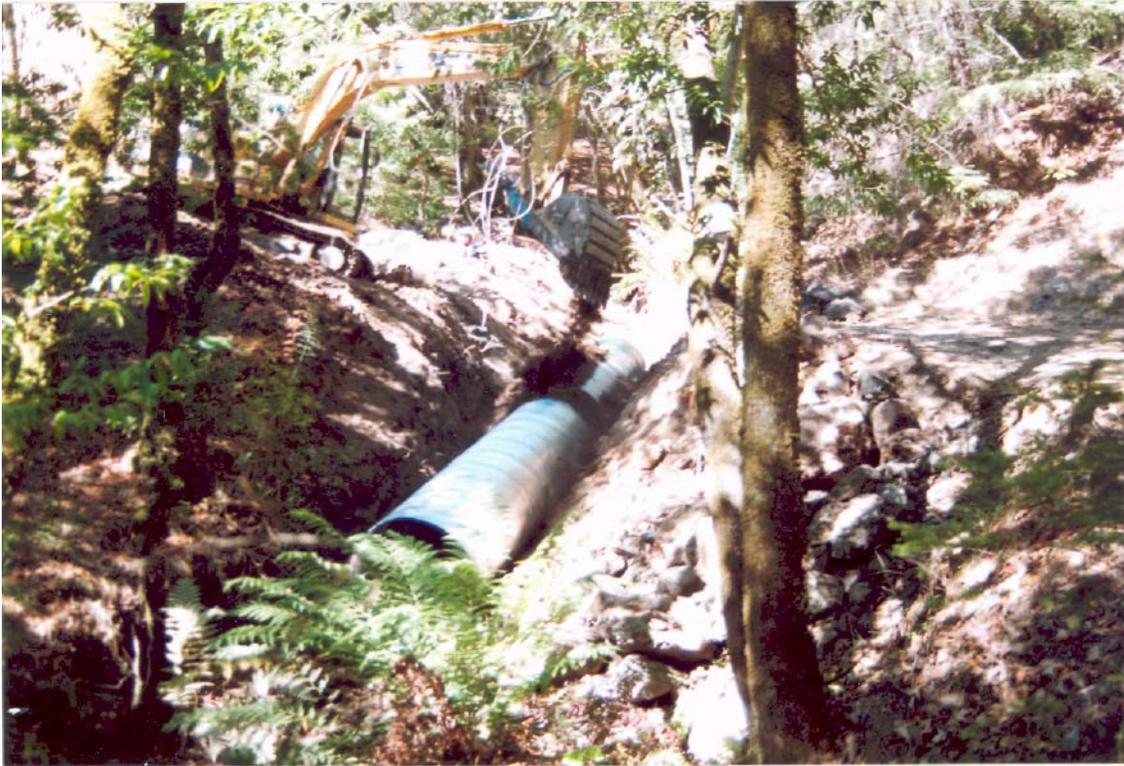
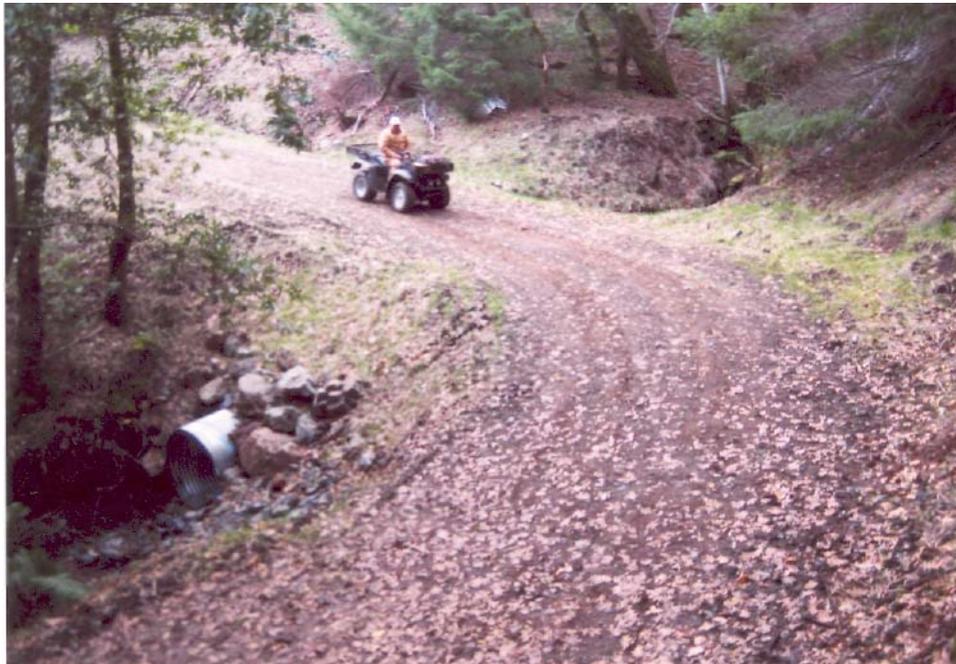
Figure 4A (top) and 4B (bottom). Thirty-one stream crossings had culverts installed which were sized for the 100 year storm. The culverts were installed at the base of the fill in line with the natural channel, had sufficient culvert length to construct stable fill slopes and were fitted with critical dips to prevent future stream diversions.

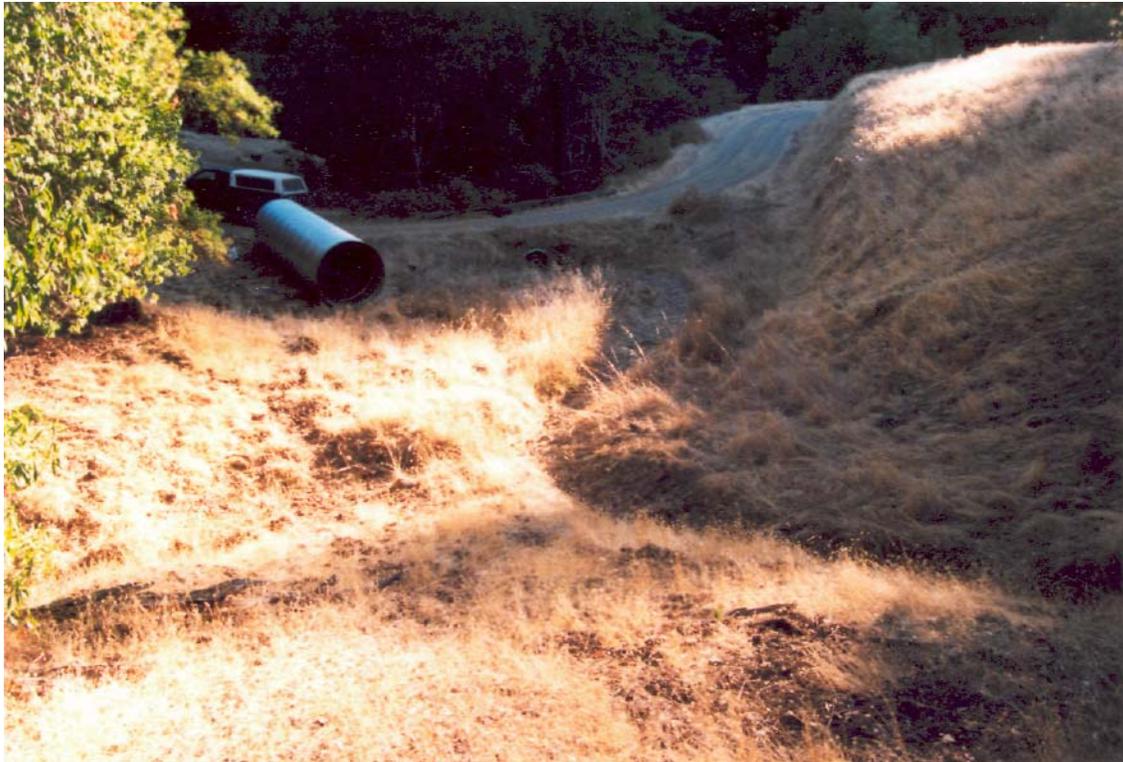
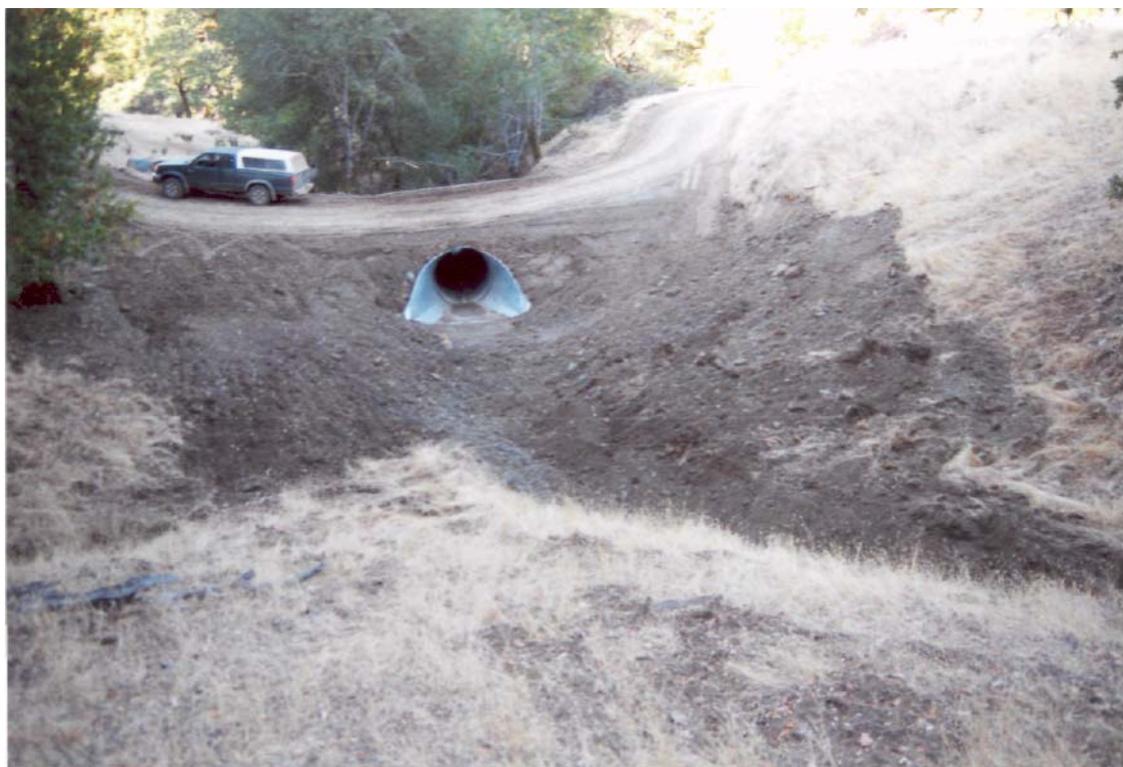
Figure 5 A (top) and 5B (bottom). View downstream at Site #43. Before and after photographs of upgraded stream crossing. Note prior and current culvert size, use of flared inlet to lower the plug potential at the inlet, use of low berm at outside edge of road to protect newly constructed fill slope and the excavation of channel stored sediment above the prior culvert inlet.

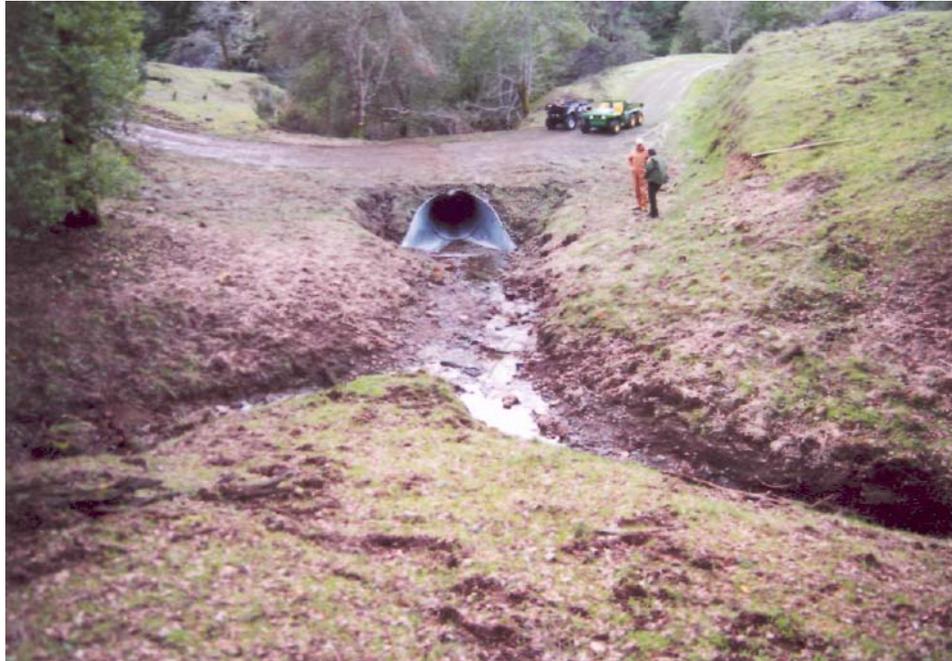
Figure 6. View downstream at Site #43 one winter after installation. Channel is flowing on bedrock with minor channel adjustments in cross sectional area, and the site has stable sideslopes.

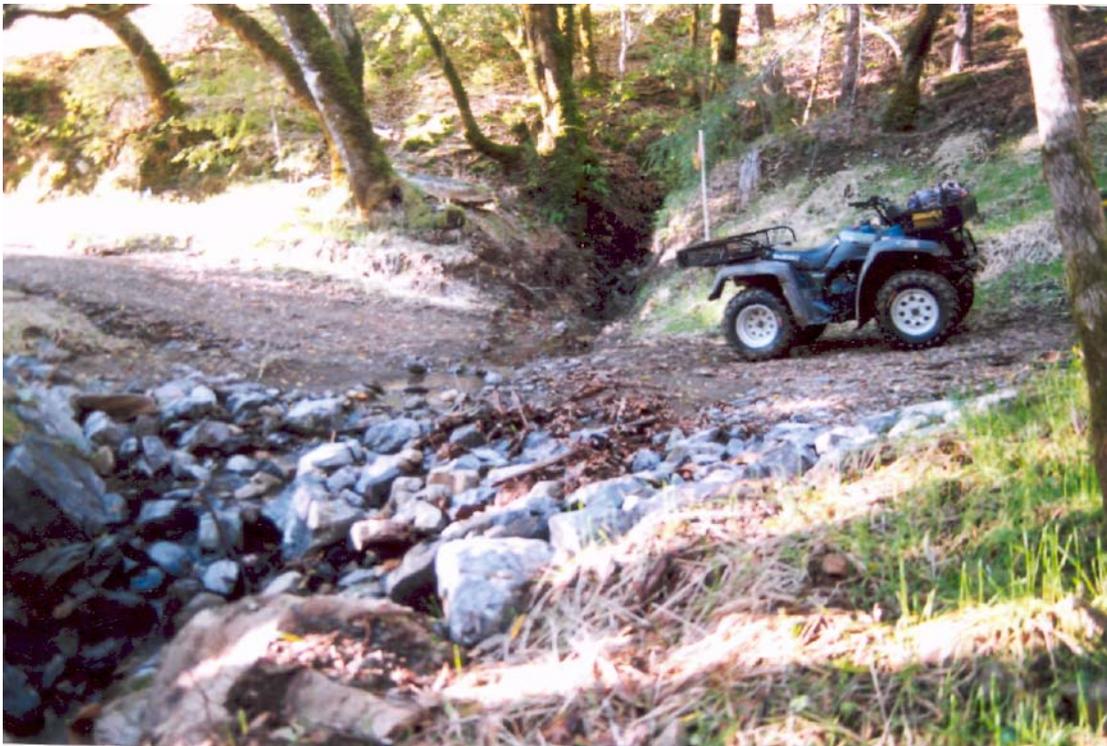
Figure 7. Twenty-three armored fill stream crossings were constructed in the East Austin Creek watershed during 2001. Armored fill crossings are appropriate along low use roads, and where properly sized culverts are difficult to install or where the culvert inlet would still have a high plug potential.

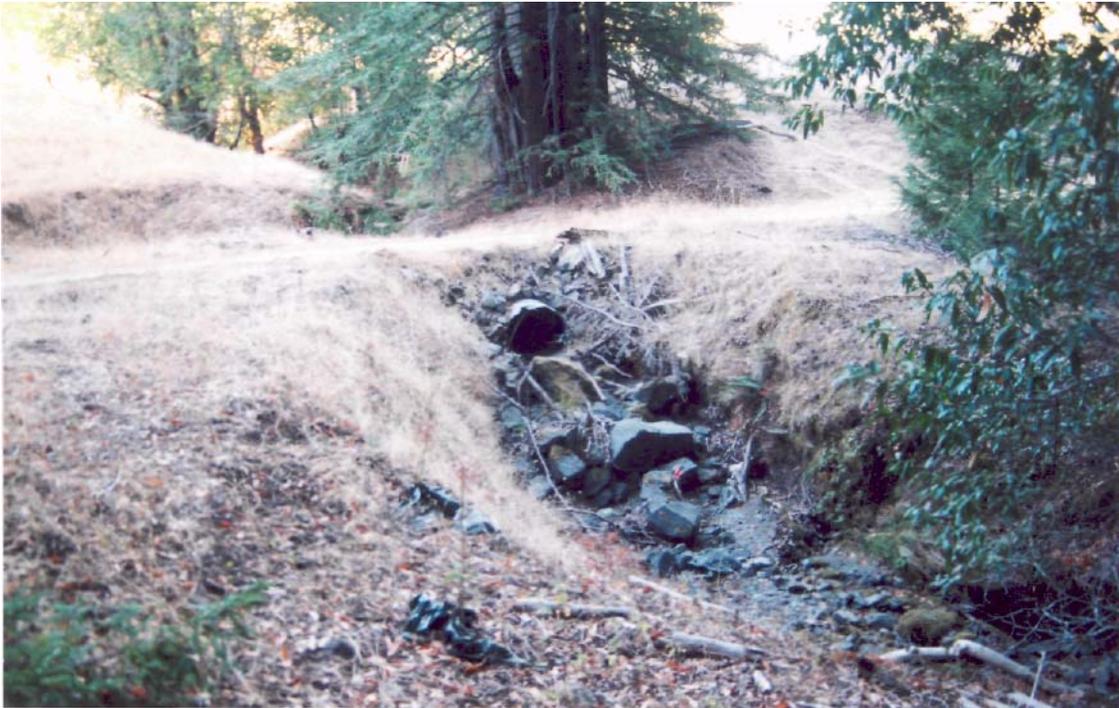
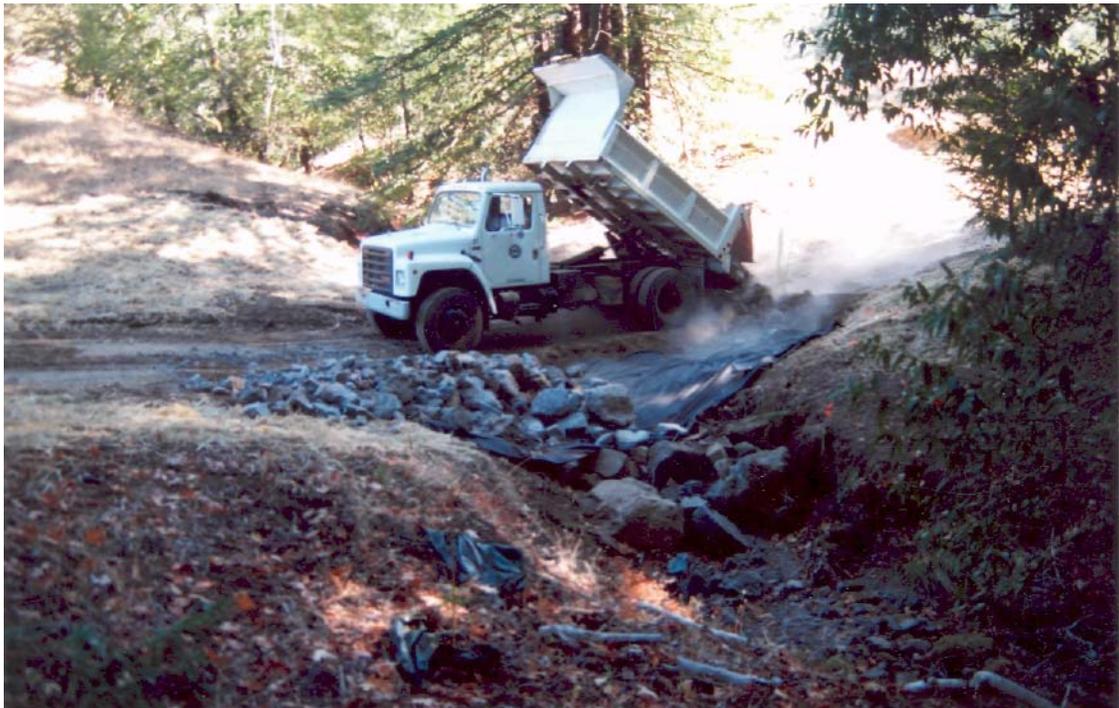
Figure 8A (top) and 8B (bottom). View upstream at Site #44. Before and during photographs of armored fill stream crossing installation. The shallow fill crossing limited the ability of Park Staff to install a properly sized culvert. Consequently, the culvert plugged frequently resulting in stream diversions and hillslope gullies. During installation, the road is lowered several feet vertically with a broad rolling dip, a keyway is dug from the base of the fill to the mid-point of the road bed, filter fabric is placed over the keyway, and a mix of rock armor is applied which is coarser than the stream is capable of transporting at high flows.

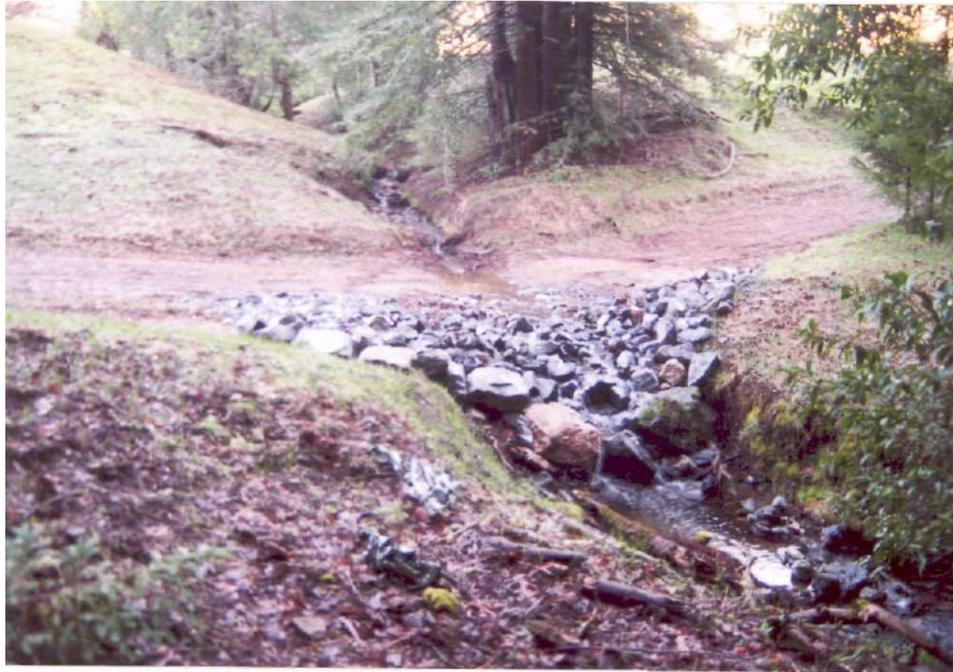
Figure 8C. View upstream at Site #44 one winter after installation. The stream must flow over the armored apron at all stream flows to function properly and prevent future sediment delivery to stream channels.

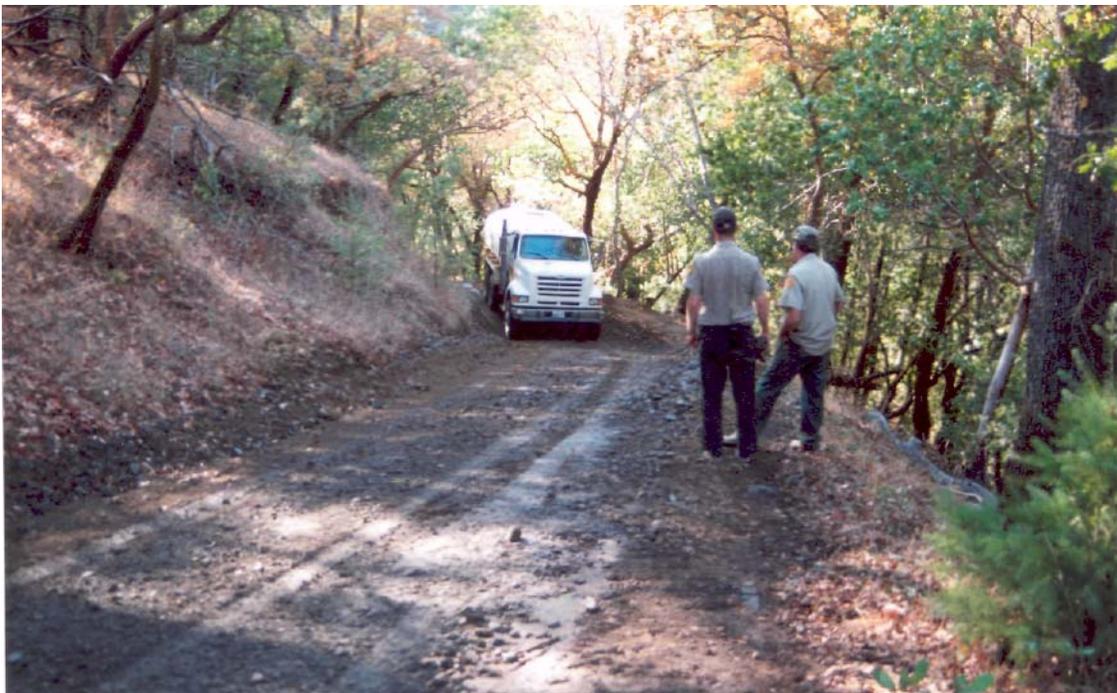
Figure 9. One hundred and thirty-six rolling dips were installed along roads in the Austin Creek State Recreation Area. Where appropriate, the road bed was outsloped, berms were removed and used to fill the inboard ditch, and broad, very driveable rolling dips were installed in order to disperse road runoff to the maximum degree possible.

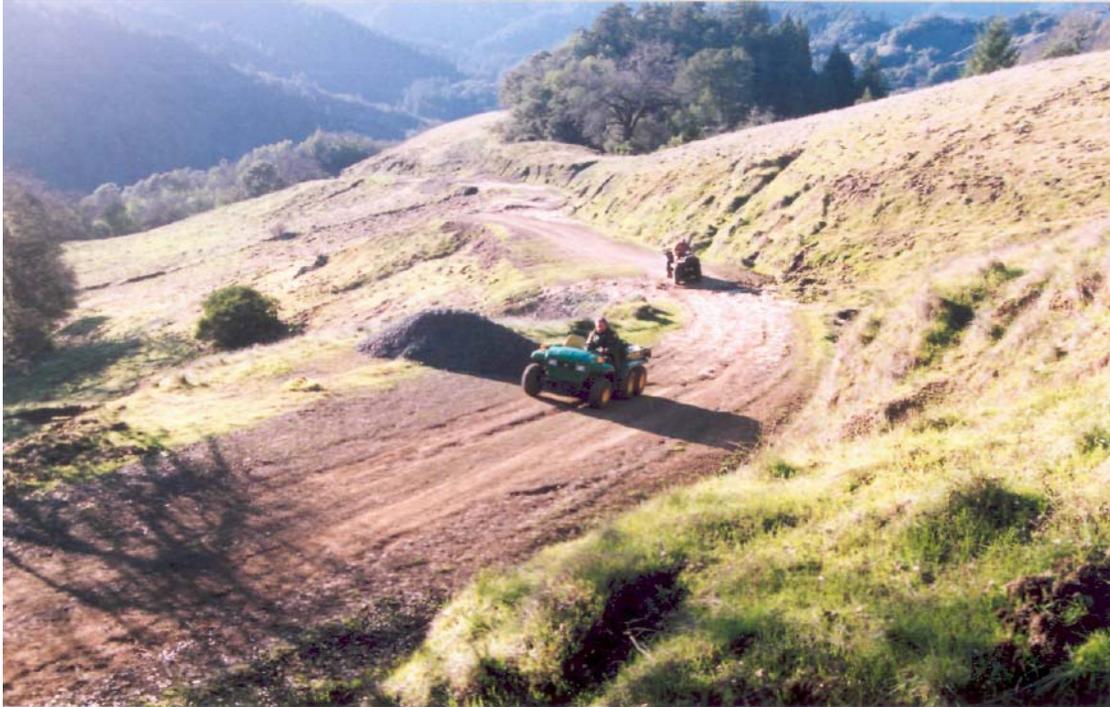
Figure 10. Often in grassland settings, ditches must be retained to insure a stable road bed. However, the road bed should be outsloped and berms removed, where possible, to disperse fine sediment originating from the road bed off the outside edge of the road, and not be delivered to live ditch. Heavy fall rains terminated the project last year prior to final road grading and the distribution of road rock. Some rilling of the road bed occurred during the winter. This section of road was recently re-graded to improve the outslope and insure the road drains properly in future years.

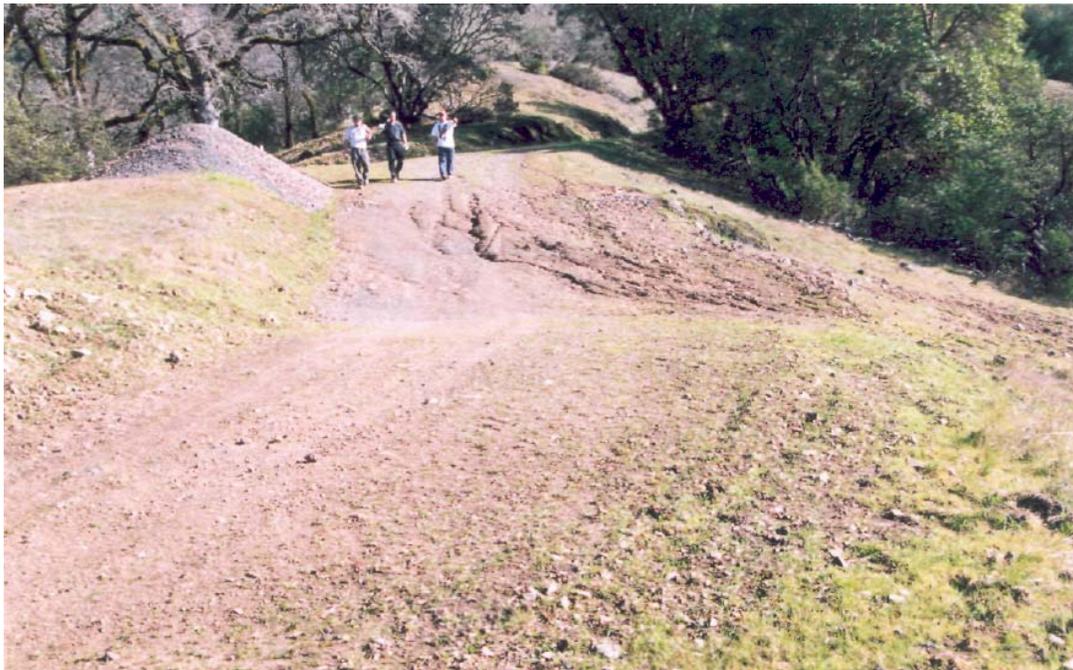
Figure 11. The erodability of the soil and the spacing between rolling dips dictates the extent of erosion occurring on the road bed. This rolling dip shows rills developing on the road bed when the road grade steepens, however all the sediment is deposited on the hillslope beyond the road with no sediment delivery to nearby streams.
