CALIFORNIA DEPARTMENT OF FISH AND GAME

STREAM SURVEY

NAME..... JOHNSON CREEKCOUNTY..... Mendocino

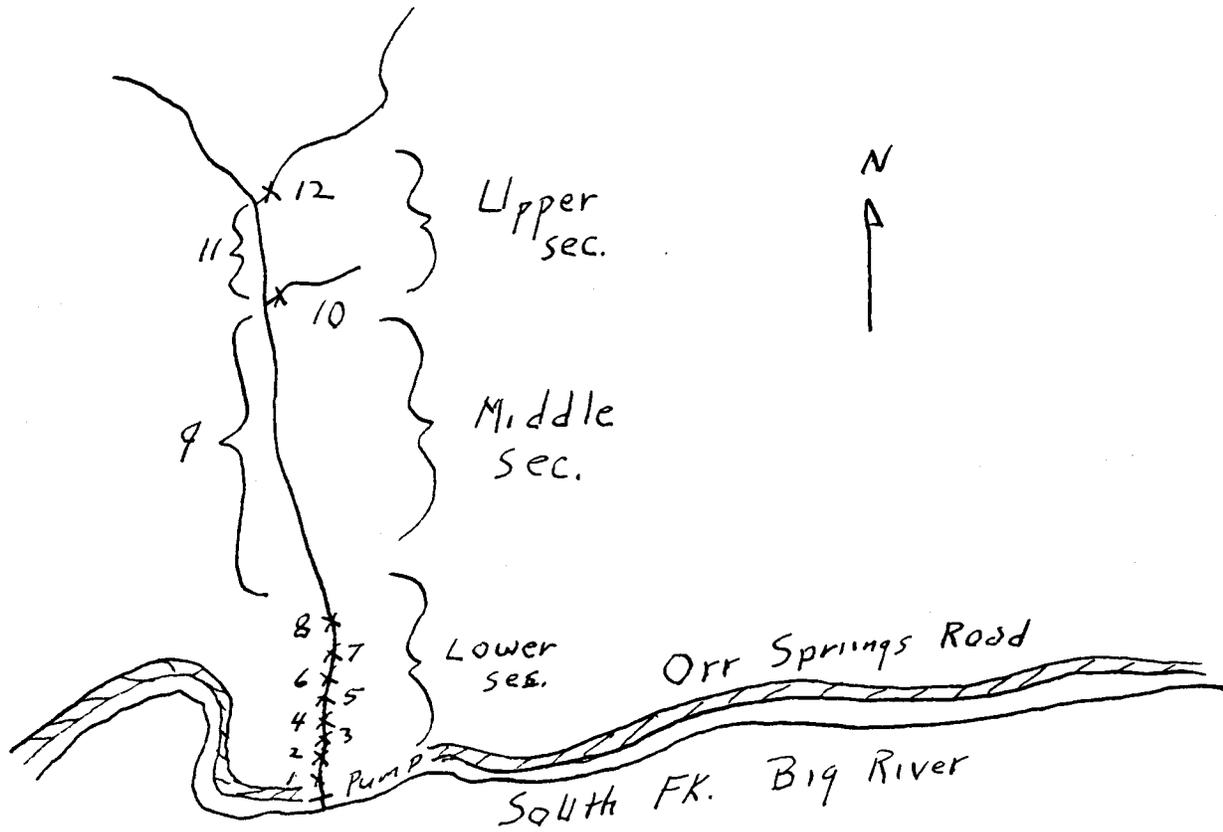
Johnson Creek
Trib. to S. FK. Big River

Jams and Barriers

1. Small pump 1-1/2 inch draft irrigation or domestic 200 yards upstream
2. 250 yards upstream small concrete dam no barrier - 1 ft high x 9 ft log
3. Log jam - no barrier - 10 ft wide 10 ft long - 3 ft high. void area

4. Log bridge crossing - barrier 4 ft high 30 ft long 10 ft wide 75% void dirt covering bridge 1000 yards upstream, from mouth.
5. Area 50 yards long - logging debris.

6. Log jam - no barrier - 20 ft wide 6 ft long 5 ft high void 60% 1/2 mile upstream from mouth.
7. Log jam - part barrier silted in - 2 ft high - 15 ft wide 10 ft long 5 ft high 90% void area 06 mile above mouth (Estimated).

8. Old logging sluice dam area no barrier 200 yards long 10 yards wide 10 yards high 95% void area 3/4 mile upstream.
9. Area from old dam upstream considerable logging debris and recent split stuff debris.

10. Tributary - little fisheries value.
11. Area between East Branch and Main Fork - heavily silted with considerable logging debris.
12. Forks - Minor flows in East and West forks - doubtful fisheries value.

Although Johnson Creek has undergone considerable logging damage it has a potential of becoming a fair Silver Salmon stream if the logging debris and old dam are removed. If the stream is rehabilitated to the main fork further investigation should be made for rehabilitating these forks.
