FISH HABITAT IMPROVEMENT COMPLETION FORM REGION 3

Stream or Lake Name <u>Horse Creek</u> Tributary to <u>Rancheria Creek</u>
County Mendocino Township 13N Range 15W Section 2&3 ½S
Section of stream work One mile upstream from confluence with Rancheria Creek
Sponsor Fish and Game Work crew New Growth Forestry
Landowner name, address, phone # Congaree River Limited (Western Timber Services)
P.O. Box 1136 Arcata, CA 95521 and Harry Merlo 11 SW Fifth Ave., Ste. 4200. Portland OR 97204
Project duration Dec 1986 - Jan 1987 Man-days expended (dates)
Source of funding SB400 Total cost
Project benefitFish passage Species affected SH
Number of jams removed 10 Number that were barriers 4
Cubic yards of material removedAmount of sediment
Miles of stream opened 1½2 Miles improved
Methods used Hand labor, chainsaws - burn material
Further action recommended
Location of maps and photos
Additional comments, explanations, or details:

HORSE CREEK SITE DESCIPTIONS

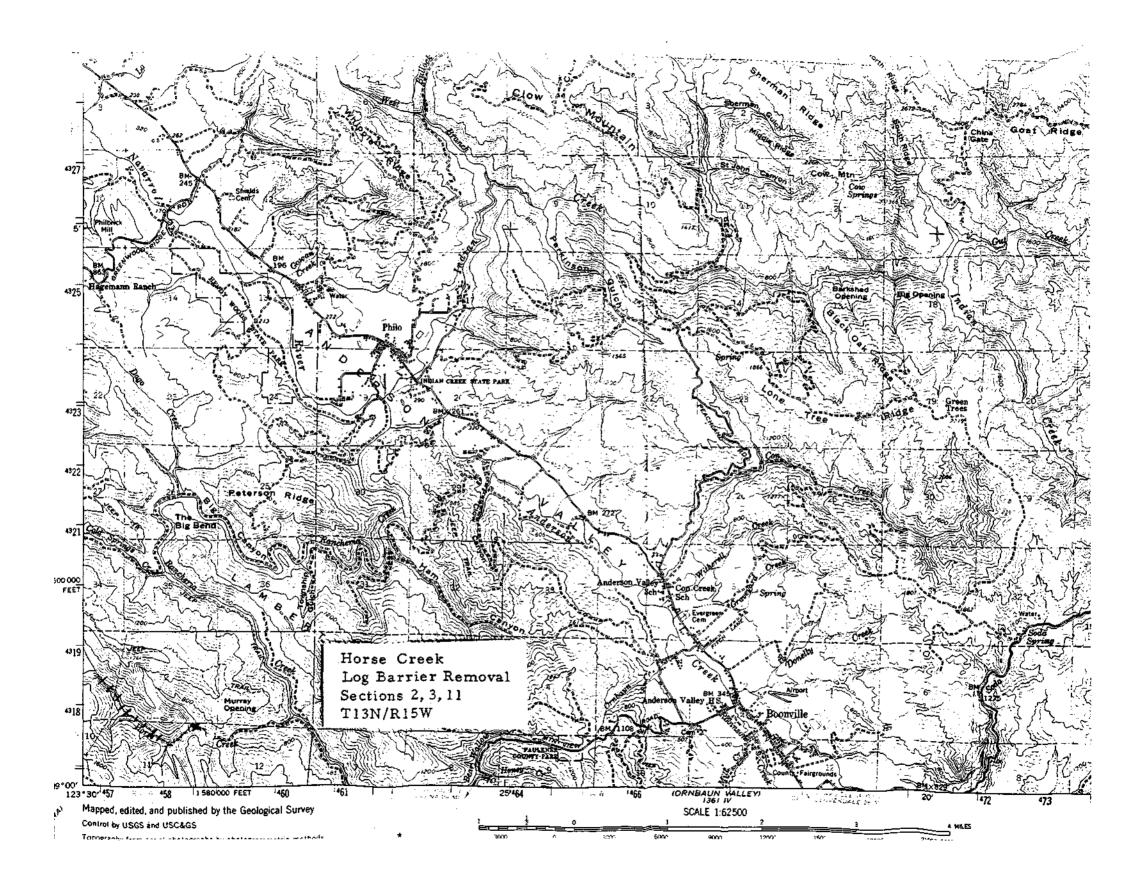
- Site 1. Debris jam, 60'x20'x8', not a barrier. Causing side bank erosion and bringing down adjacent trees. Widen channel and burn.
- Site 2. Partial barrier, 25'x25'x7', at confluence of two main branches. Full remove and burn.

Site 3. Partial barrier, completely embedment of 8' of gravel. Partial removal and burn.

- Site 4. Waterfall. Minor removal of debris from channel to lower jump slightly and remve obstructions.
- Site 5. Debris jam, not a barrier, in narrow section of creek. Clear a channel for debris flushing from above. Burn.
- Site 6. Debris jam behind old Humboldt crossing, not a barrier. Clear a channel to one side.
- Site 7. 5' waterfall and downstream debris pile. Remove obstructing pieces from the spillway and reduce height of fall as necessary. Remove downstream debris.
- Site 8. Partial barrier impounding 15'-20' of bedload. Clear a channel and burn.
- Site 9. Debris jam, not a barrier, with active slides from each bank. Clear a channel and burn.

- Site 10. Debris jam, not a barrier, impounding 6' of bedload. Clear a channel for low flow passage.
- Site 11. Complete barrier, no fish above. Clear a channel and burn.
- Site 12. Debris jam. Clear center of channel.
- Site 13. 4' fall over rock and debris. Remove debris.
- Site 14. 4' fall over rock. Remove adjoining log to lower and clear jump.
- Site 15. 4' fall. Lower jump.
- Site 16. 5' drop over bedrock formation. Blasting may be necessary.
- Site 17. Debris jam, not a barrier. Clear a channel.
- Site 18. Partial barrier impounding 4^{\prime} of bedload. Clear a channel.
