CALIFORNIA DEPARTMENT OF FISH AND GAME

STREAM SURVEY

NAME..... RICE CREEK.....COUNTY..... Mendocino.....
 STREAM SECTION.....FROM..... mouth.....TO..... branch of east and south fork.....LENGTH.....
 TRIBUTARY TO..... Rice Creek at Big River.....Twp..... 17N.....R..... 14W.....Sec..... 34.....
 OTHER NAMES..... none Known.....RIVER SYSTEM..... Big River.....
 SOURCES OF DATA..... personal observation.....

RICE CREEK (Lower)

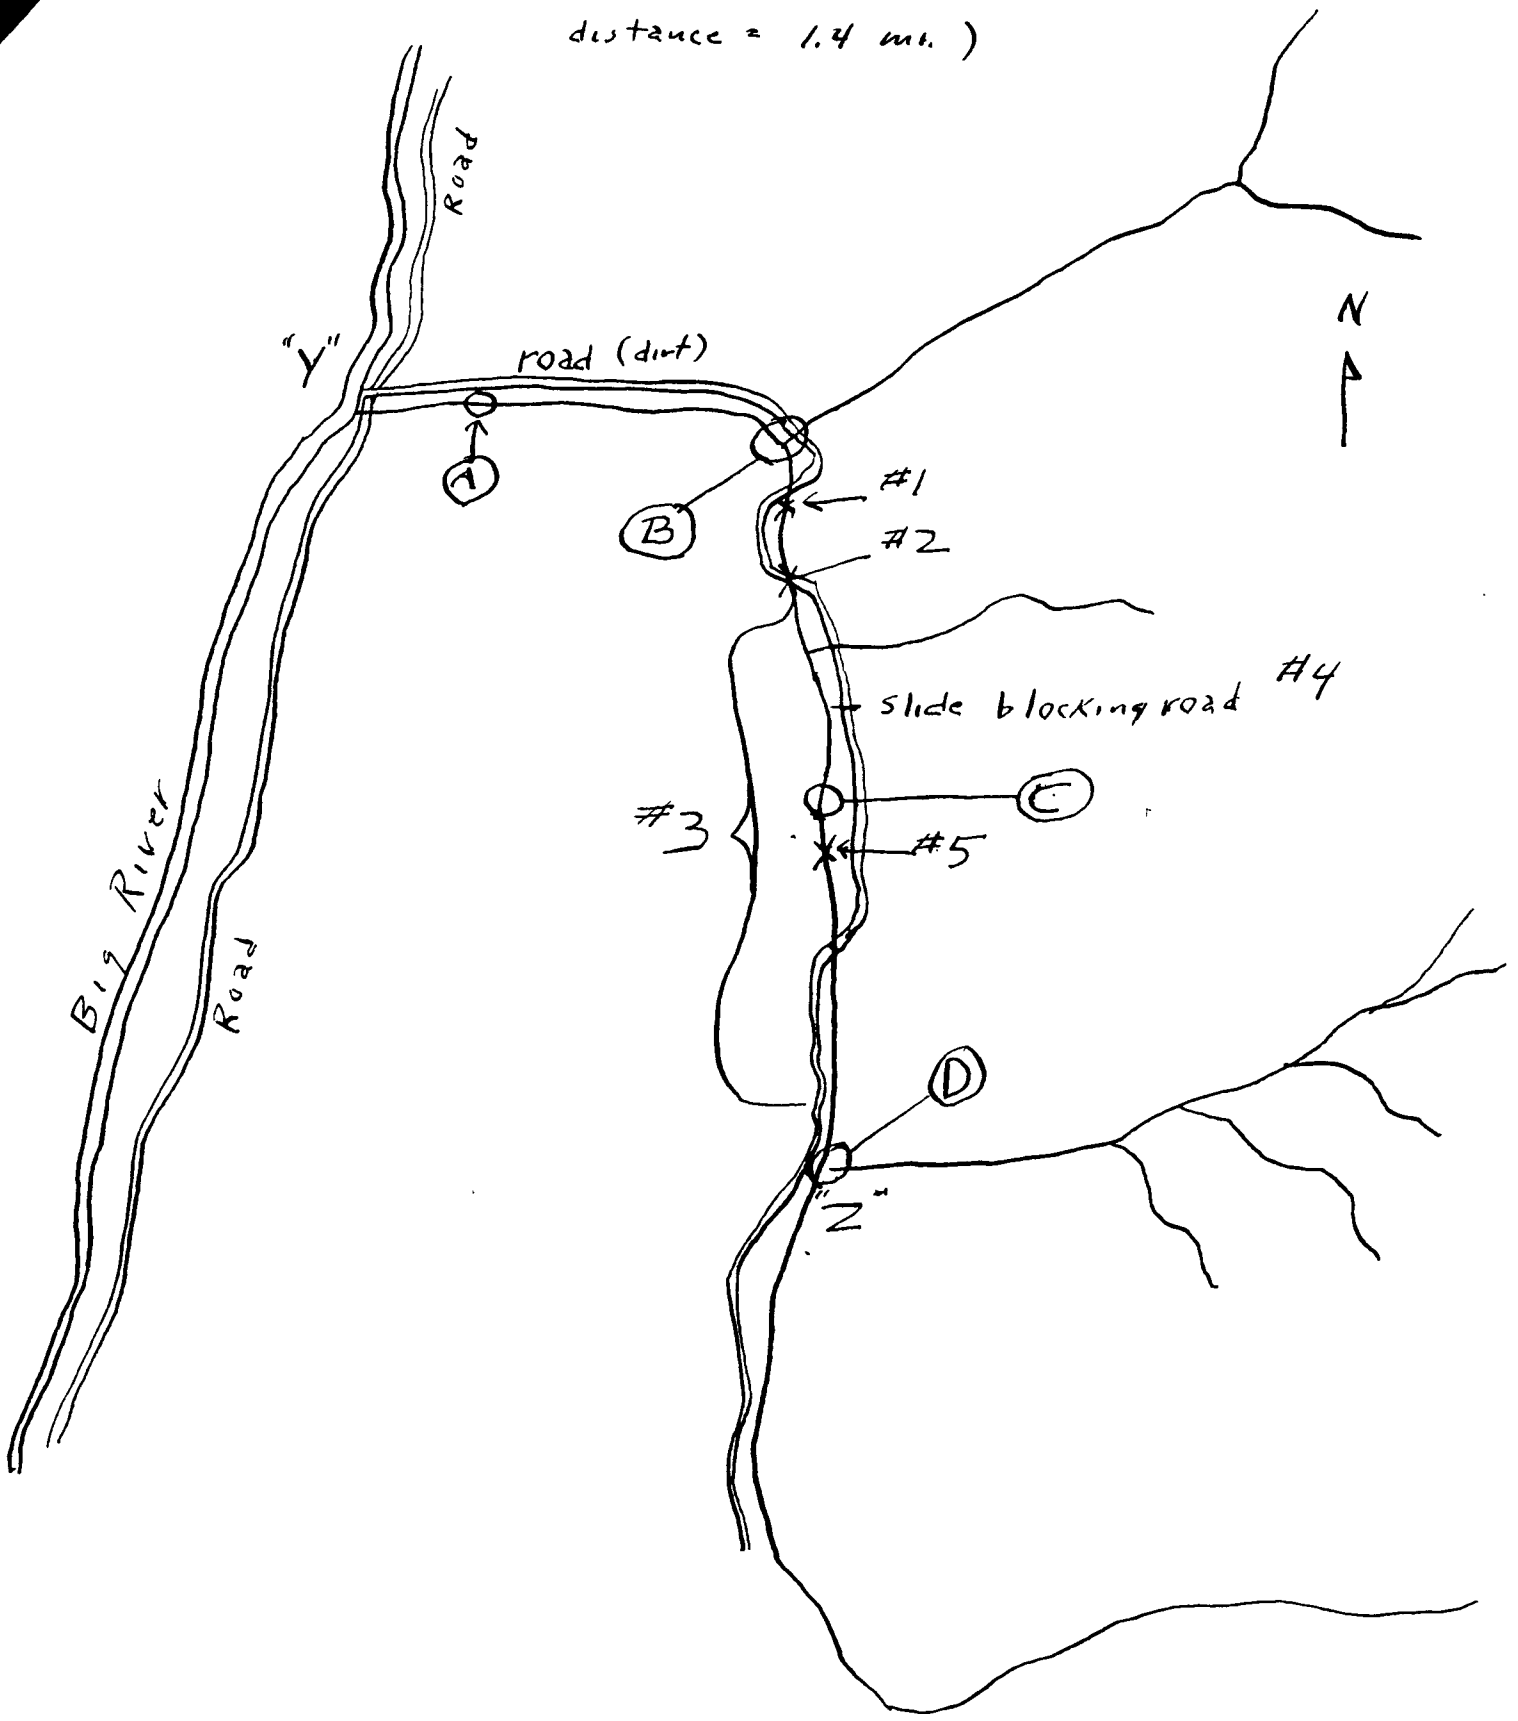
1. Log jam and barrier - just above 1st bridge crossing - log and dirt - 100 ft long 30 ft wide 6 ft high - 99% void bed drop 6 ft - silted in.
2. Log jam and barrier - at second bridge crossing - log dirt - silted in 40 ft long 20 ft wide 5 ft high - 70% void area - bed drop 5 ft.
3. On up from #2 could be classed as intermittent to continuous, jams, fallen logs, slash and debris (barriers) in the streams One long log jam x 20 ft wide 5 ft high - 99.9% void.
4. Located .8 mile up from mouth - blocking the road.
5. A large log jam and slide silted in-by the 3rd bridge, over stream - 200 yards above #4. Barrier. 75 ft long 20 ft wide 8 ft high -75% void - bed drop 6ft.

(Mouth to E. fork - "y" to "z"
distance = 1.4 mi.)

Food - Appears to be common.
 Aquatic Plants - Heavy growth of algae and other aquatic plants.
 Winter Conditions - Considered to be mild with normal fluctuating winter runoff.
 Pollution - Logging damage observed.
 Springs - Common to uncommon.
 FISHES PRESENT AND SUCCESS - No fish life observed therefore apparently there
 is no success.
 OTHER VERTEBRATES - Frogs, lizards, squirrels, chipmunks, cows, deer, abundant.
 Snakes uncommon.
 FISHING INTENSITY - none.
 OTHER RECREATIONAL USE - Unknown.
 ACCESSIBILITY - See other Rice Creek report.
 OWNERSHIP " " " " "
 POSTED OR OPEN " " " " "
 IMPROVEMENTS " " " " "
 PAST STOCKING- - Unknown
 GENERAL ESTIMATE - the lower section of Rice Creek appears to exhibit suitable
 spawning conditions. The upper section of the stream is similar to conditions
 listed in other report.
 RECOMMENDED MANAGEMENT - Log jams should be removed in the lower section of the
 stream.
 SKETCH MAP- See attached.
