**OVERVIEW OF
STREAM CHANNEL CONDITIONS
NORTH FORK GARCIA RIVER**

by Jack Monschke
16 May 1996

**OVERVIEW OF
STREAM CHANNEL CONDITIONS
IN THE NORTH FORK GARCIA
FROM PRE-1953 TO PRESENT:**

Submitted by
Jack Monschke
for Coastal Forestlands, Ltd.

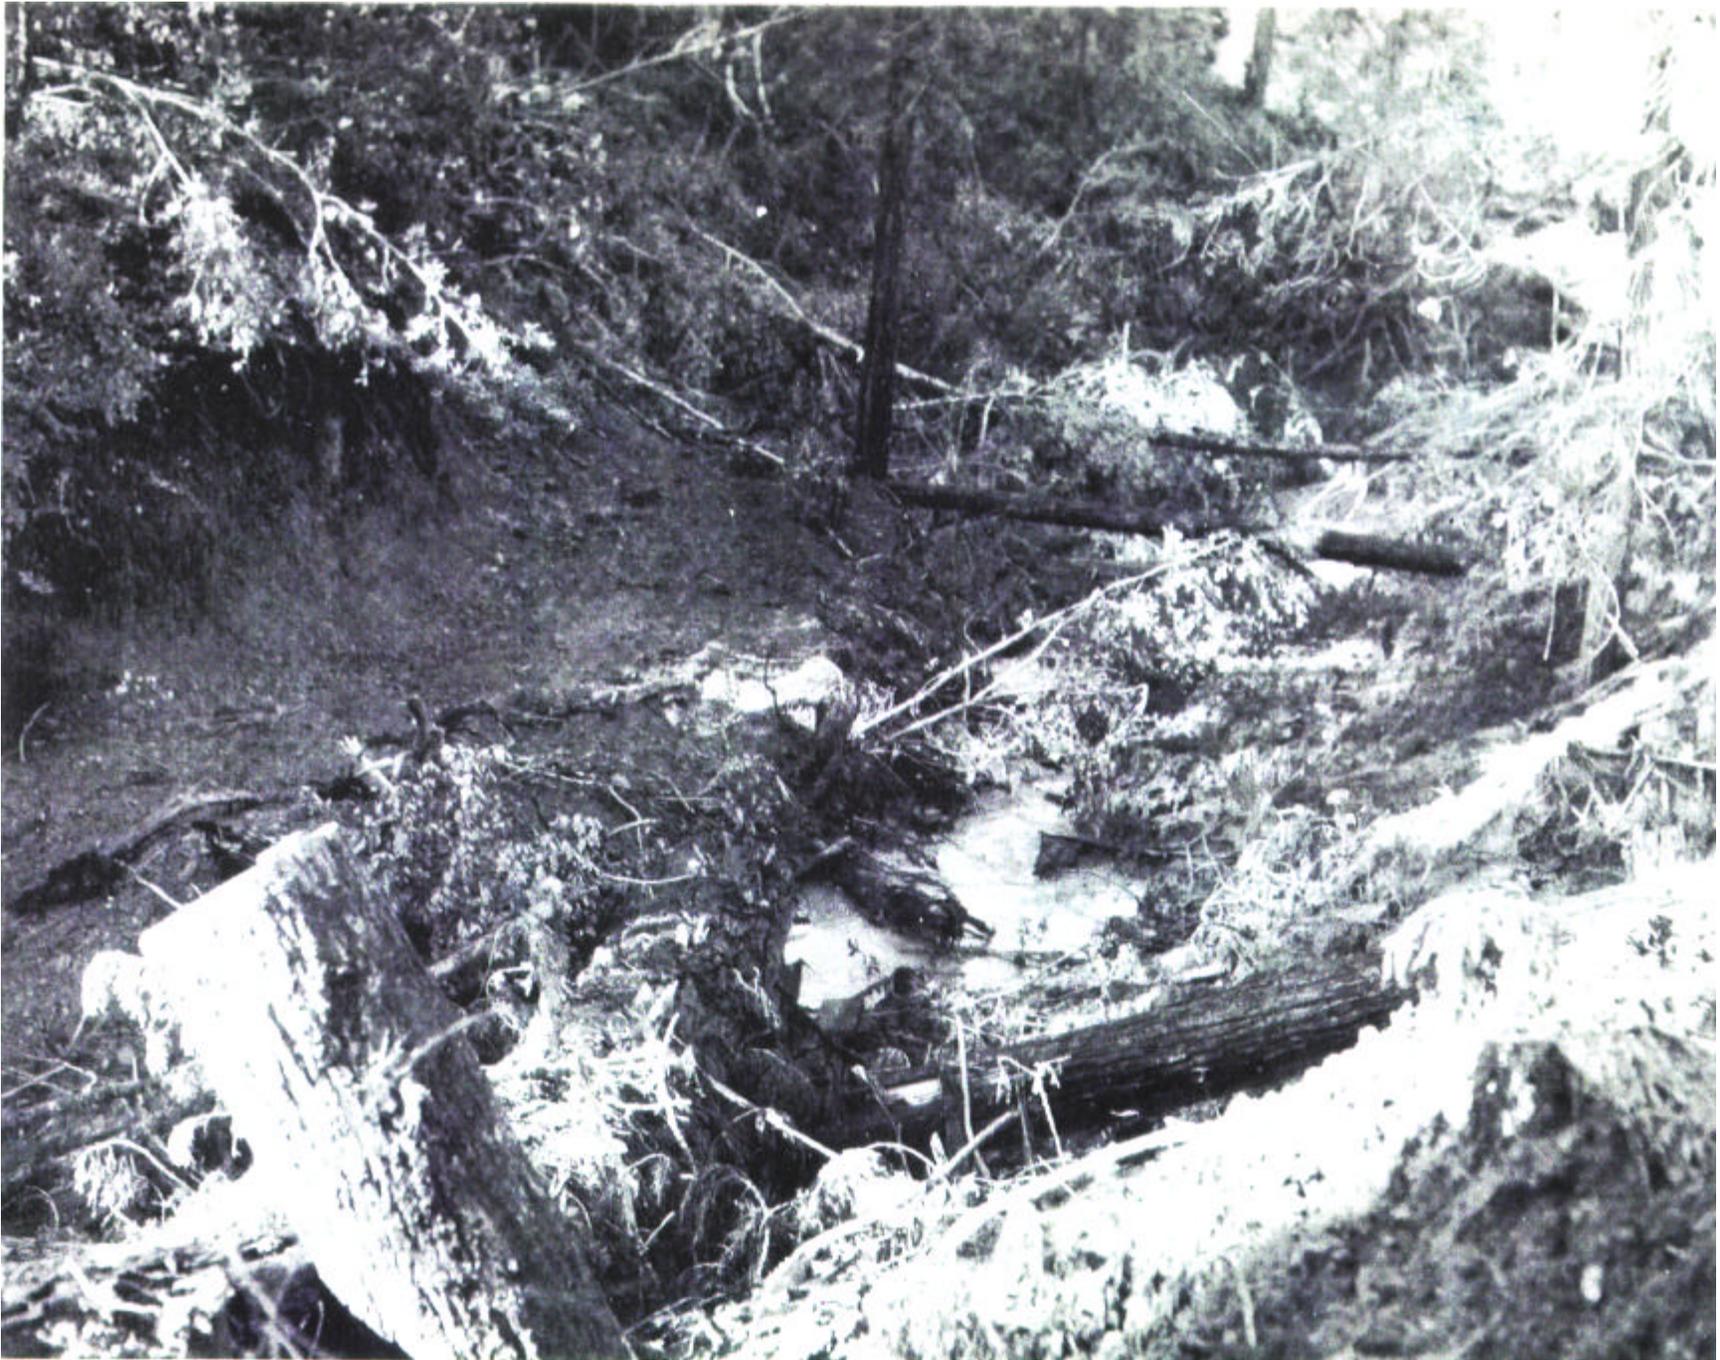
NORTH FORK, GARCIA RIVER, MENDOCINO COUNTY, Nov. 22, 1955. Road from which picture was taken, and skid road at left, virtually obliterated stream here. Water can be seen running out from under logs and rubble. (*Fish and Game photo*)

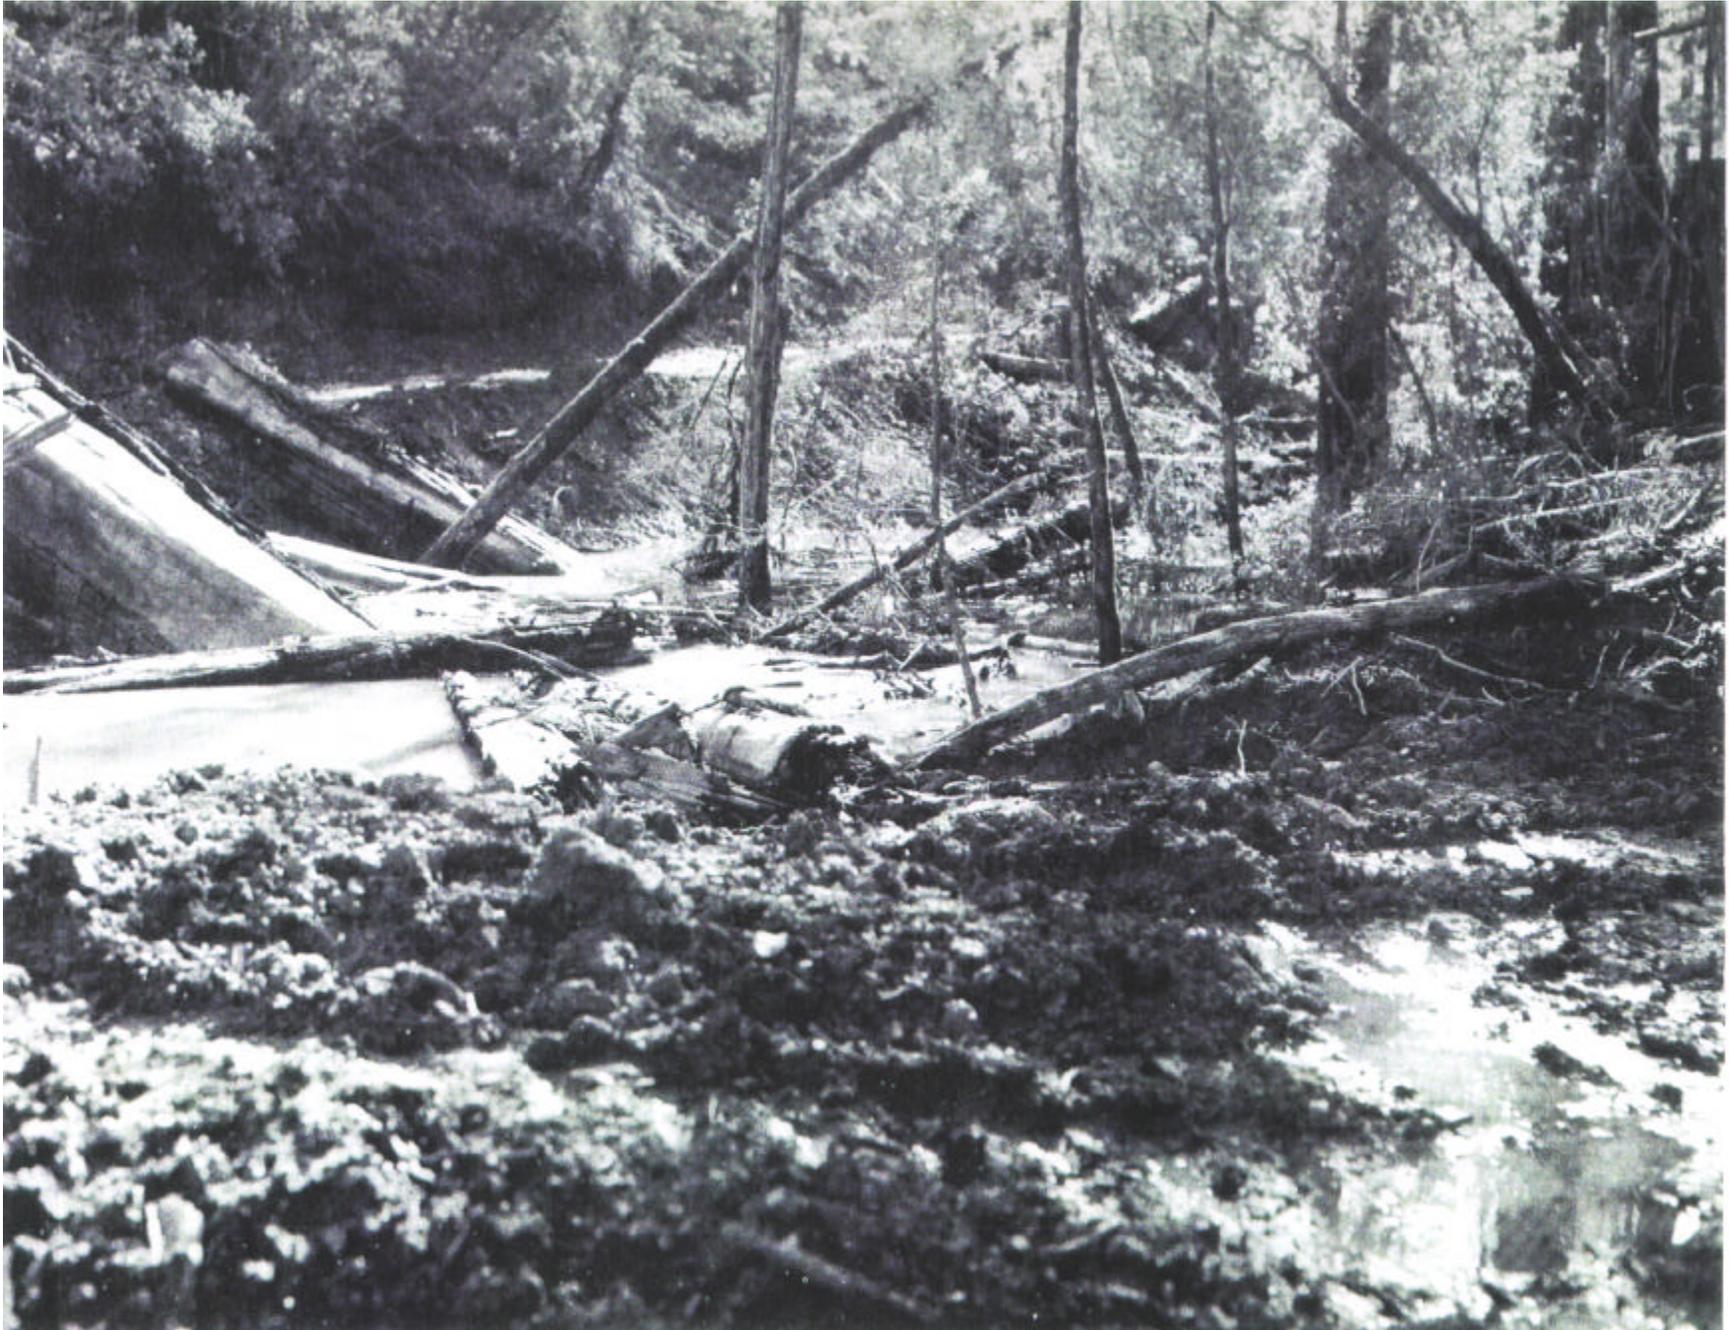
NORTH FORK, GARCIA RIVER, MENDOCINO COUNTY, intersection of a small tributary, Nov. 22, 1955. Landing and parking area built into confluence. Mud in foreground is shoulder of parking area, looking upstream into tributary. No culvert apparent and water appears to be seeping under logs and rubble. No flow visible into the Garcia. (*Fish and Game photo.*)

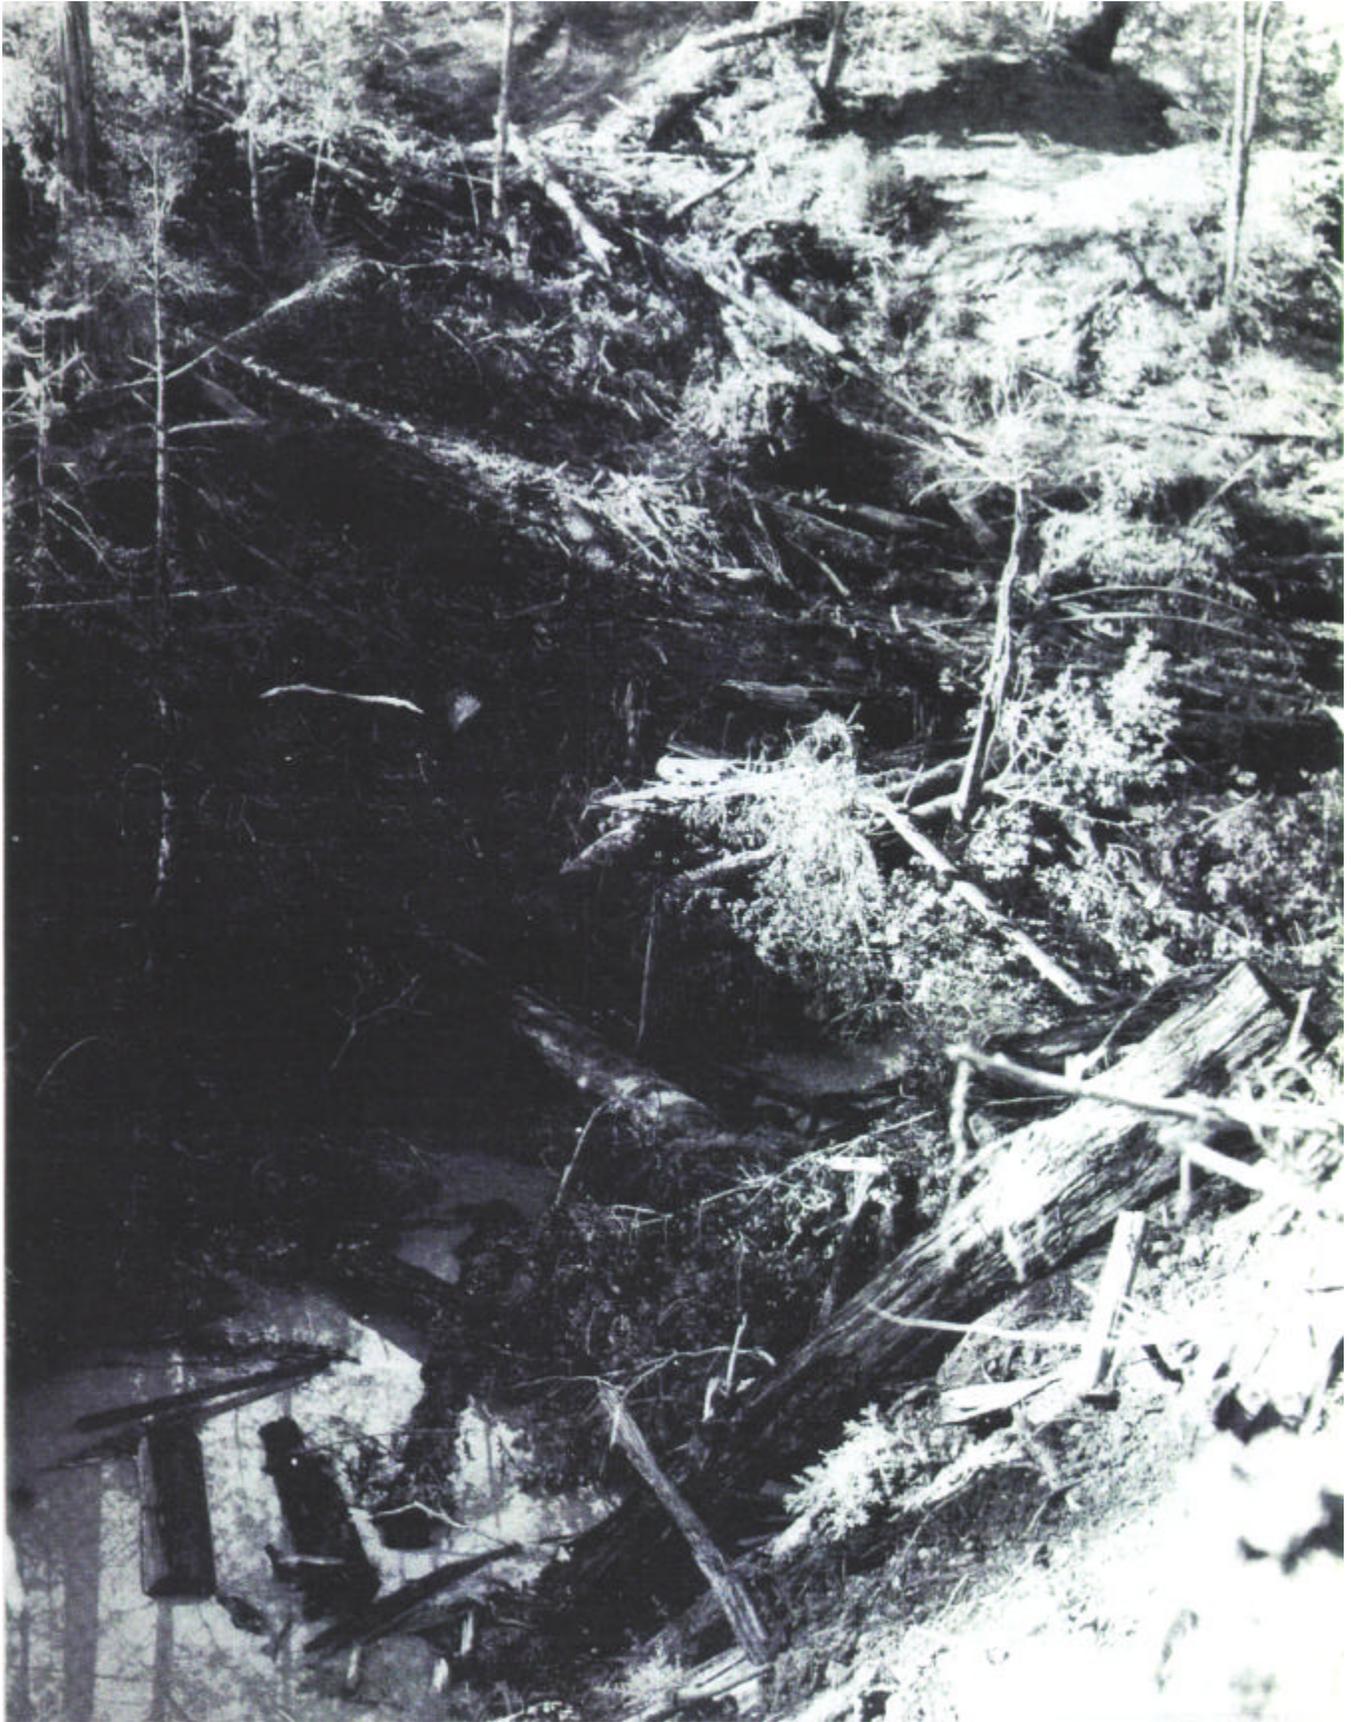
NORTH FORK, GARCIA RIVER, MENDOCINO COUNTY, Nov. 22, 1955. Stream bed blocked. Side hill left with skid roads running into stream bed without water checks; covered with debris which will be washed into stream by heavy runoff. Rubble which blocked stream was pushed off road by operator. (*Fish and Game photo.*)

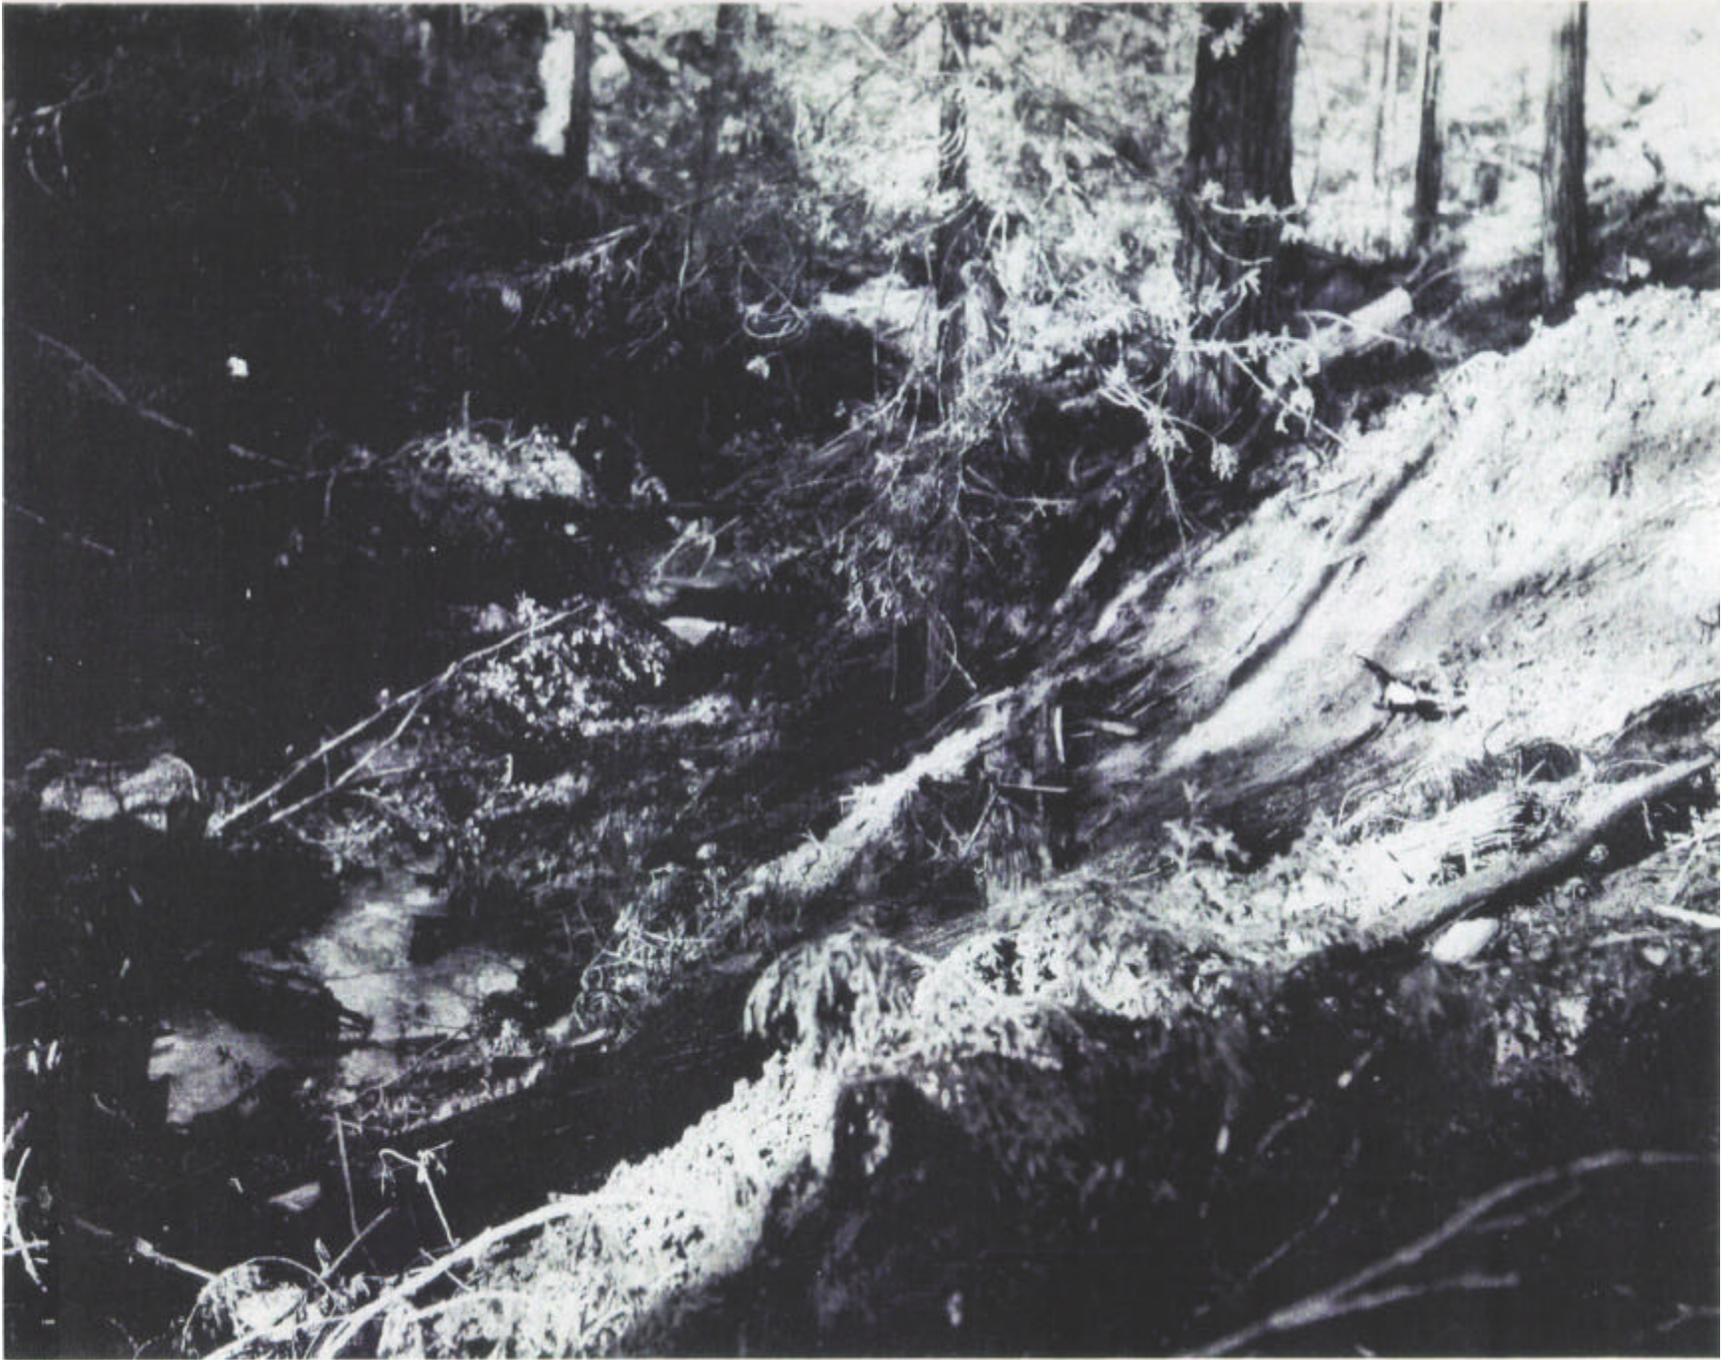
NORTH FORK, GARCIA RIVER, MENDOCINO COUNTY, Nov. 22, 1955. Stream bed and skid road visible at lower left. Road shoulder at right is contributing heavy silt second day after rain. (*Fish and Game photo.*)

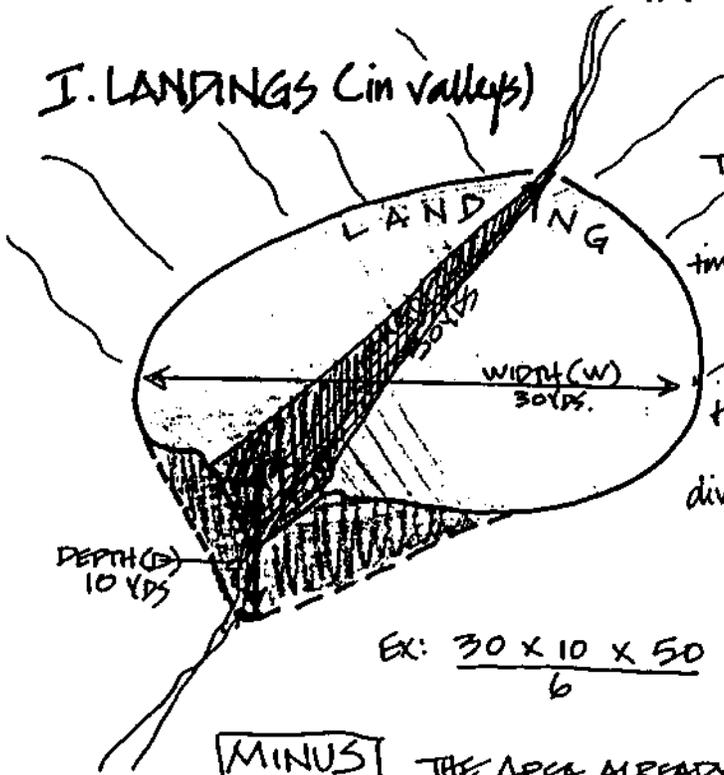
I. LANDINGS (in valleys)

TO GET TOTAL YDS³ OF LANDING FILL:
 WIDTH (AT WIDEST POINT) - W
 times DEPTH (FROM SURFACE OF LANDING
 FILL TO ORIGINAL STREAM
 GRADE AT BOTTOM OF
 LANDING) ~ D
 times LENGTH ~ L

divided by 6

EX: $\frac{30 \times 10 \times 50}{6} = 2500 \text{ YDS}^3$ (ESTIMATED YDS³ LANDING FILL)

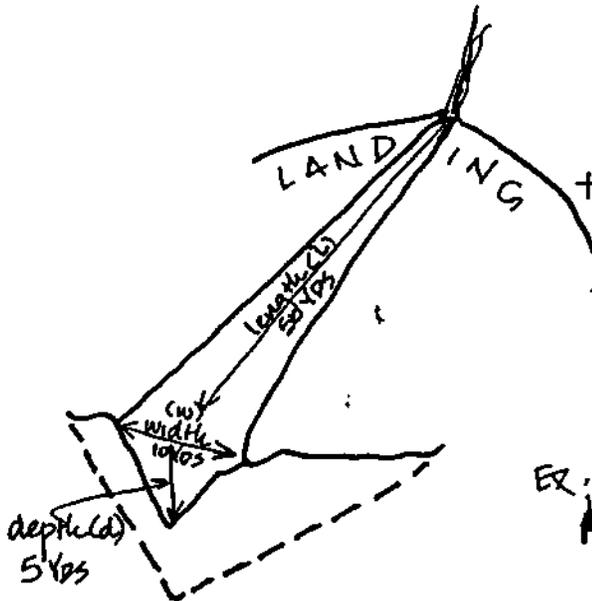
MINUS THE AREA ALREADY ERODED (SHADED AREA)
 WHICH CAN BE ESTIMATED AS FOLLOWS:

width (w) OF ERODED AREA AT
 BOTTOM END OF LANDING

times depth (d) OF ERODED AREA AT
 BOTTOM OF LANDING

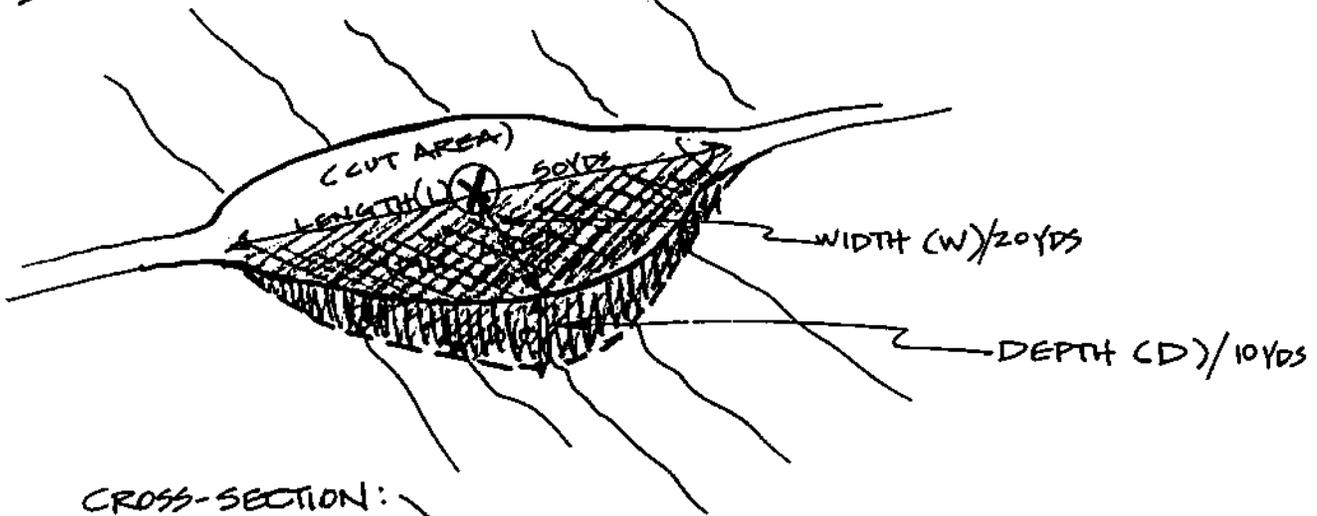
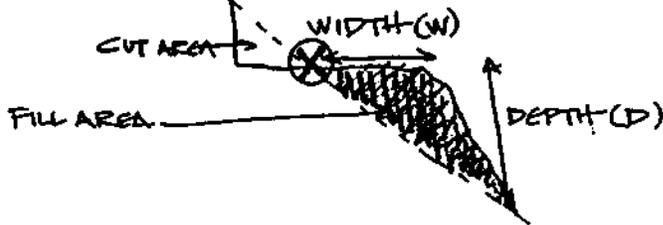
II. PERCHED FILL (roads, landings, etc)

CROSS-SECTION:

- times WIDTH OF FILLED AREA (AT WIDEST POINT) ~ W
- times DEPTH OF FILLED AREA (AT DEEPEST POINT) ~ D
- times LENGTH OF FILLED AREA ~ L

divided by 6

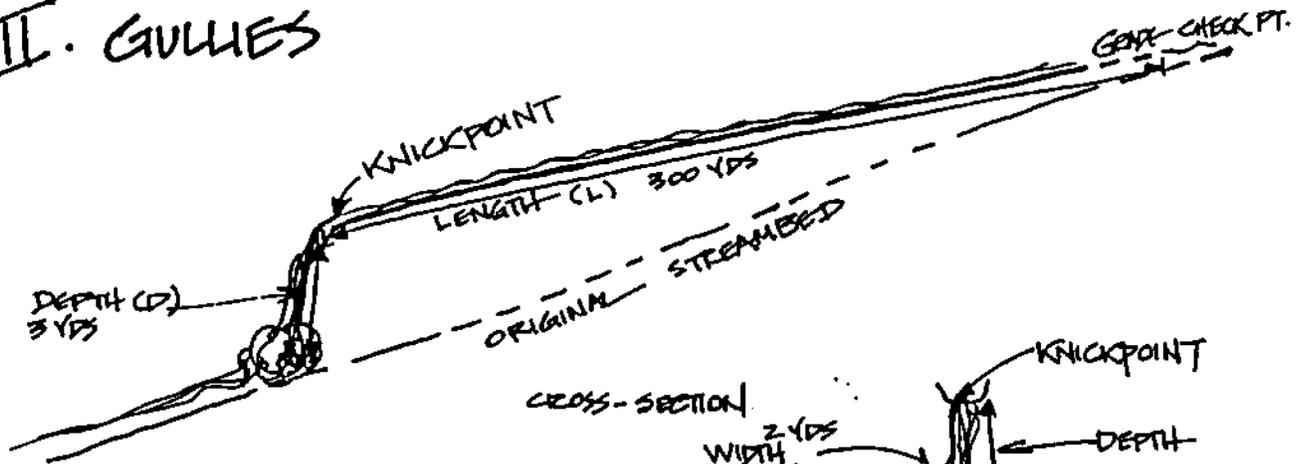
III. GULLIES

- times WIDTH OF GULLY BELOW KNICKPOINT
- times DEPTH OF WATERFALL AT KNICKPOINT
- times LENGTH (FROM KNICKPOINT TO GRADE CHECK UPSTREAM)

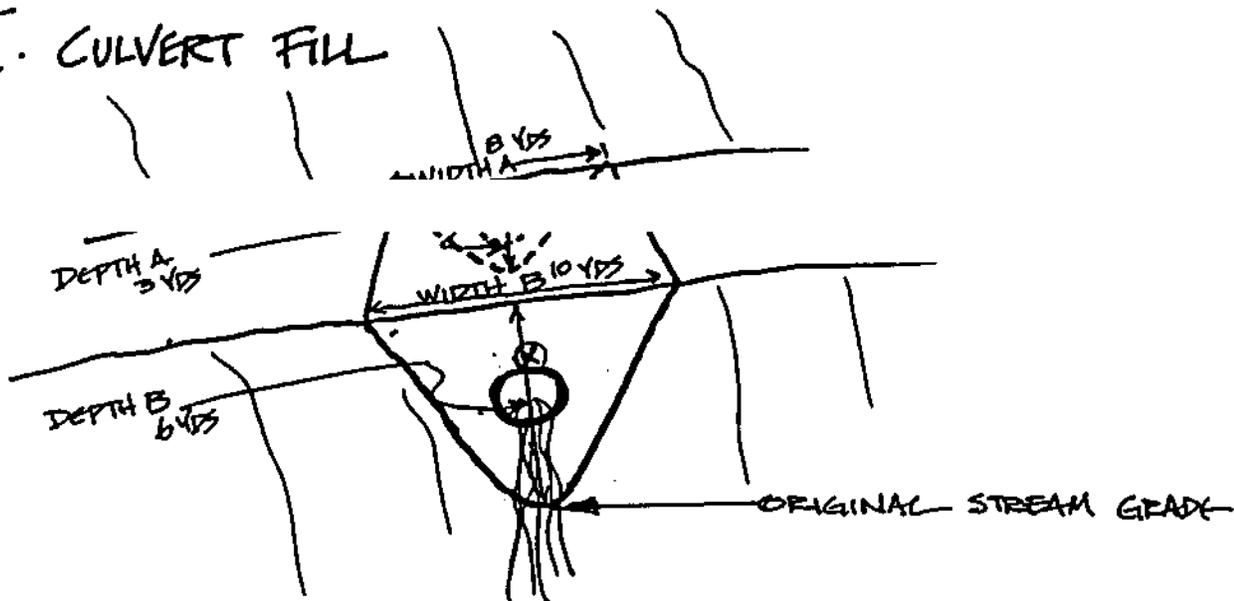
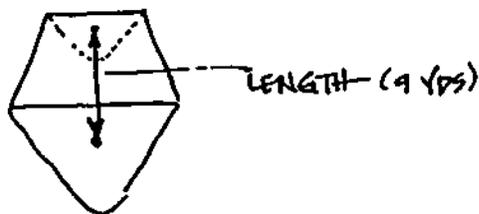
IV. CULVERT FILL

FIND LENGTH BY MEASURING DOWN APPROX. $\frac{1}{3}$ OF DISTANCE FROM ROADBED TO ORIGINAL STREAM GRADE—CONNECT TWO POINTS MARKED (X.)

WIDTH A times DEPTH A divided by 2 = AREA of A (SMALL END Δ)

plus WIDTH B times DEPTH B divided by 2 = AREA of B (LARGE END Δ)

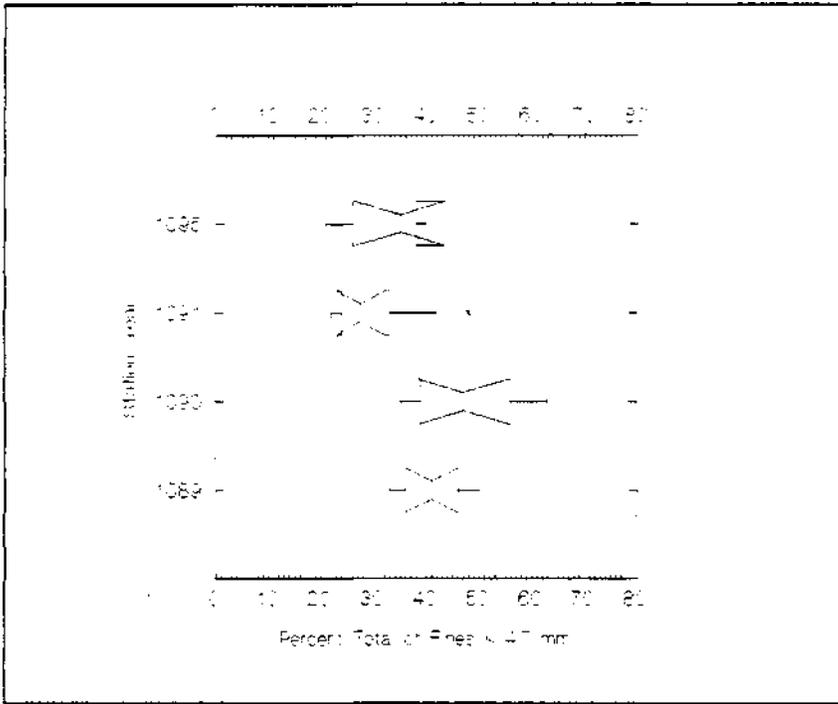
Figure 1. Station 1; 1989, 1990, 1991, 1995. The notches of 1095 overlap those of 1091, 1090, and 1089. Therefore this site shows no significant difference between fines levels in 1995 and earlier years. The notches of 1091 do not overlap those of 1090, and 1089. Therefore, the 1991 median is significantly different from the 1990, and 1989 medians. The 1991 median is lower than the 1990, and 1989 medians. ANOVA finds the 1991 means significantly different from the 1990, and 1989 means. In addition, the 1995 mean is different from the 1990 means. The 1991 means is lower than the 1990, and 1989 means and the 1995 mean is lower than the 1990 means.

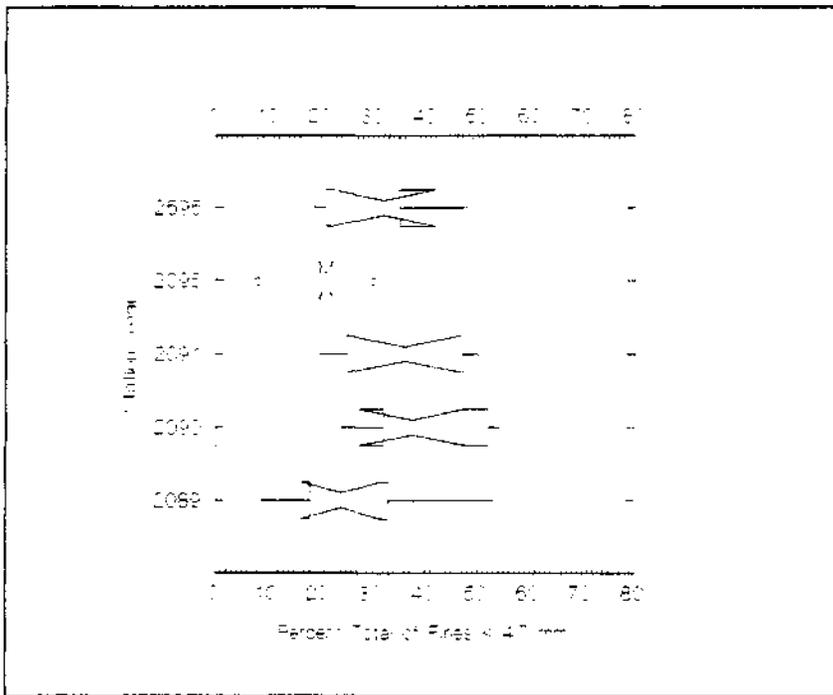
Figure 2. Stations 2.0 and 2.5 (lower and upper); 1989, 1990, 1991, 1995. The 1995 median at site "2 lower" (2095) is significantly different from the 1990 and 1991 medians. The 1995 median at site "2 lower" (2095) is lower than the 1990 and 1991 medians. There are no other significant differences. ANOVA finds the 1995 means significantly different from the 1990 means for the "2 lower" station. The 1995 mean lower than the 1990 means for the "2 lower" station.

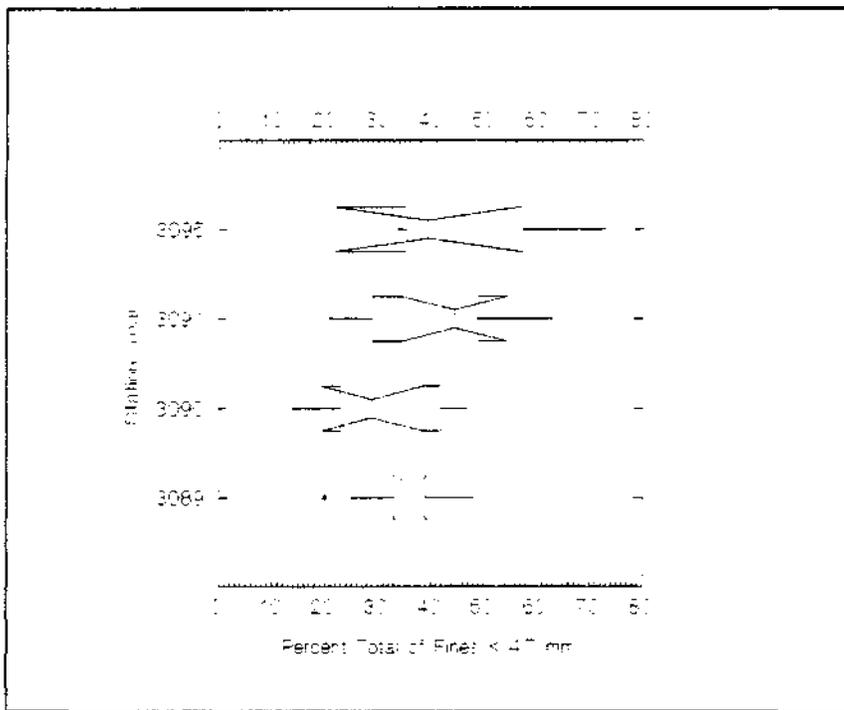
Figure 3. Station 3; 1989, 1990, 1991, 1995. There are no significant differences. Note the wide confidence interval around the 1995 median that signifies that the median is between 22% and 55% at a 95% confidence level. Only 4 observations were usable for station 3 in 1995. ANOVA finds no significant differences between the means.

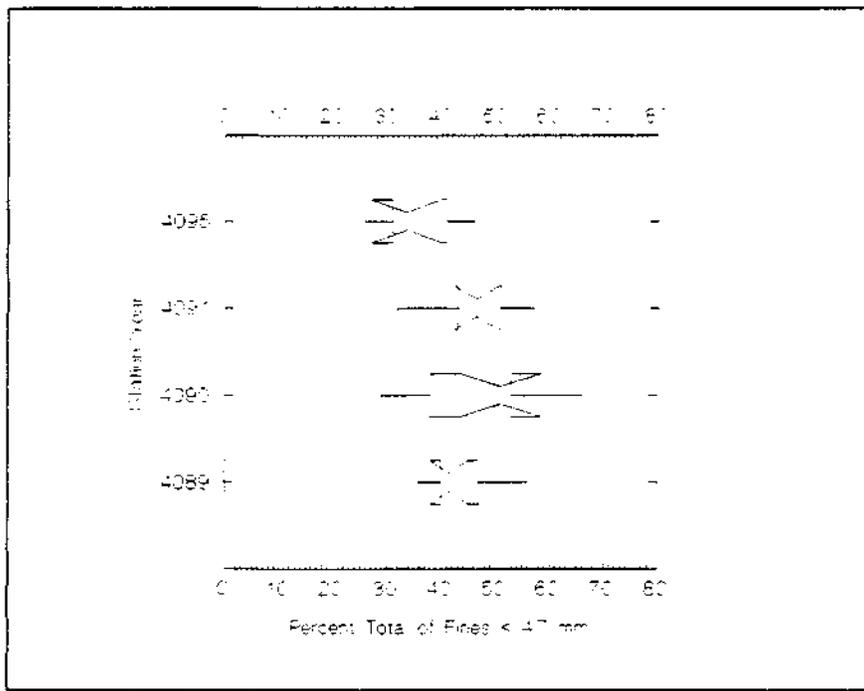
Figure 4. Station 4; 1989, 1990, 1991, 1995. The 1995 median is significantly different from the 1991 and 1990 medians. The 1995 median is lower than the 1991 and 1990 medians. ANOVA finds the 1995 means significantly different from the 1990 means. The 1995 means is lower than the 1990 means.

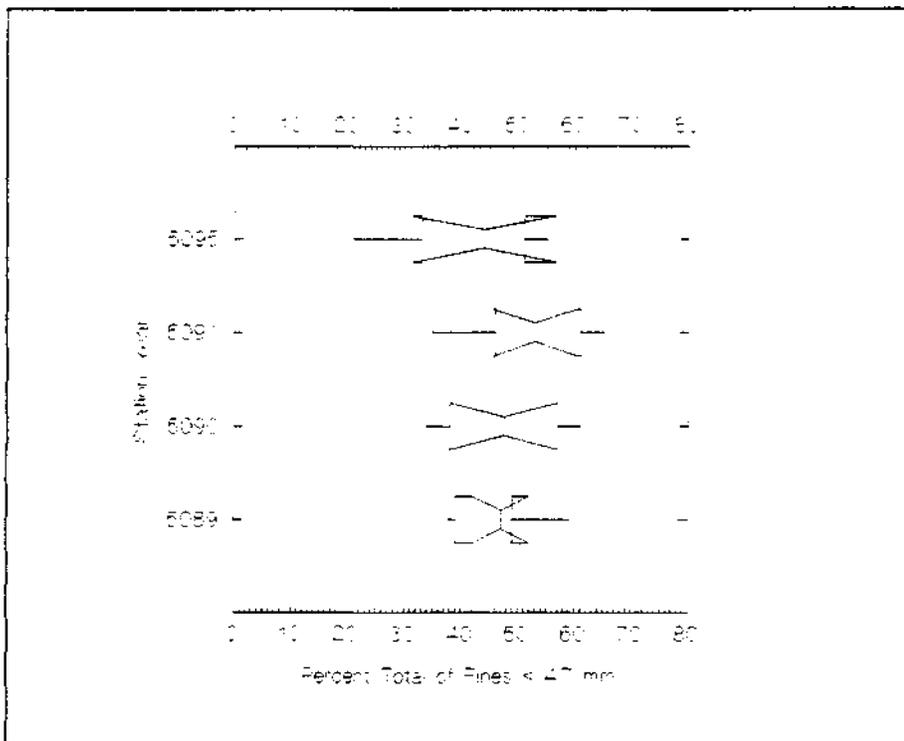
Figure 5. Station 5; 1989, 1990, 1991, 1995. No significant differences between the medians. ANOVA finds no significant differences between the means.
