**GEOMORPHIC CHANGES IN THE LOWER
REACHES OF CARRIGER CREEK,
SONOMA COUNTY**

By Laurel Collins, Donna Morton, and Paul Amato

WATERSHED SCIENCES, 2002

EXECUTIVE SUMMARY

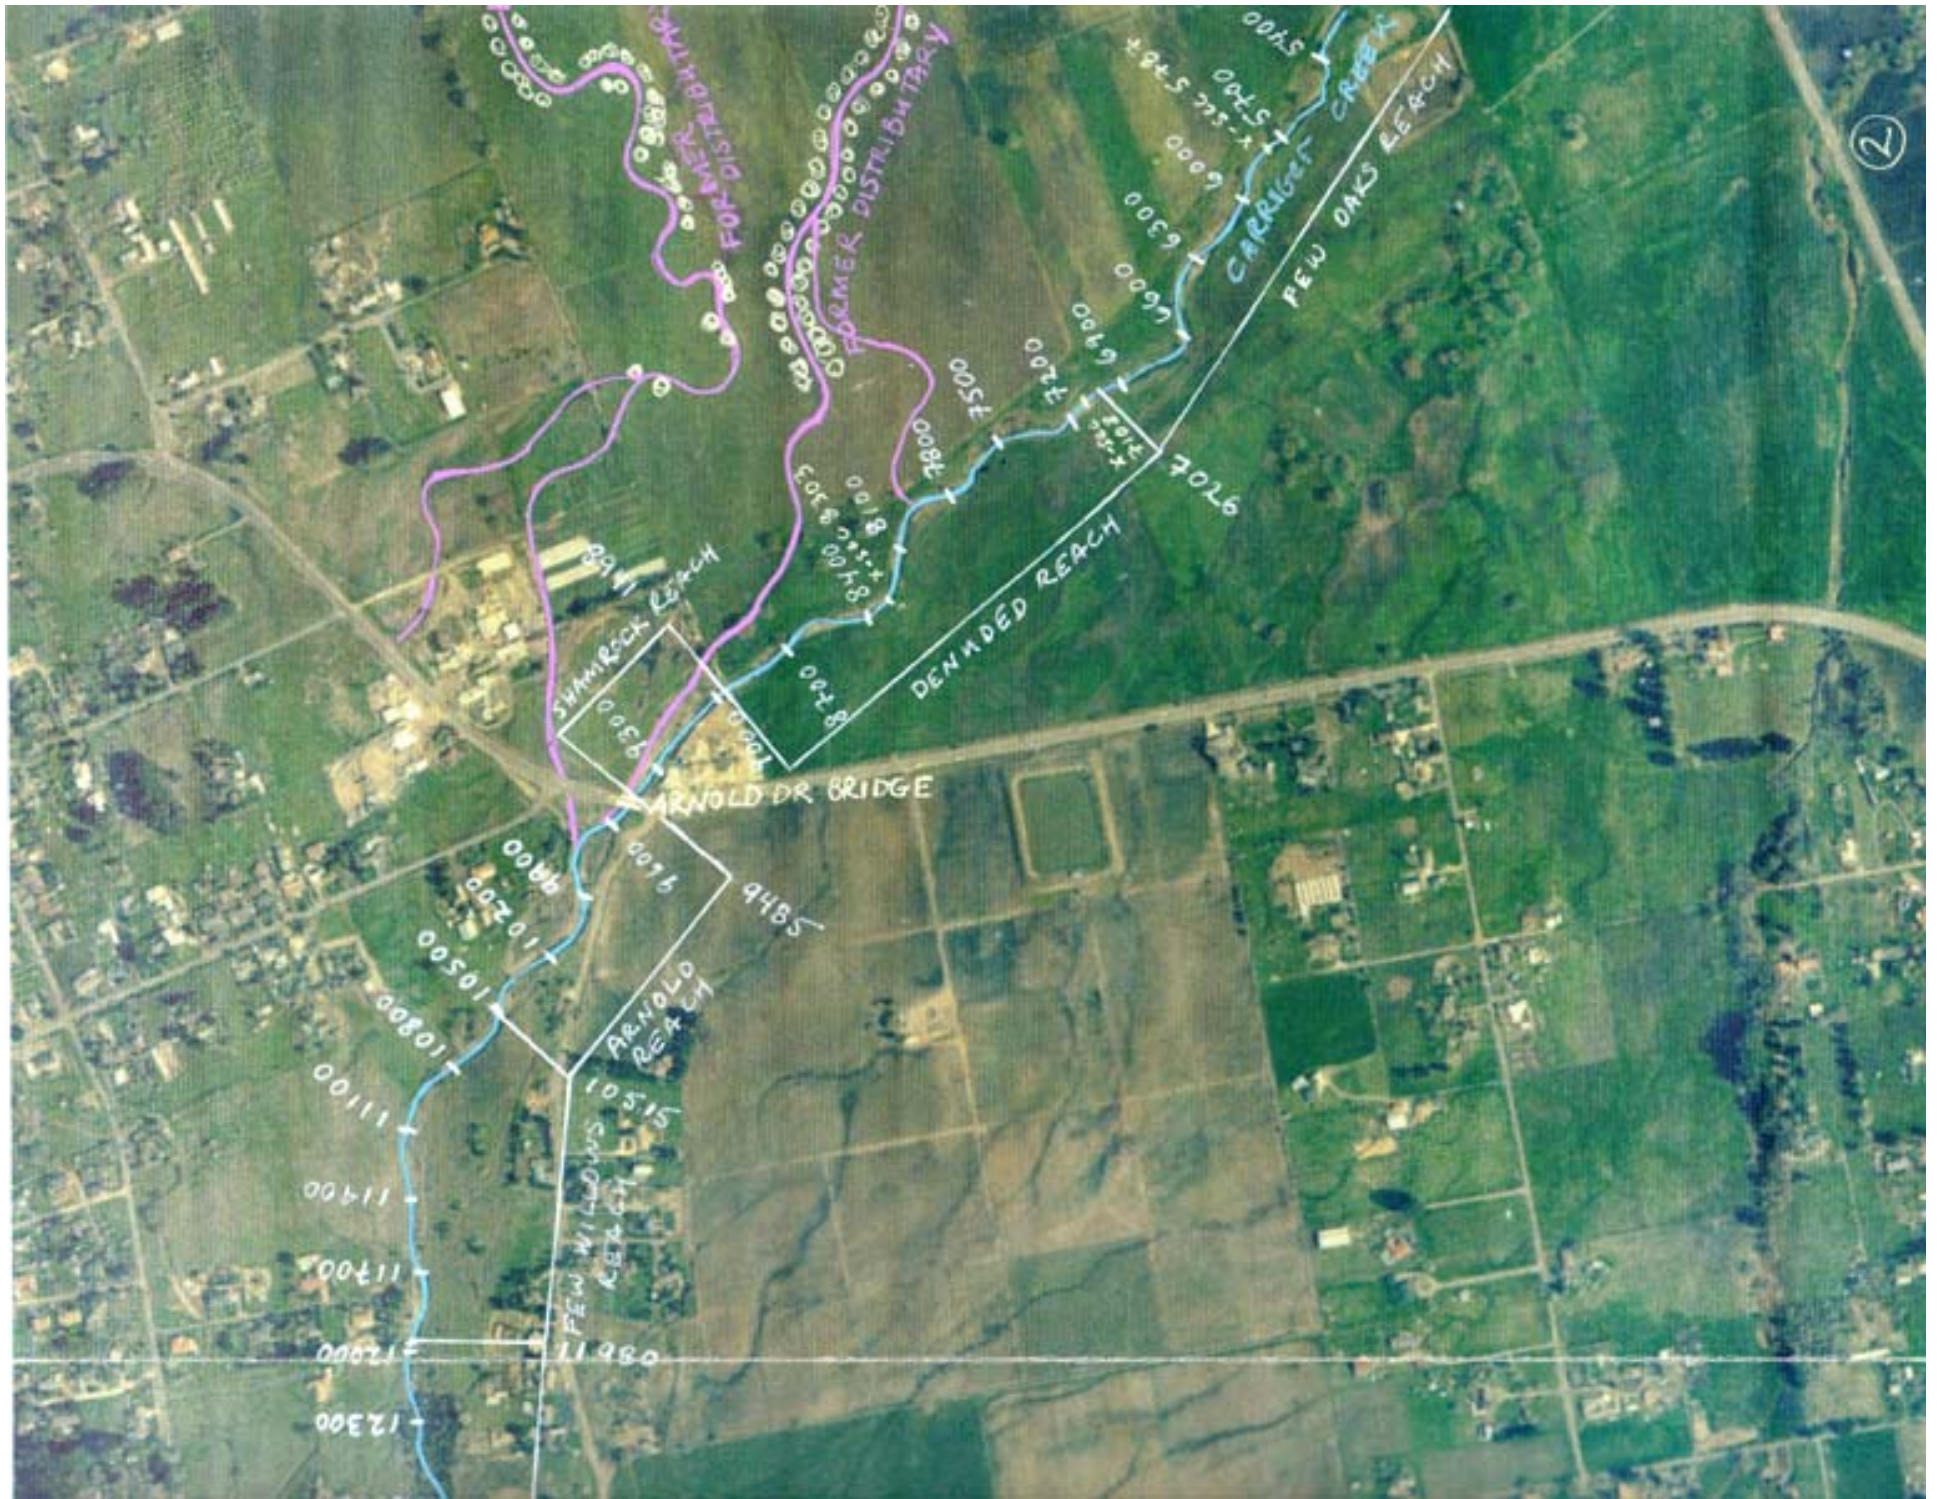
Figure 3. Topographic Map Longitudinal Profile

The energy slope of a stream is approximated by its gradient. Local stream gradient largely depends upon discharge, bed-material size and load. The slope of Carriger Creek, derived from a USGS 7.5" quadrangle is shown for the entire mainstem channel. Individual reaches within the Study Site are shown in color at the downstream end of the profile. The reach breaks were based upon differences in morphology and/or the presence of instream structures such as dams or bridges as described in Table 2. The reported percent slopes are based upon the end point elevations within each reach. Channel distances measured on the topographic map do not match the distances measured in the field because the topographic map does not depict much of the channel curvature. For accurate distances refer to Table 2. The length of the Study Site represents slightly less than 50% of the length of Mainstem Carriger Creek. Grove Reach is the steepest reach in the Study Site. Riparian Reach is the least steep.

Please note that a more recent and accurate representation of actual surveyed slopes for the different reaches is shown in the Appendix, Figure 4. It shows a comparison of the topographic map slopes versus the surveyed field conditions for the length of channel between Arnold Bridge and the Grove St. box culvert.

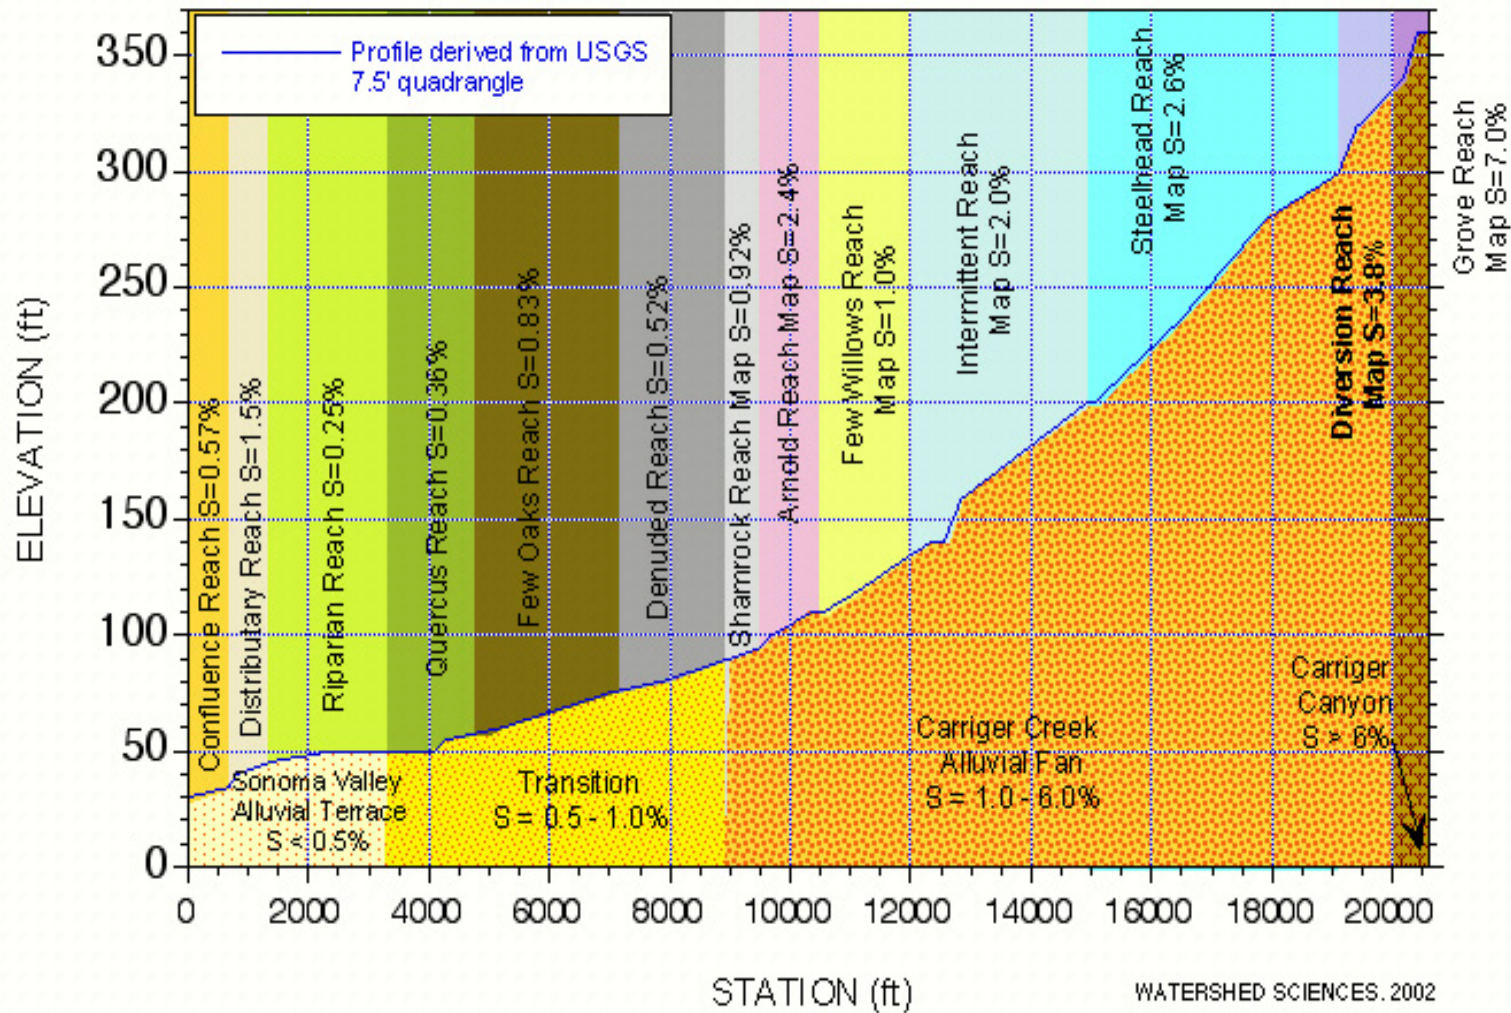
Figure 4

Carriger Creek 3.9 Mile Study Reach

Detail of Longitudinal Profile with Morphologic Zones and Stream Reaches

Elevation endpoints of each reach were used to determine percent slope.

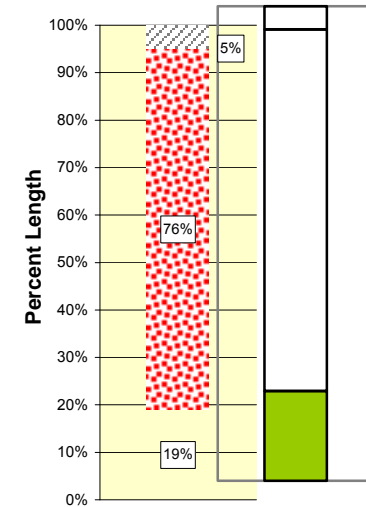
Percent Length of Bank Condition

(*Right and left banks above and below bankfull combined)

Total Percent Length of Different Bank Conditions for Mainstem Study Reach

Stable
 Eroding
(threshold = 0.25' of bank retreat)
 Revetted

Figure 6. Percent Length of Bank Condition

These graphs show the combined condition of banks above and below bankfull that have been subjected to fluvial processes since the time of non-native settlement 165 years ago. There are two graphs. The graph on the left shows bank condition by reach. The graph on the right shows the summation of bank condition for the entire Study Site. The green color represents stable banks, the red-stippled pattern indicates eroding banks, and the gray diagonal pattern indicates banks with revetment.

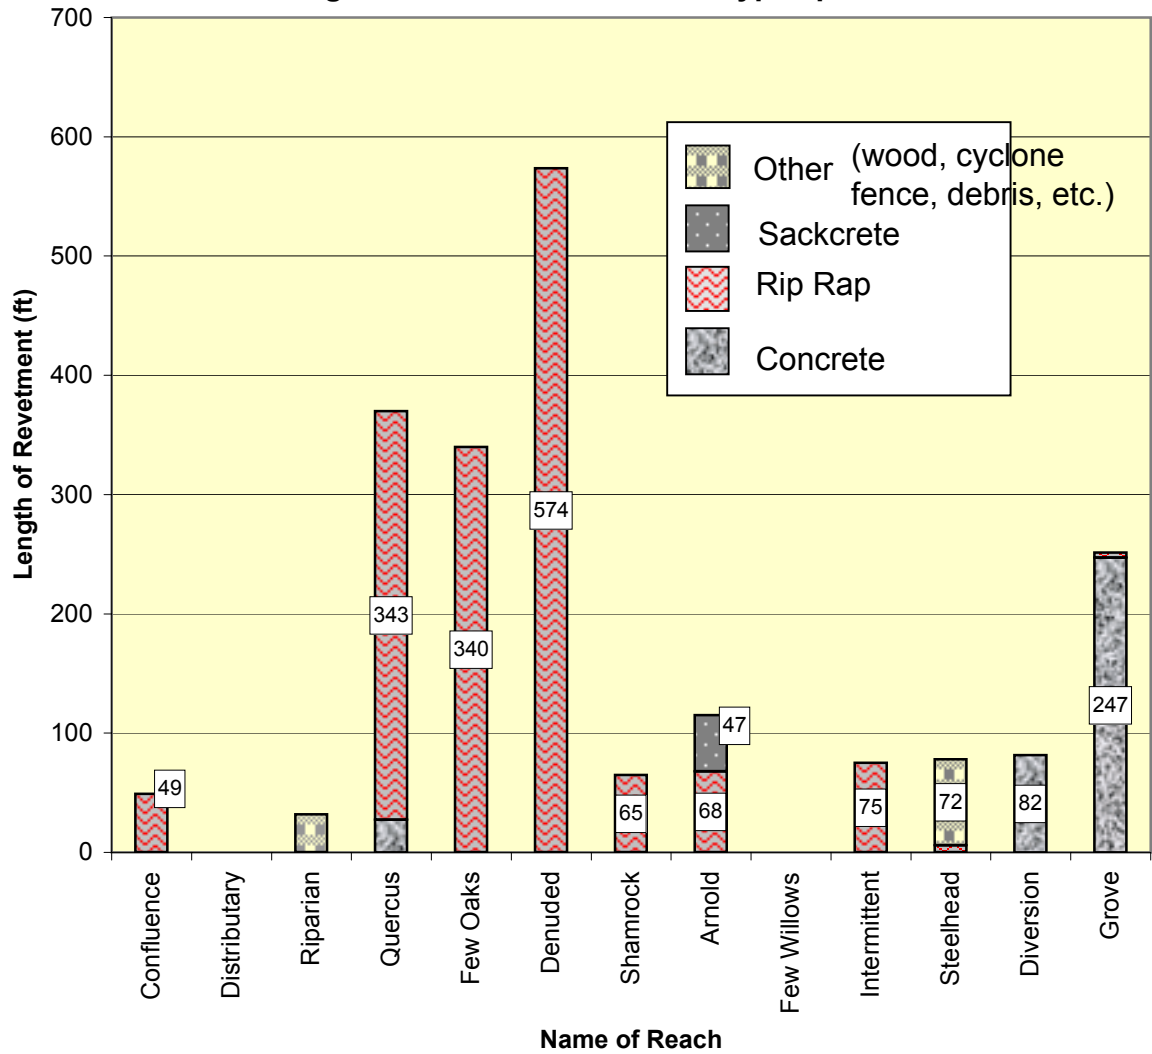
Figure 10

CARRIGER CREEK 3.9 MILE STUDY REACH, 2000
Length of Different Revetment Types per Reach

Length of Different Revetment Types and Percent of Total Length in Feet of All Types

(In each white box, number on top is length of revetment (feet); number on bottom is the percent)

Total length of revetments = 4.9% of entire 3.9 mile Study Reach

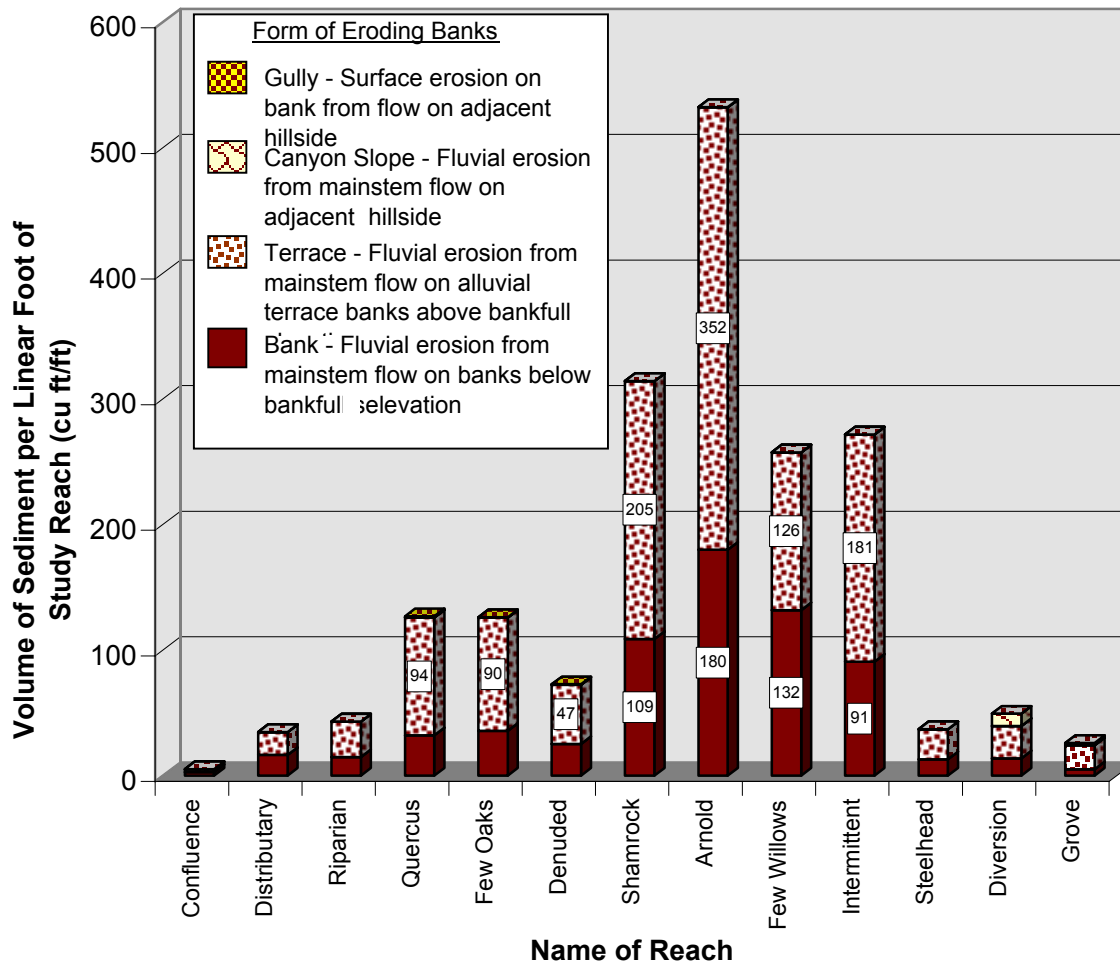
CARRIGER CREEK 3.9 MILE STUDY REACH, 2000
Bank Erosion Volume per Reach Over the Last 165 Years

Bank Erosion Volume per Linear Foot of Channel for the 3.9 mi Study Reach over the Last 165 Years

For the entire study reach, there is 137 cu ft of sediment supplied by bank erosion per linear foot of channel

The graph on the left shows that the reaches with the greatest volume of sediment supply are located in the middle of the Study Site which includes Shamrock through Intermittent Reaches. These reaches occur on the alluvial fan where the channel is less entrenched than the upstream and downstream reaches. The reach with the greatest sediment volume is Arnold, accounting for 532 cu ft/linear ft of sediment supplied over the last 165 years (or 3.22 cu ft/linear ft/yr). We expect that this extremely high rate is partly due to the impacts of an earlier undersized bridge constructed at Arnold Avenue and the channel straightening activities. There is also a corresponding and dramatic decrease in riparian vegetation along the alluvial fan where straightening activities were performed below Steelhead Reach. This can be seen on Figure 2b Photo Map. Whether the riparian vegetation below Steelhead Reach was lost before or after the channel straightening was conducted is presently unknown. It is possible that bank erosion rates upstream of the old distributary confluences have also been influenced by the loss of distributaries.

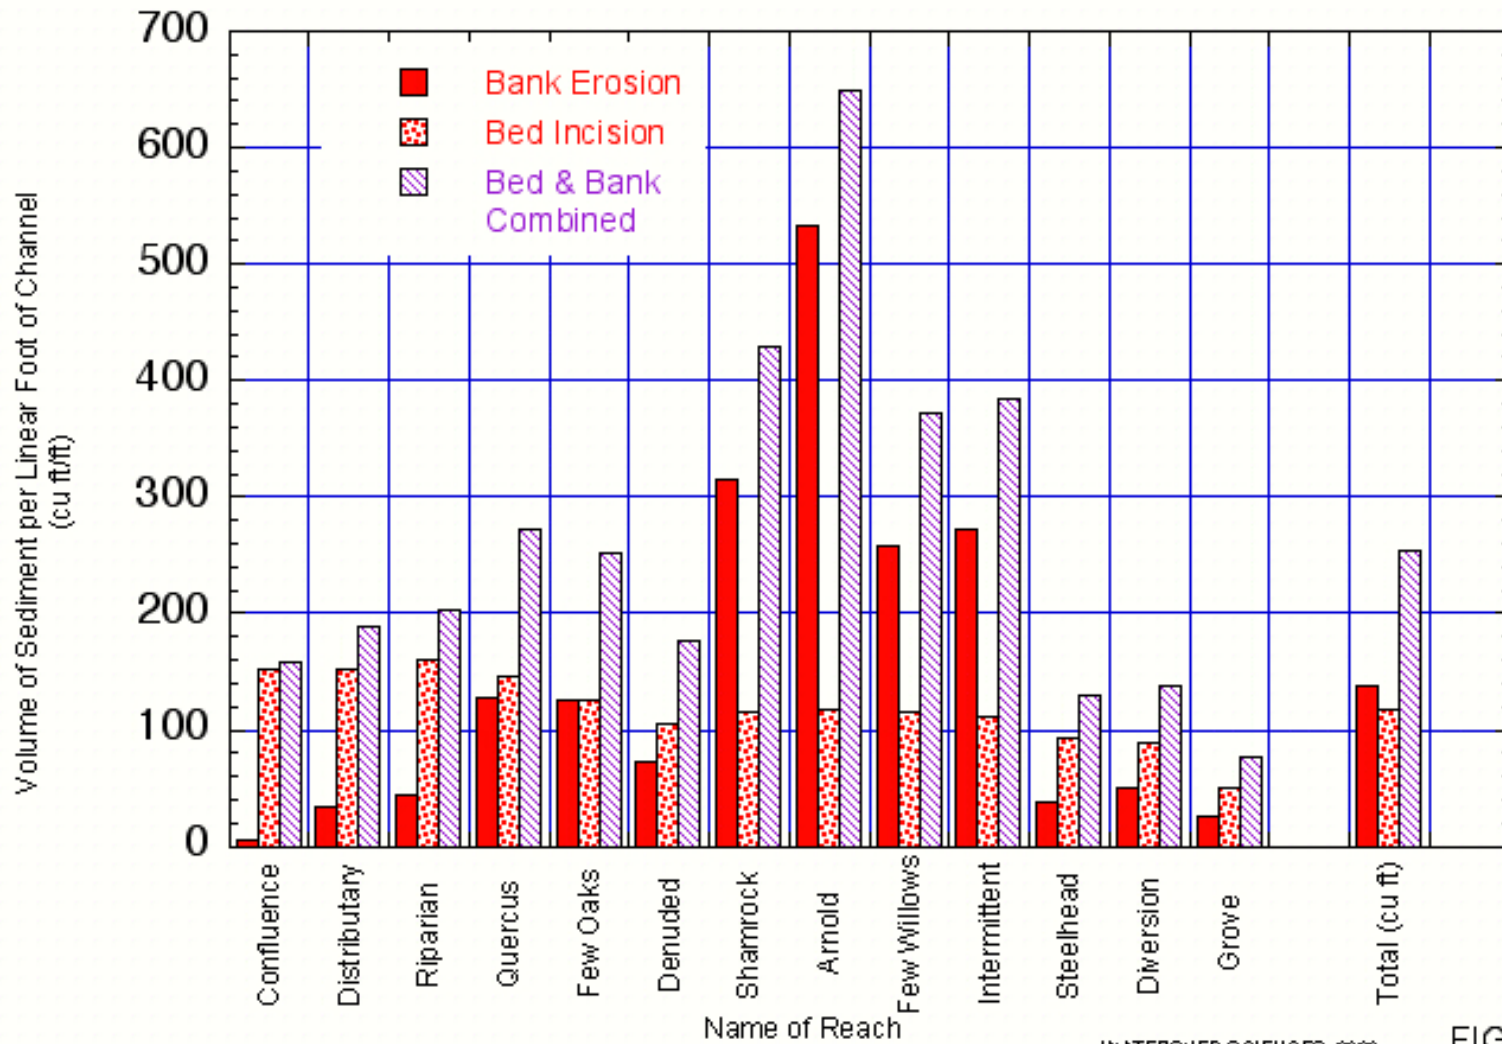
CARRIGER CREEK 3.9 MILE STUDY REACH, 2000
Volumes of Bank and Bed Sediment Supply per Linear Foot of Channel
Since the Time of Nonnative Settlement about 165 Years Ago

Since the total combined sediment supply for the Study Site is about 254 cu ft/linear ft, total long-term rate of supply can be reported as 1.54 cu ft/linear ft/yr. See Table 3 below. Alternatively, we can think of this as a total long-term supply rate of 1,175 cu yd/yr from the Study Reach. Clearly a long-term rates average years of very high or low inputs, so this rate may not be representative of any actual rate in any one year. Short-term rates that are punctuated by land disturbance are much greater than long-term rates. Rates or erosion may be highest after an initial perturbation and then slow at an asymptotic rate, or acceleration of rates may propagate spatially through a channel network. The

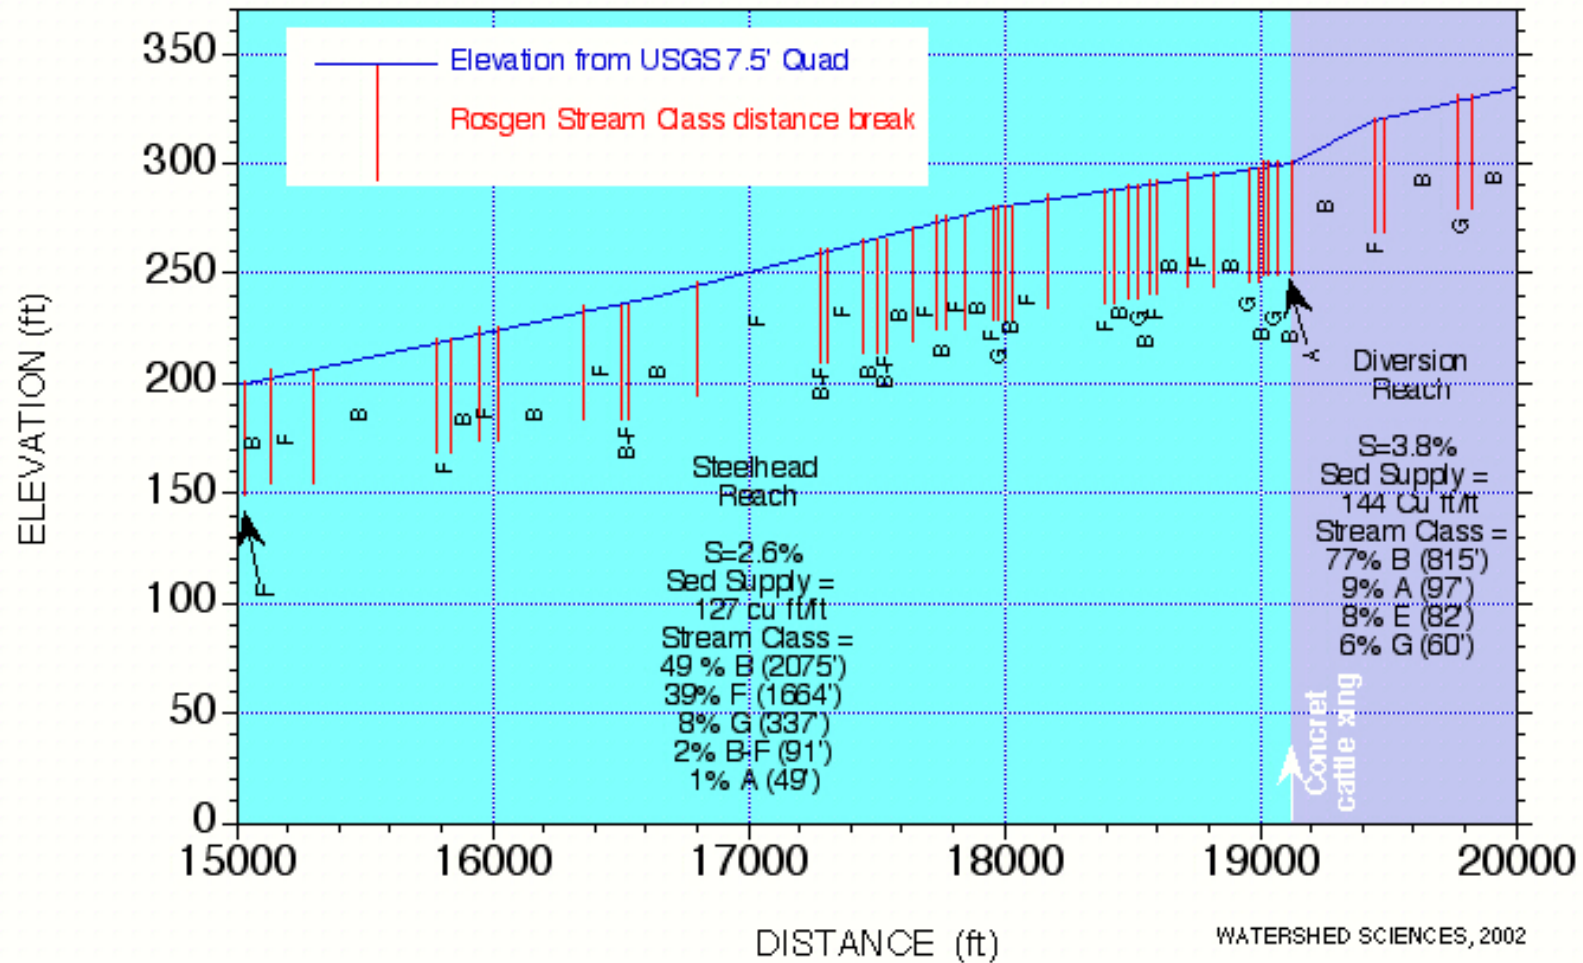
Figure 28 d

Carriger Creek 3.9 Mile Study Reach

Rosgen Stream Classes by Reach and Longitudinal Profile

NOTE: Reported sediment supply for the different reaches is for local contribution from bank erosion and bed incision over a 165 year period.

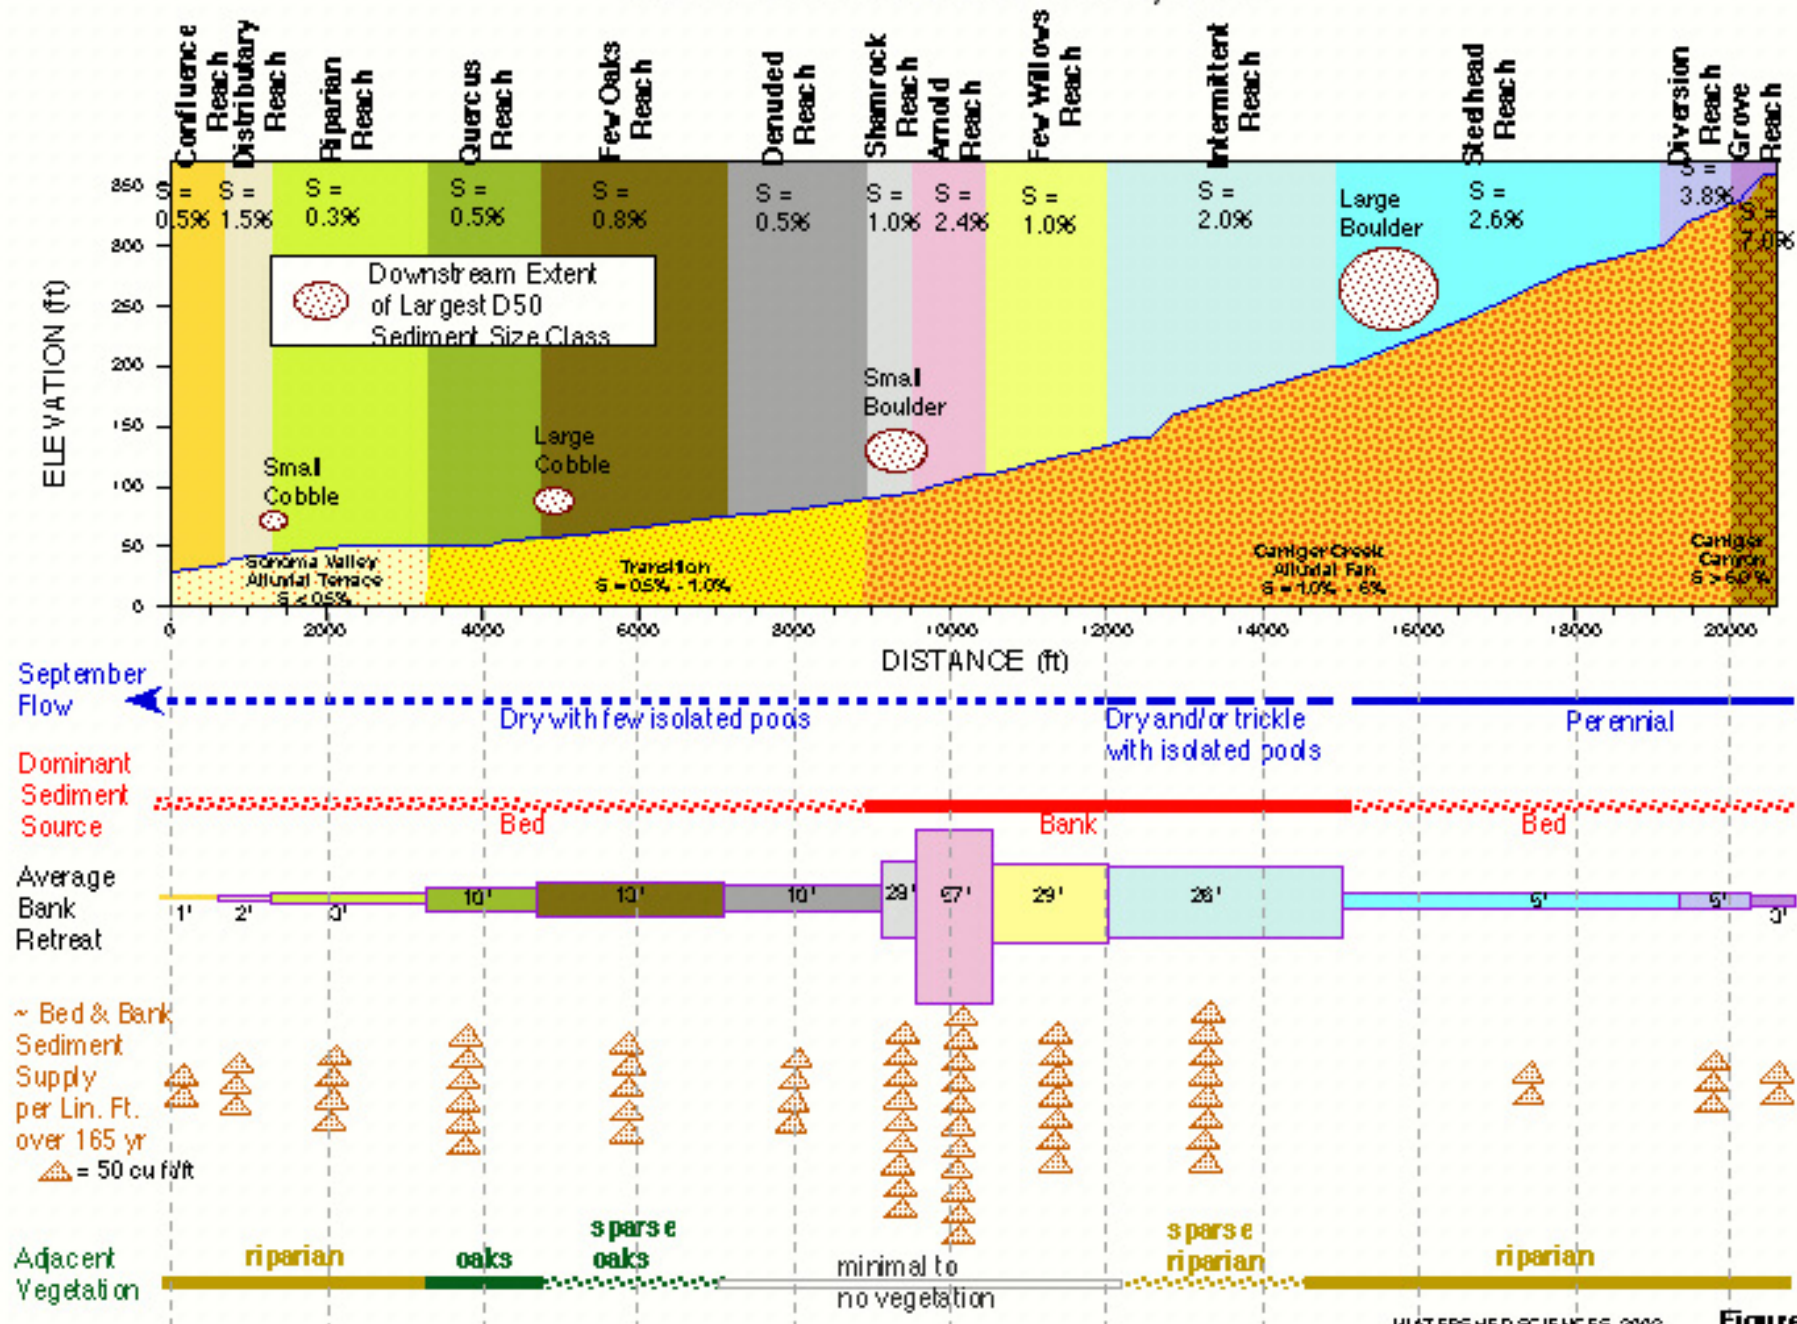
WATERSHED SCIENCES, 2002 **Figure 29**

INTEGRATED PICTURE OF CARRIGER CREEK 3.9 MILE STUDY REACH, 2000

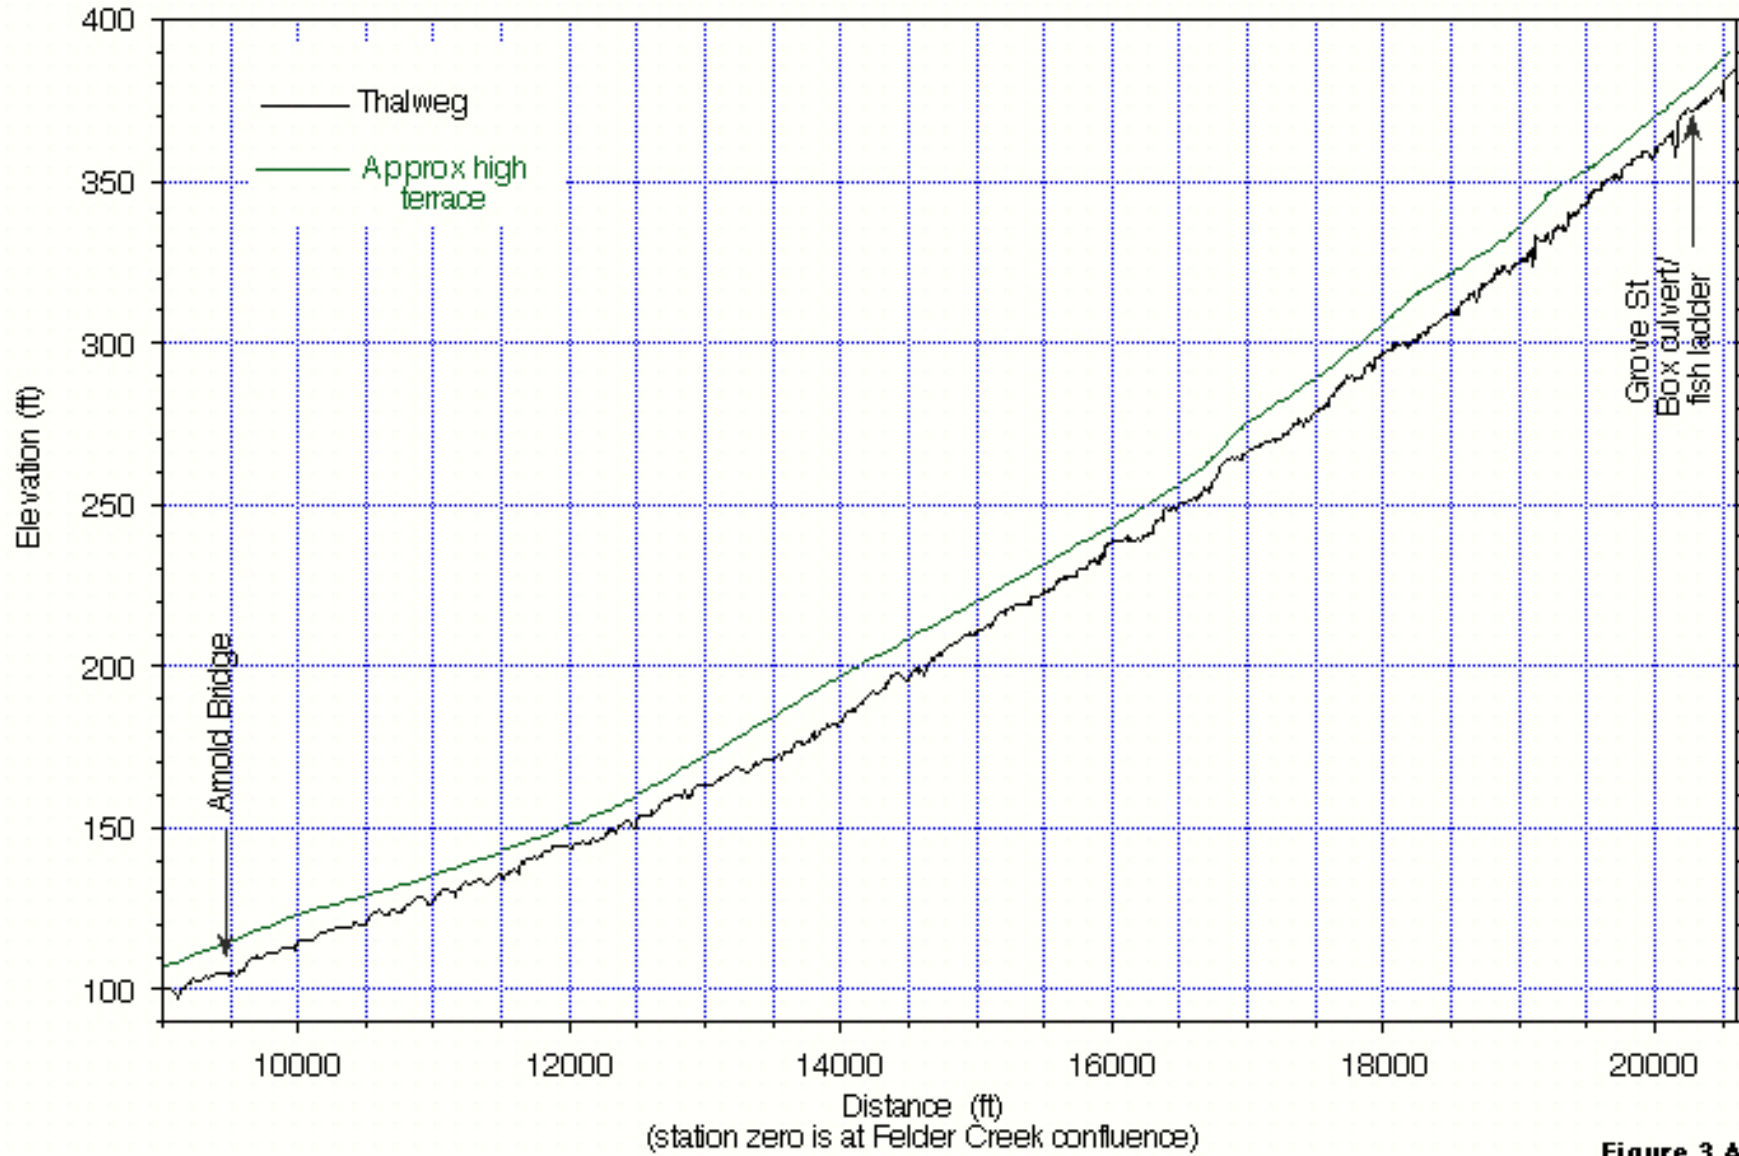
Figure 3 Appendix

Carriger Creek Longitudinal Profile, 10/2001

Surveyed by Laurel Collins, Watershed Sciences
