**ANALYSIS OF CHANNEL GEOMORPHOLOGY AND
HABITAT FORMING PROCESSES FOR FEASIBILITY
ASSESSMENT OF
RIP-RAP REMOVAL,
MUIR WOODS NATIONAL MONUMENT
MILL VALLEY, CALIFORNIA**

Final Report

The National Park Service,
Muir Woods National Monument,
And the
Golden Gate National Recreation Area

Lisa C. Kimball
G. Mathias Kondolf
Center for Environmental Design Research
Department of Landscape Architecture and Environmental Planning
The University of California, Berkeley

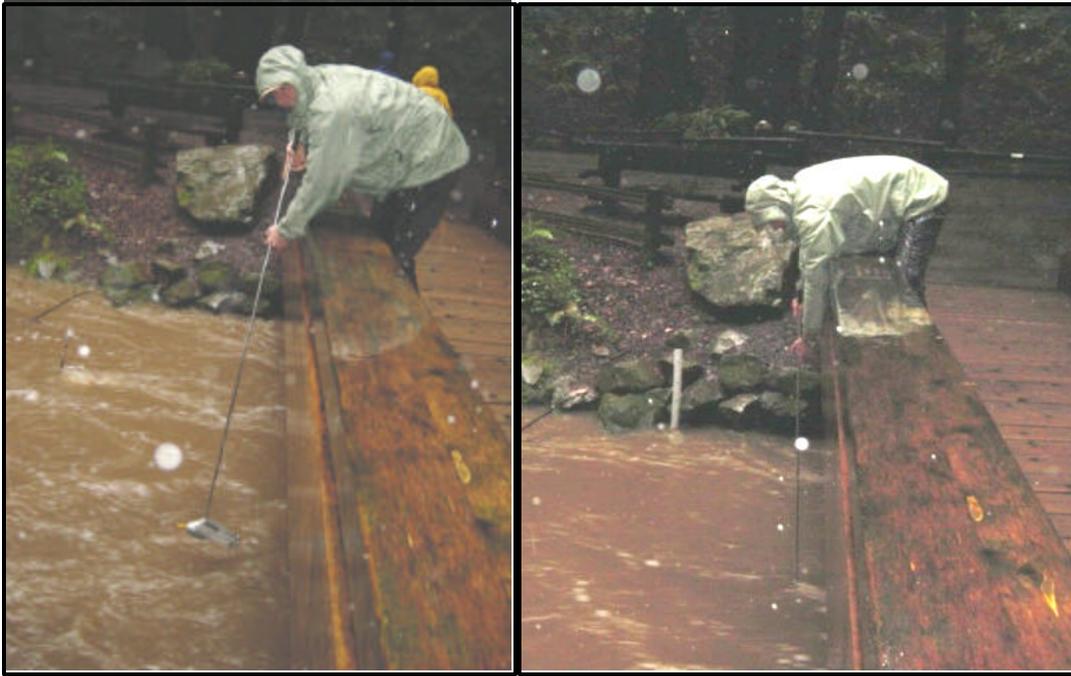
Figures 2 and 3. Suspended sediment sampling. Lowering and raising a DH-48 sampler into the flow across the channel and a temporary gage on left bank.

flow from the left bank to the right bank. We lowered and raised the sampler in even motions so it was in contact with the water for the same amount of time at each spot. We repeated this at intervals of about two feet moving across the creek. Samples will be analyzed by NPS and the data used in decision making about riprap removal.

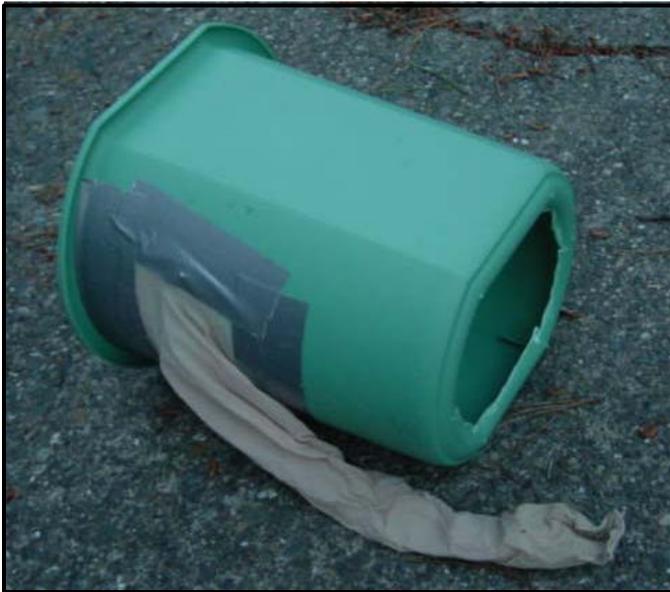
Figure 4. Hess-like sampler used to sample aquatic insects in Redwood Creek. A plastic garbage can with a 0.5 ft opening and a nylon stocking to catch the sample.

We collected samples of aquatic insects at five sites on Redwood Creek in Muir Woods by using a modified Hess sampler (Figure 4). The mouth of the sampler had a 0.5 ft² (0.046 m²) opening area, which we placed over the substrate to achieve a known sampling area. We taped a nylon stocking around the hole in the side of the bucket to act as a sieve and catch the sample. For each site, we took samples from three strata: the surface of riprap in water, a natural bank in water, and the bed (Figure 5). We placed the sampler over three areas per sample and disturbed the substrate to put any insects into the water column and then into the collection net. For example, at one riprap site, we sampled three different 0.5 ft² (0.046 m²) areas for one minute each, giving a total sampling time of three minutes and a total sampling area of 1.5 ft² (0.14 m²) for one riprap site. This method allowed for a more representative sample to be collected from each site. We repeated the process for a natural bank and a bed area within 100 feet to achieve somewhat constant conditions.

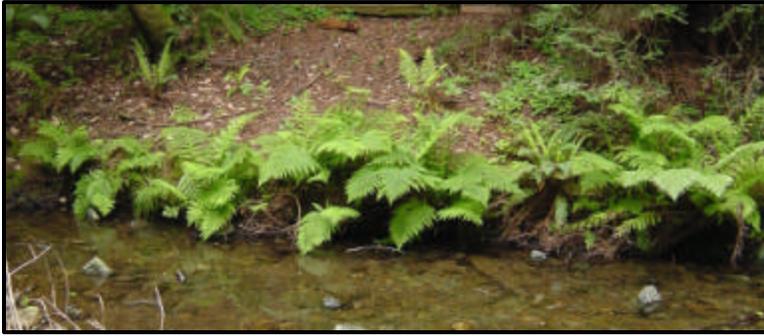
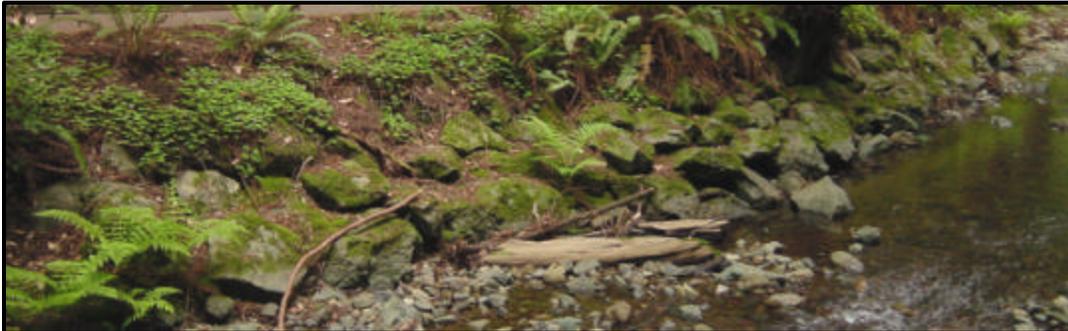
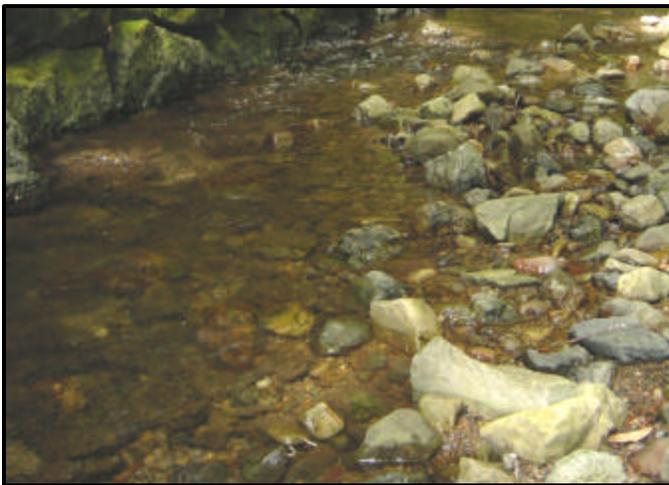
Natural Bank Strata Example

Riprap Strata Example

Bed Strata Example

Figure 5. Examples of the three strata samples for aquatic insect abundance and diversity.

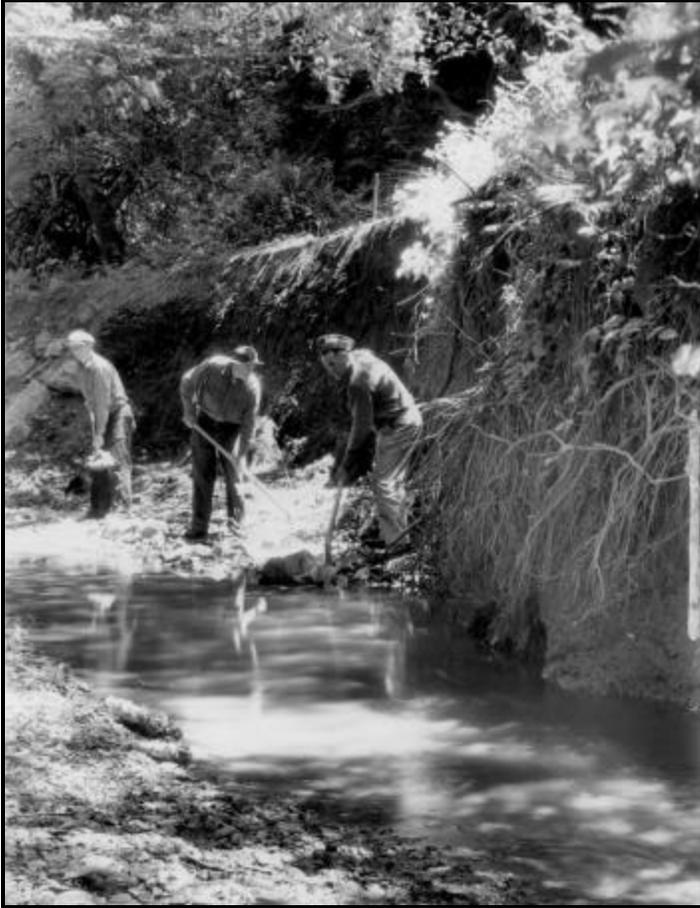
Figure 6. CCC workers in the Redwood Creek channel. Note the height of the bank in relation to the men and the roots exposed from scour (from NPS Archives).

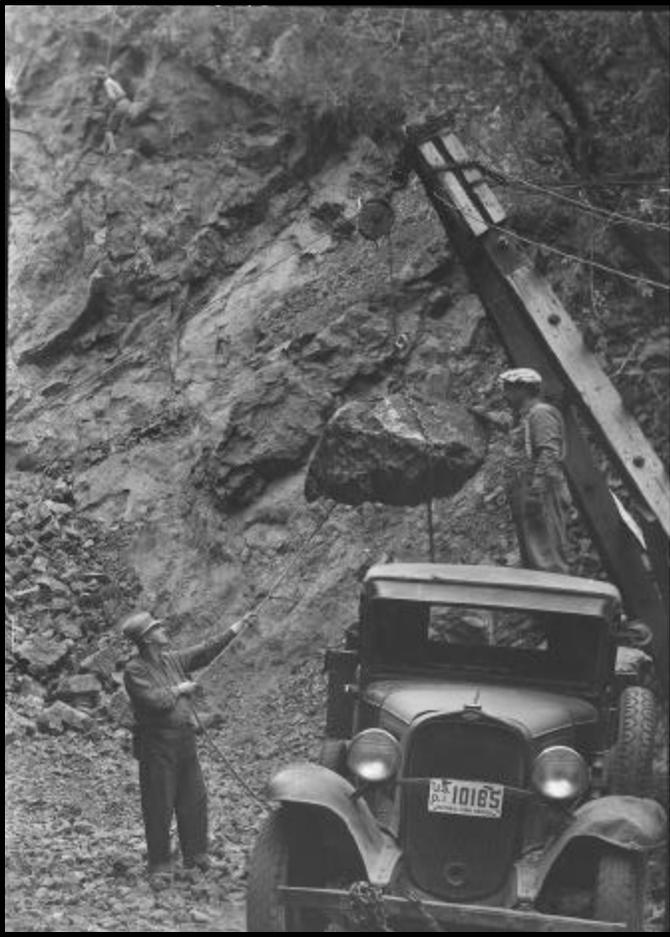
Figure 7. CCC workers loading rocks at the Kent quarry for riprap in Muir Woods ca. 1934 (from NPS Archives).

The CCC project officially began on November 21, 1933 and on the 15th of December of that year, William Kent was recorded to have stated a preference for installation of brush revetments, however rock was used instead (Hildreth, 1966), as is evident today. The large rock was quarried from Kent's land (Figure 7) about $\frac{3}{4}$ mile from the monument at a cost of \$ 0.10/y³ (Hildreth, 1966).

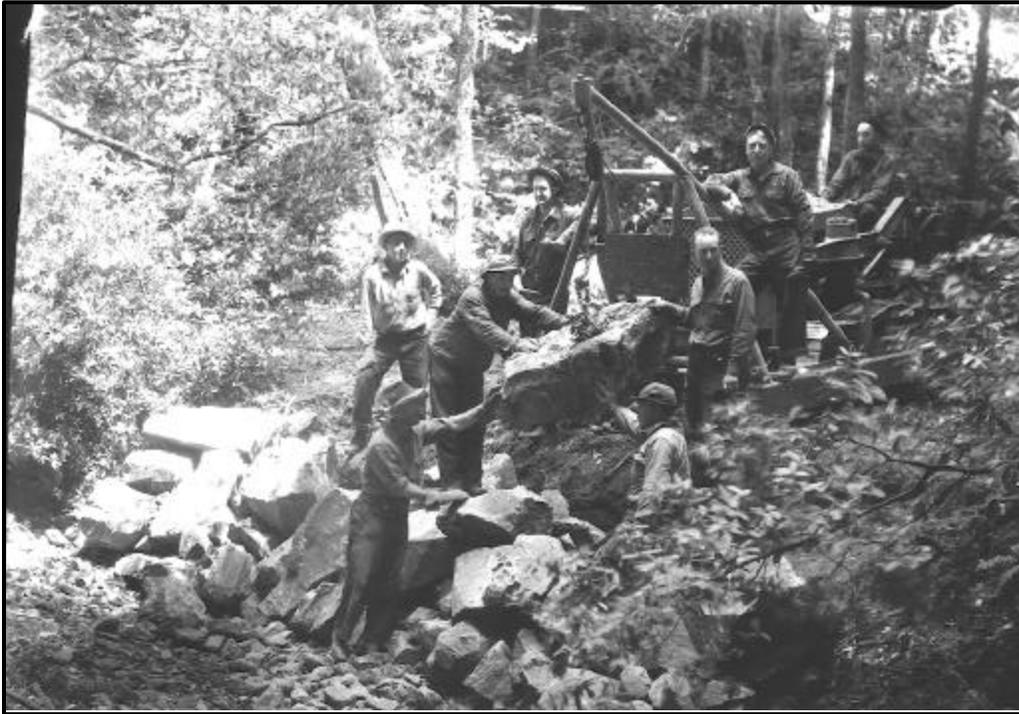
Figure 8. CCC workers placing large boulders on Redwood Creek in Muir Woods ca. 1934 (from NPS Archives).

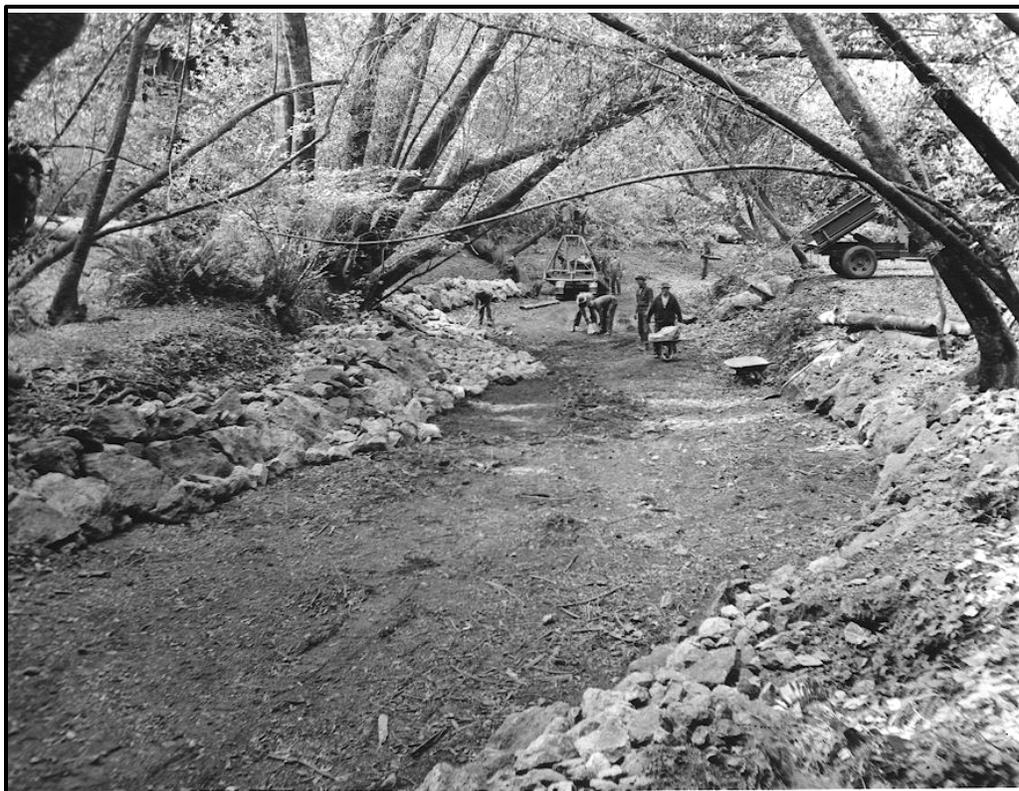
Figure 9. CCC workers installing rock riprap along the banks of Redwood Creek. Note the lack of bank vegetation and the truck on the bank, showing bank disturbance, also the machinery in the creek. ca. 1934 (from NPS Archives).

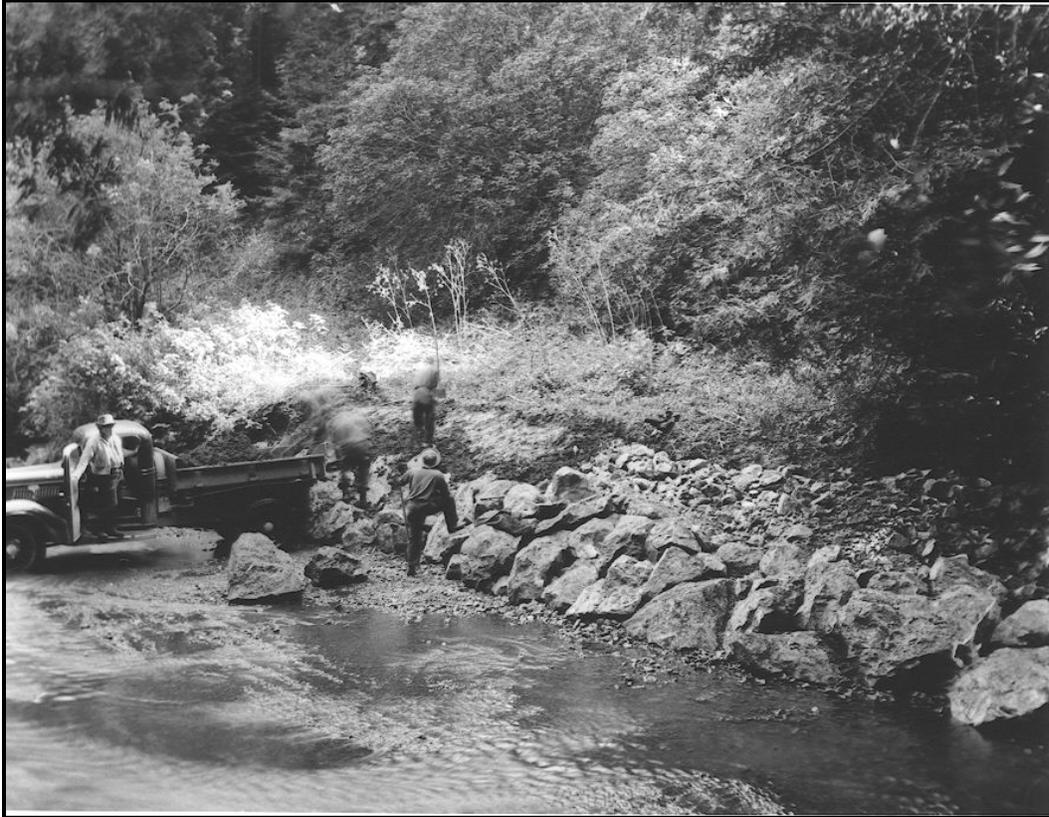
Figure 10. Equipment working in streambed during CCC riprap construction ca. 1937, note the bed and bank disturbance (from NPS Archives).

Trucks and heavy equipment were driven in the creek bed to excavate parts of the bed for the riprap and check dam installations (Figures 10,11) (Haynes, 1936), however it is not clear whether the bed was excavated and then filled in after rock placement, or if the material was moved elsewhere, leaving the bed wider or lower than previously, or even if the channel was straightened as part of the project³ (Figure 12).

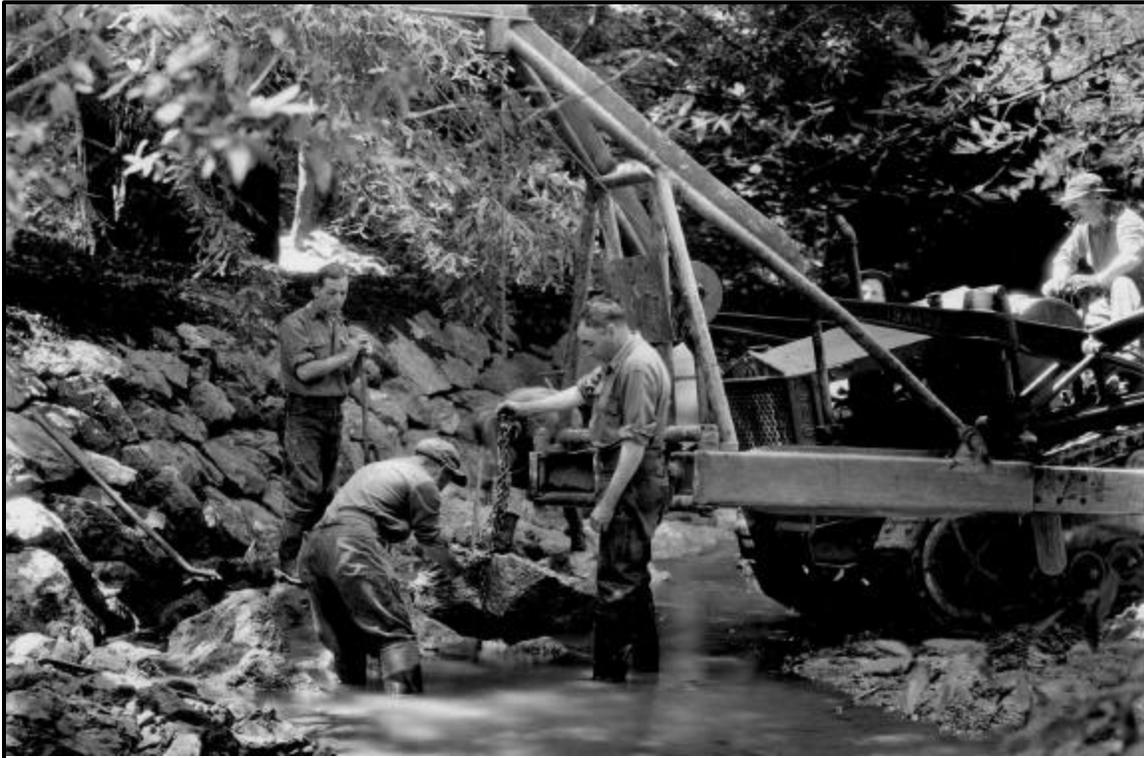
Figure 11. CCC workers with equipment in the streambed placing rock ca. 1936 (from NPS Archives).

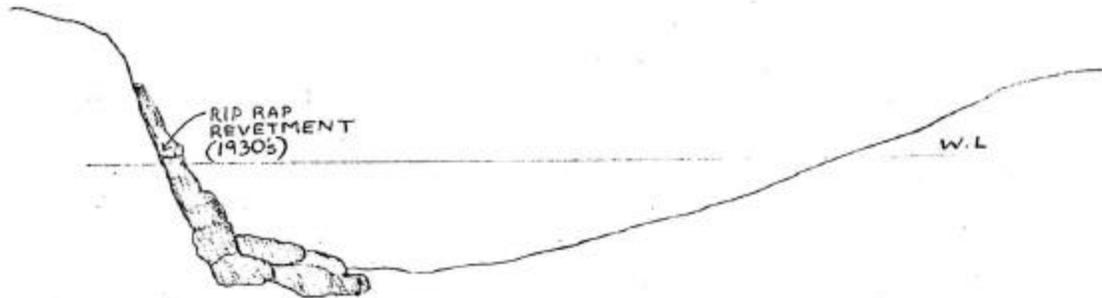
Figure 13. Cross section diagram of CCC rock revetment construction showing the bank protected along the toe and into the channel bed (From Howell and Milestone, 1981).

revetment constructed by the CCC (Figure 13) shows rock protecting the bank from just below the top of the bank to the toe and extending about $\frac{1}{4}$ of the way across the bed. Figure 14 shows such bank toe armor. A group from the NPS recently probed the bed adjacent to some of the riprap sections and found no sign of bed armoring as shown in the diagram (Carolyn Shoulders, pers. comm. 2001). However, some riprap sections appear to extend below the bed such as section R-11 and bed aggradation may have covered the rocks at bank toes.

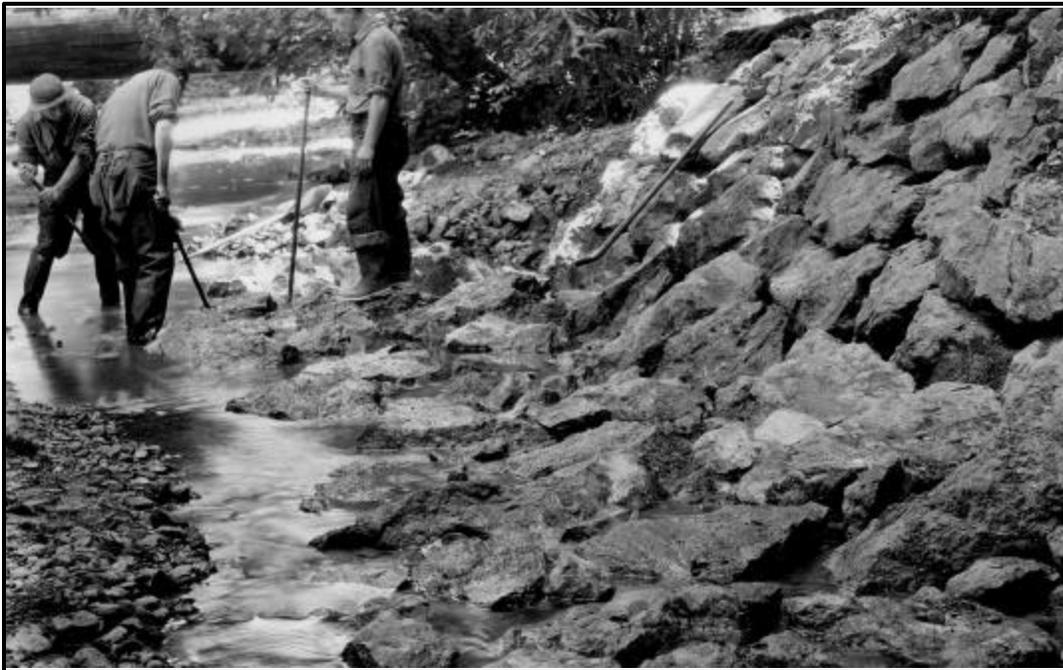
Figure 14. Rock riprap armoring the stream bank and extending into the channel as depicted in Figure 13 (from NPS Archives).

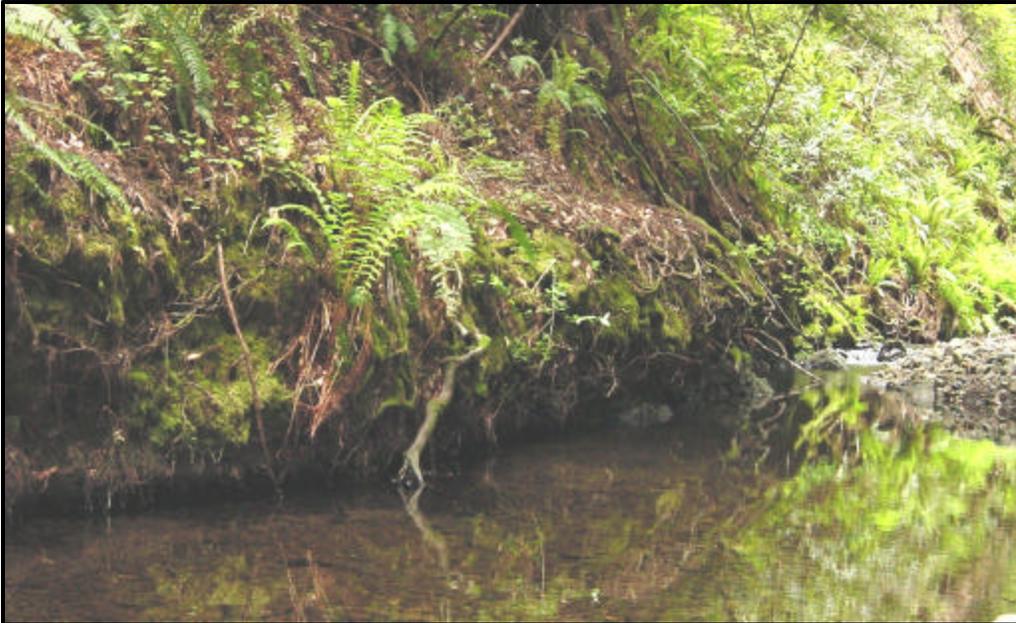
Figure 15. Undercut bank with pool on a non-riprapped meander bend in Muir Woods. Tree roots and ferns and a bedrock outcrop stabilize the bank.

bends as it can where banks are not armored (Figure 15). Cross-sections of areas with riprap (Appendix 2) show flatter streambeds or, as in section L-11, a narrow channel adjacent to the riprap with a high gravel bar opposite the riprap. Without the ability to erode the outside bend and move in that direction, the channel also cannot create a point bar that grows and evolves as the channel moves.

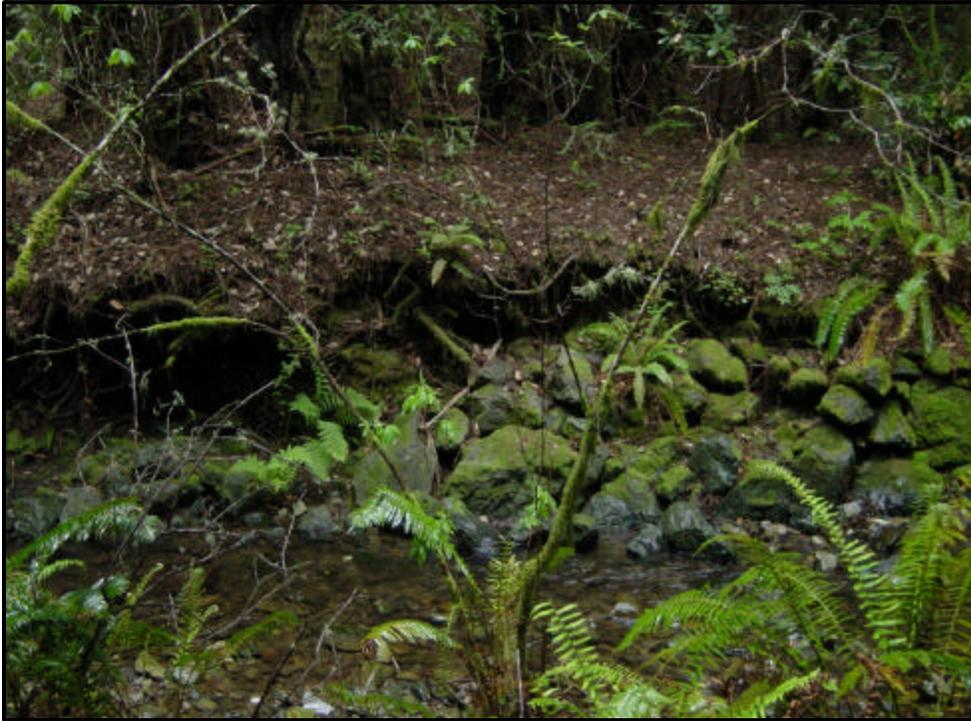
Figure 16. Downstream end of riprap section R9. Note the rock slumping into the channel and the bank scour on the left.
