GUALALA RIVER WATERSHED LITERATURE SEARCH AND ASSIMILATION

BY PATRICK HIGGINS Consulting Fisheries Biologist 791 Eight Street, Suite N Arcata, CA 95521 (707) 822-9428

Introduction: Gualala Watershed Overview

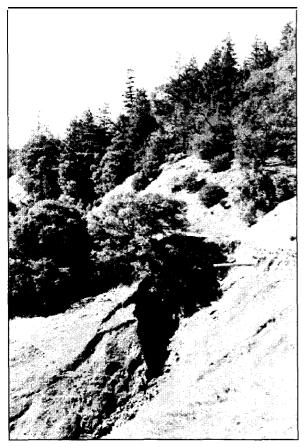
Figure 15. Massive gully caused by improper drainage on Kelly Road.

Kelly Road, which extends from Lake Sonoma to Annapolis, is a major source of sediment entering the Gualala River and its tributaries. The road was originally constructed for log hauling in the late 1940's but was purchased by the Army Corp of Engineers at the time Warm Springs Dam was constructed. Pacific Watershed Associates (1996a) made the following observations on Kelly Road: "While Kelly Road has existed in its present location for nearly 50 years, it exhibits a long history of triggering widespread past erosion and man-made accelerated sediment yield to stream channels. Many stream crossings show indications of past failure and reconstruction. Long segments of inboard ditch are enlarged and eroded by gullying (Figure 14). Most of the ditch relief culverts, stream crossing culverts and berm drains have varying sized fillslope and hillslope gullies below their outlets (Figure 15). Many scars from cutbank and fillslope failures are present along the route." The NCRWQCB recently issued a Cleanup and Abatement order to the Army Corp of Engineers regarding Kelly Road. Williams and Bedrosian (1976), in a study covering the North Fork Gualala watershed, noted that: "many erosion problems are associated with road construction, particularly within the sheared and shattered material of the San Andreas fault zone. Several deep gullies and many smaller, potentially hazardous gullies parallel to the roads have been formed by erosion as a result of improper drainage. Where the gullies have become enlarged and water has saturated underlying materials, the roads either have started to slide or have been washed out. In many places, minor cost remedial work could greatly reduce these erosion problems and deter future damage that would be much more costly to repair."

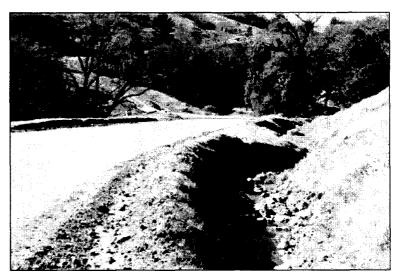
Figure 16. Enlarged Kelly Road ditch where small stream has been captured
