Survey identifies sediment sources in North Coast rangelands

David J. Lewis □ Kenneth W. Tate □ John M. Harper □ Julie Price

We conducted a sediment source survey to gain insight into soil erosion on Northern California rangeland watersheds and to provide information to facilitate informed land-use management, conservation prioritization and water-quality regulation decisions. The results indicate that by focusing on erosion associated with natural and historical influences, inventory and assessment efforts on these watersheds can characterize the majority of sediment deliverable to streams. While this volume of sediment does not require mitigation under current water-quality regulations, it none-

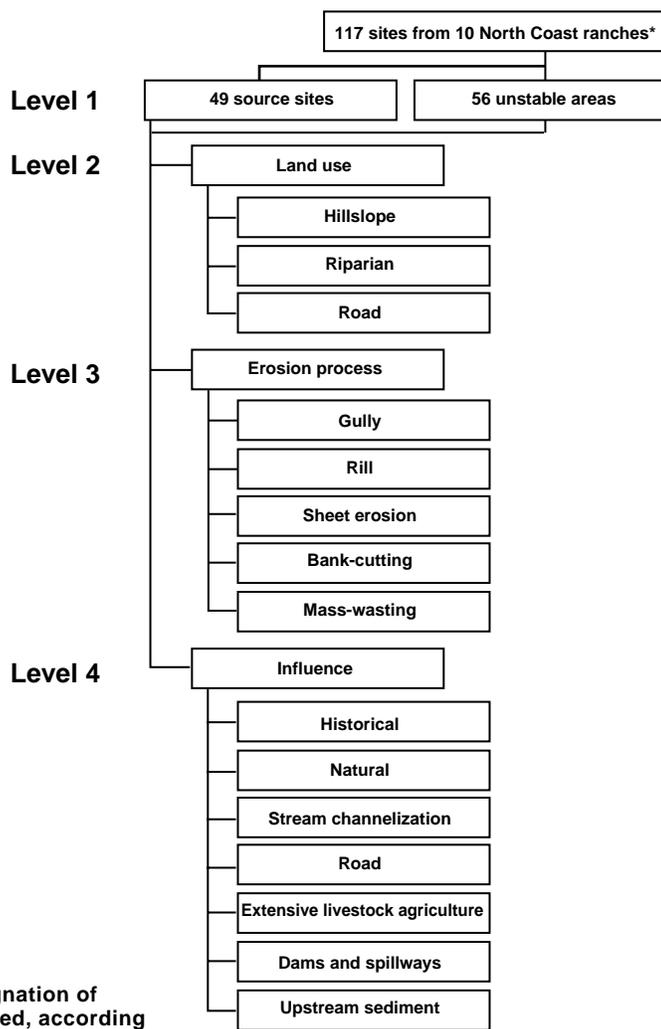
Fig. 1. Designation of sites surveyed, according to inventory designation.

*117 includes 12 noninventory sites

Site classification. We first classified each sediment delivery site as a source site, unstable area or noninventory site according to NCRWQCB site-selection criteria established in the Garcia River sediment TMDL (NCRWQCB 1998a; fig. 1):

The 117 sites were first grouped by inventory designation to assess sediment delivery from source sites, unstable areas and noninventory sites (fig. 1). Source sites and unstable areas were then grouped by landscape position and erosion processes. Land-use types were divided according to three landscape geographic positions: hillslope, riparian and road. Finally, source sites and unstable areas were sorted by influence, including historical, natural, stream channelization, roads, extensive livestock agriculture, dams and spillways, and upstream sediment.

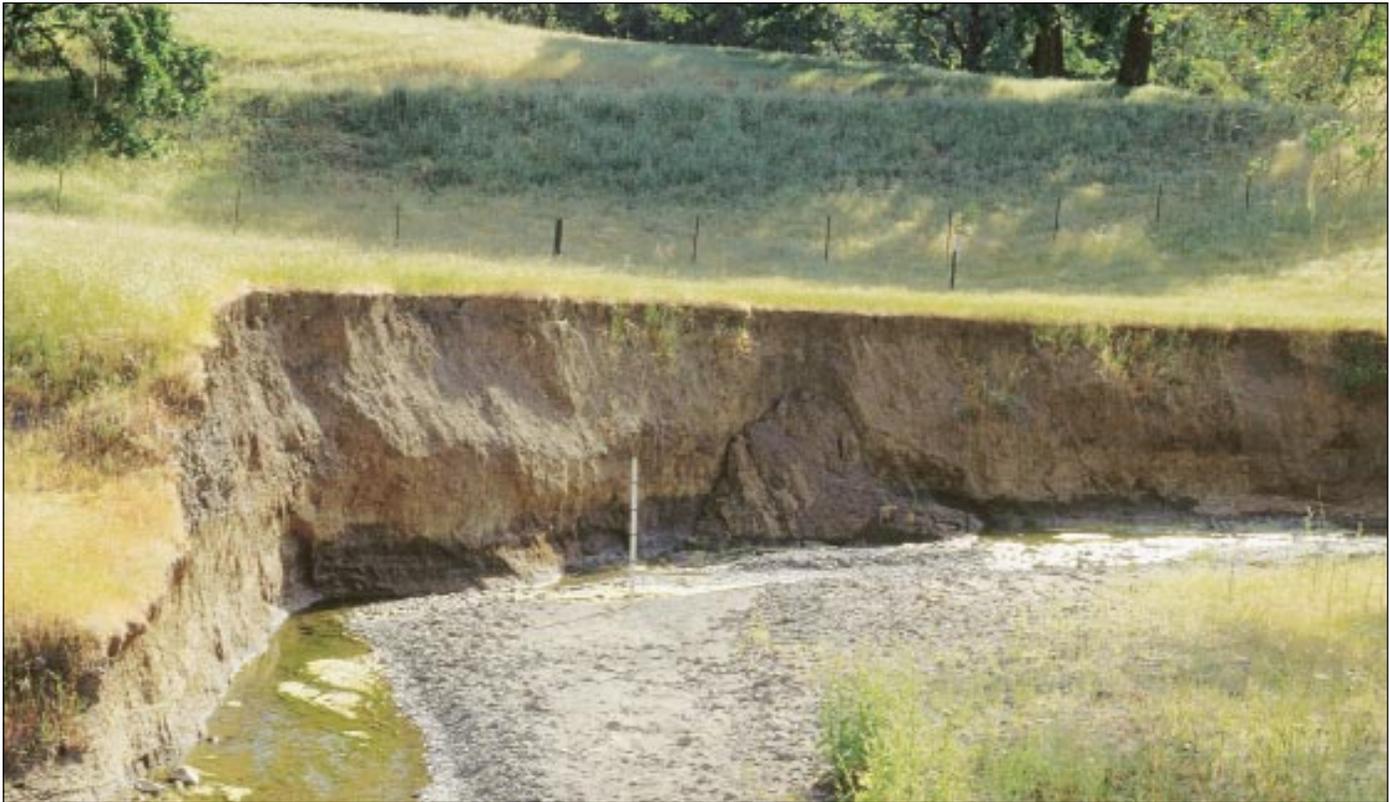
Unstable area of sediment delivery associated with bank-cutting and resulting from historical and natural influences. Current water-quality regulations require inventory and monitoring but not mitigation of this site.*

The percentage of eroded sediment that could be delivered to a stream channel was estimated based on the site’s connectivity to a watercourse, and was designated using four broad categories or ranks: (1) 0% to 30%; (2) 30% to 60%; (3) 60% to 90%; and (4) 90% to 100%. For example, the estimated sediment that could be eroded from the site shown on page 35 over a 40-year period is 160 cubic yards. Based on site connectivity to the nearest stream channel, we estimate that 60% to 90% of sediment eroded will be delivered to the stream. Therefore, the potential sediment delivery from this site is estimated to be between 96 and 144 cubic yards

(160 cubic yards × 60% and 160 cubic yards × 90%).

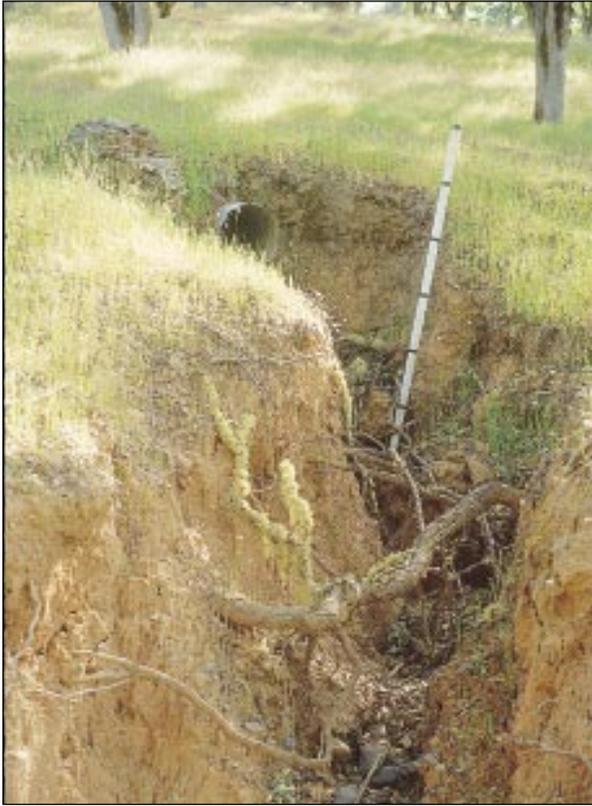
Source site of sediment delivery associated with gully erosion and resulting from road drainage management and culvert design. Current water-quality regulations require inventory, monitoring and mitigation of this site.*

In comparison, the estimated sediment that could be eroded in the site shown on page 36 is 620 cubic yards. Because the site is a stream channel, 100% of the eroded sediment will be delivered to the stream, creating an estimated potential sediment delivery of 620 cubic yards.

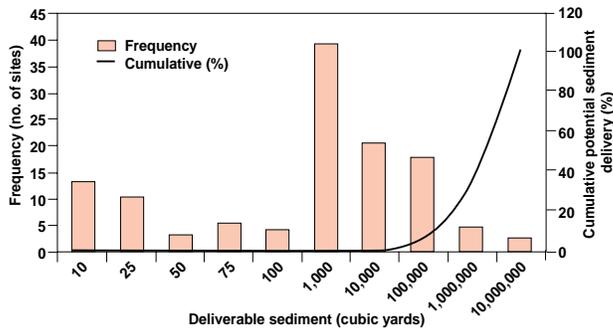
Fig. 2. Frequency and cumulative potential sediment delivery for 117 North Coast rangeland sites.

Total potential deliverable sediment was three orders of magnitude lower for source sites than for unstable areas, and represented less than 1% of the total volume for all 117 sites (table 1). The distribution analysis of the total deliverable sediment volume for all sites indicates that the majority (74%) have a deliverable volume equal to or greater than 100 cubic yards (fig. 2). In addition, this threshold of 100 cubic yards inventories nearly all of the deliverable sediment from all 117 sites.
