Restoration Research and Monitoring in Bayland Wetlands of the San Francisco Bay Estuary: The Tolay Creek Project

2002 Progress Report

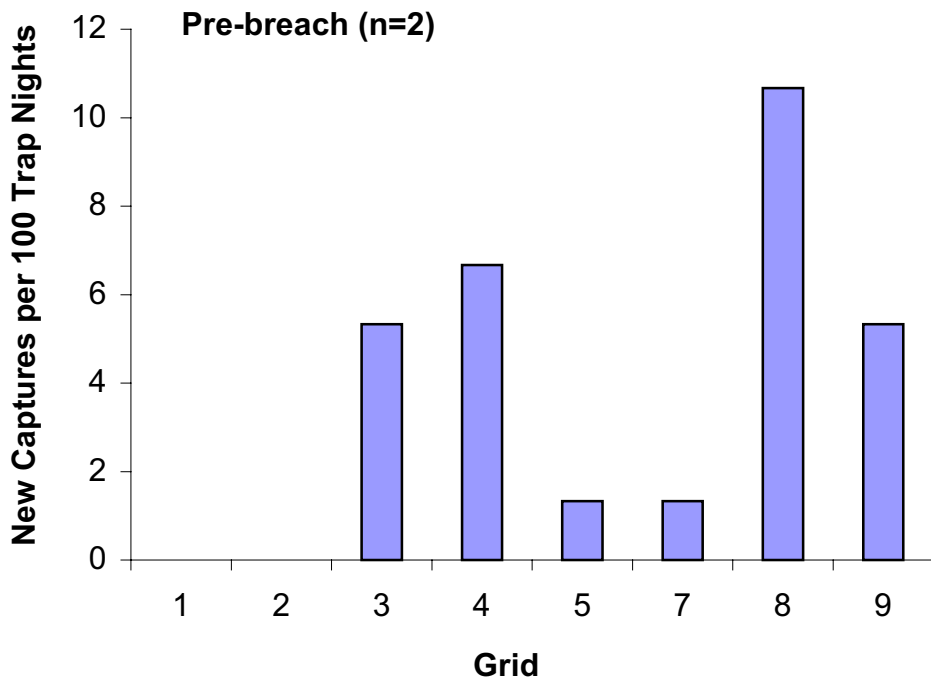
Figure 32. Abundance index (New Captures/ 100 Trap Nights) of the salt marsh harvest mouse (*Reithrodontomys raviventris*) in the Tolay Creek Restoration Project across 9 trapping grids, pre-breach (1998-1999) and post-breach (1999-2002).

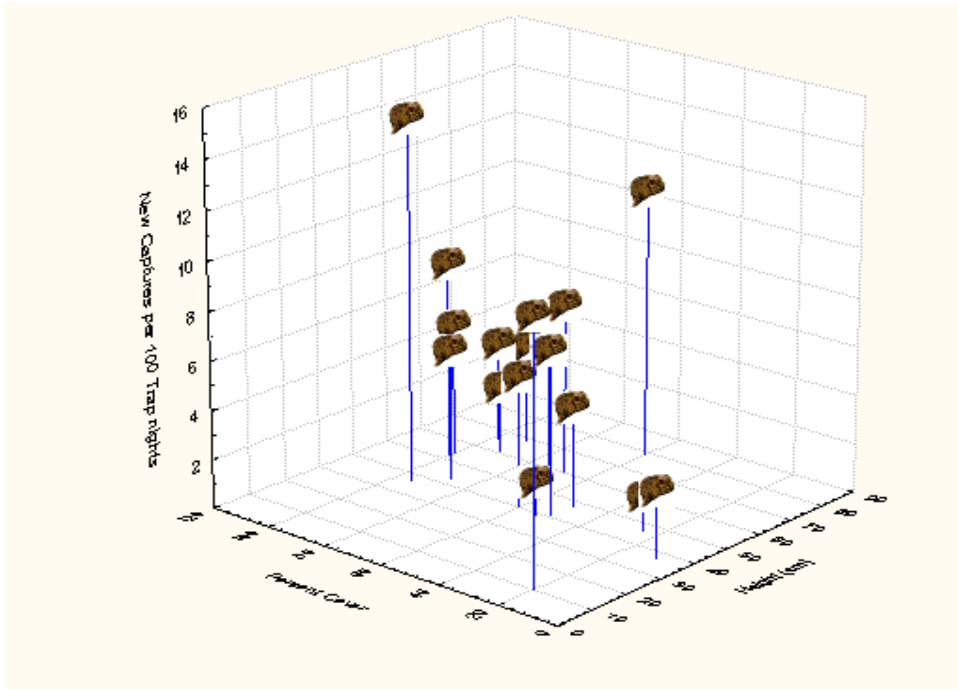
Figure 33. Three dimensional relation graphs between the salt marsh harvest mouse (*Reithrodontomys raviventris*) abundance index (new captures/ 100 trap nights) with pickleweed (*Salicornia virginica*) height (cm) and percent cover (top); and density (plants/m²: bottom) and height (cm) at the Tolay Creek Restoration Project, 1999-2002.
