Geomorphic Processes and Aquatic Habitat in the Redwood Creek Basin, Northwestern California

Magnitude and Causes of Gully Erosion in the Lower Redwood Creek Basin, Northwestern California

U.S. GEOLOGICAL SURVEY PROFESSIONAL PAPER 1454-I

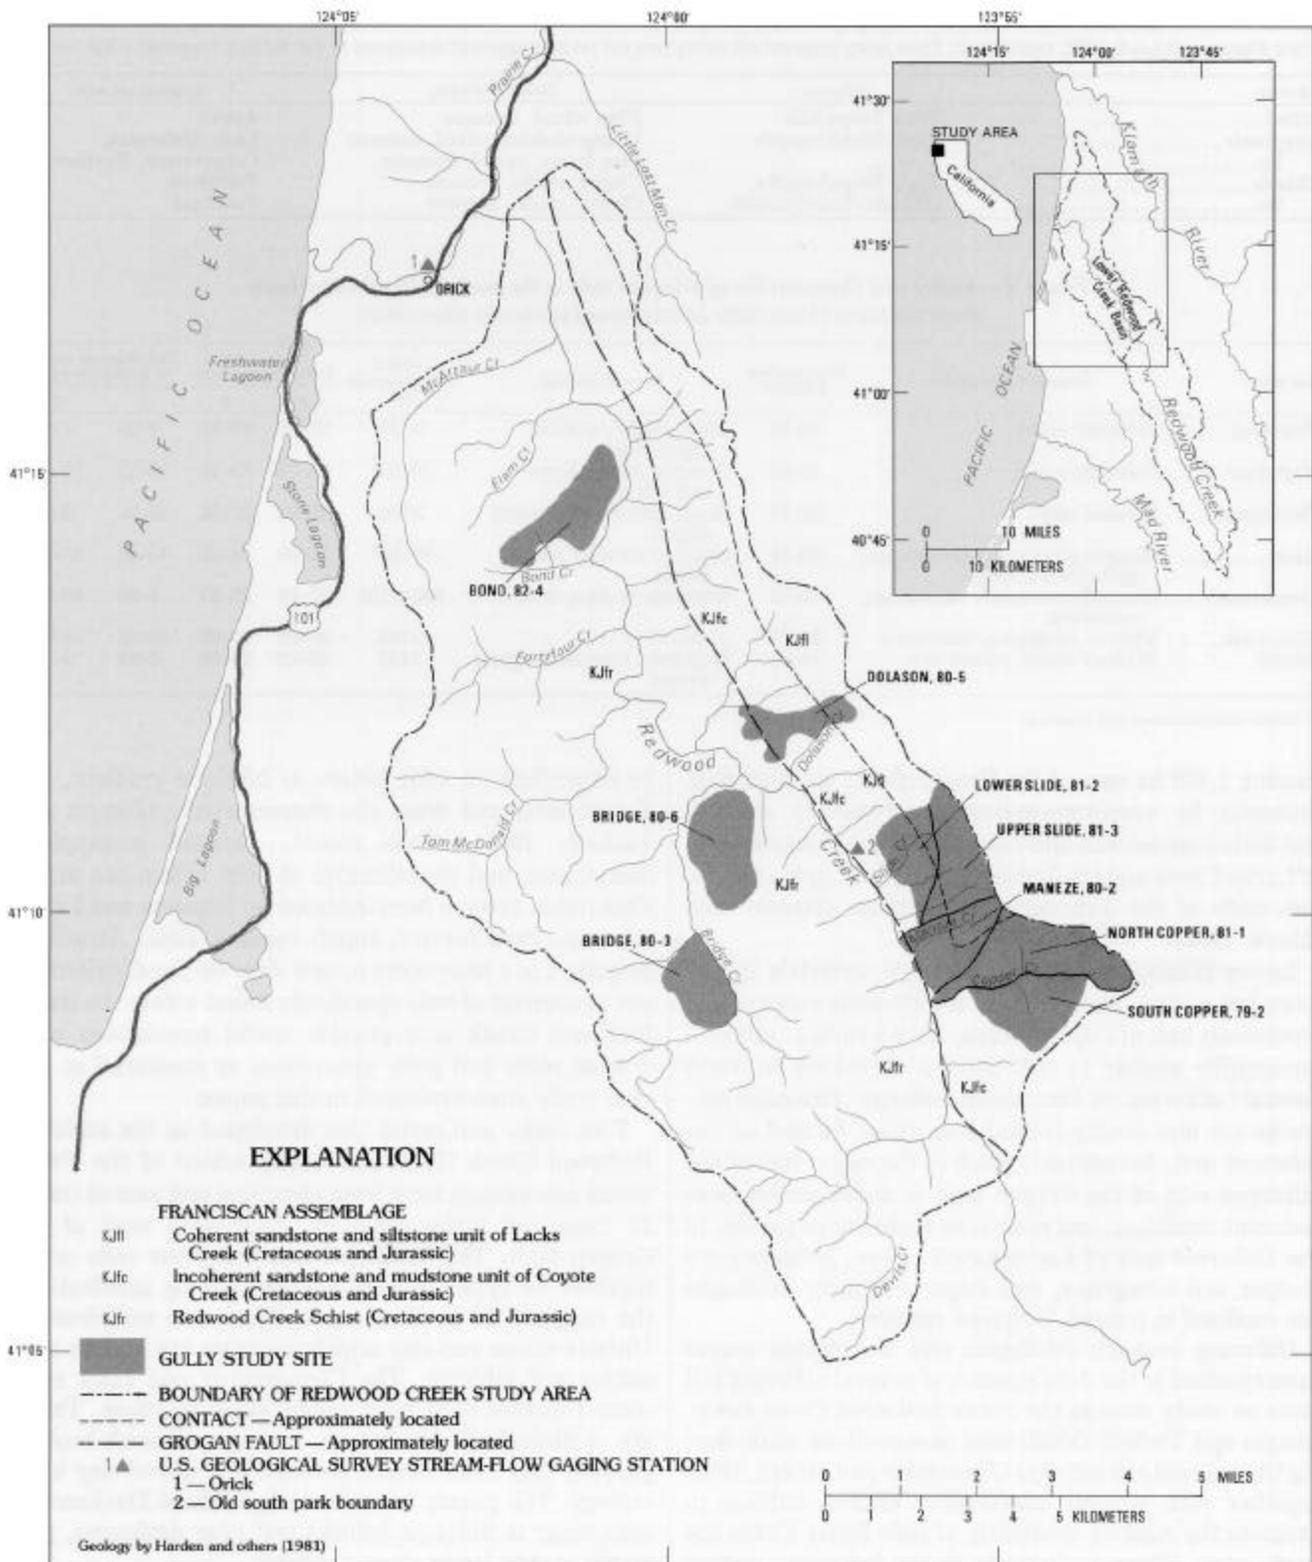
FIGURE 1.—Lower Redwood Creek basin, nine study sites (shaded areas), and generalized bedrock geology. For this study, the lower Redwood Creek basin encompasses all lands within the Redwood Creek unit of Redwood National Park, excluding the Prairie Creek drainage basin and areas downstream from the confluence of Prairie Creek and Redwood Creek.

As a result of a congressionally authorized watershed rehabilitation program in the lower Redwood Creek basin (fig. 1), cutover forested areas and prairie grasslands have been studied to locate active and potential sources of erosion for eventual erosion control. To achieve this, Redwood National Park geologists have completed detailed erosional inventories and geomorphic maps, at a scale of 1:1,200, on approximately 4,000 hectares (ha) of logged land within the lower one-third of the Redwood Creek basin. This mapping, which began in 1978, has included both the location and dimension of hillslope gullies, landslides, enlarged natural stream channels, and a variety of other erosional features.

Nine study sites totaling 2,214 ha were selected (fig. 1). Study sites were limited to those that had been mapped in sufficient detail to allow accurate determination of gully volumes as well as the causes of each newly developed gully system. Several sites were specifically chosen because of their apparent low rate of fluvial hillslope erosion. Most of the sites described in this investigation, however, displayed widespread and intense ground disturbance from recent road construction and timber harvesting. These activities had resulted in locally severe gully and landslide erosion. The study sites covered a variety of bedrock types, soil materials, hillslope positions, and slope gradients (table 3).

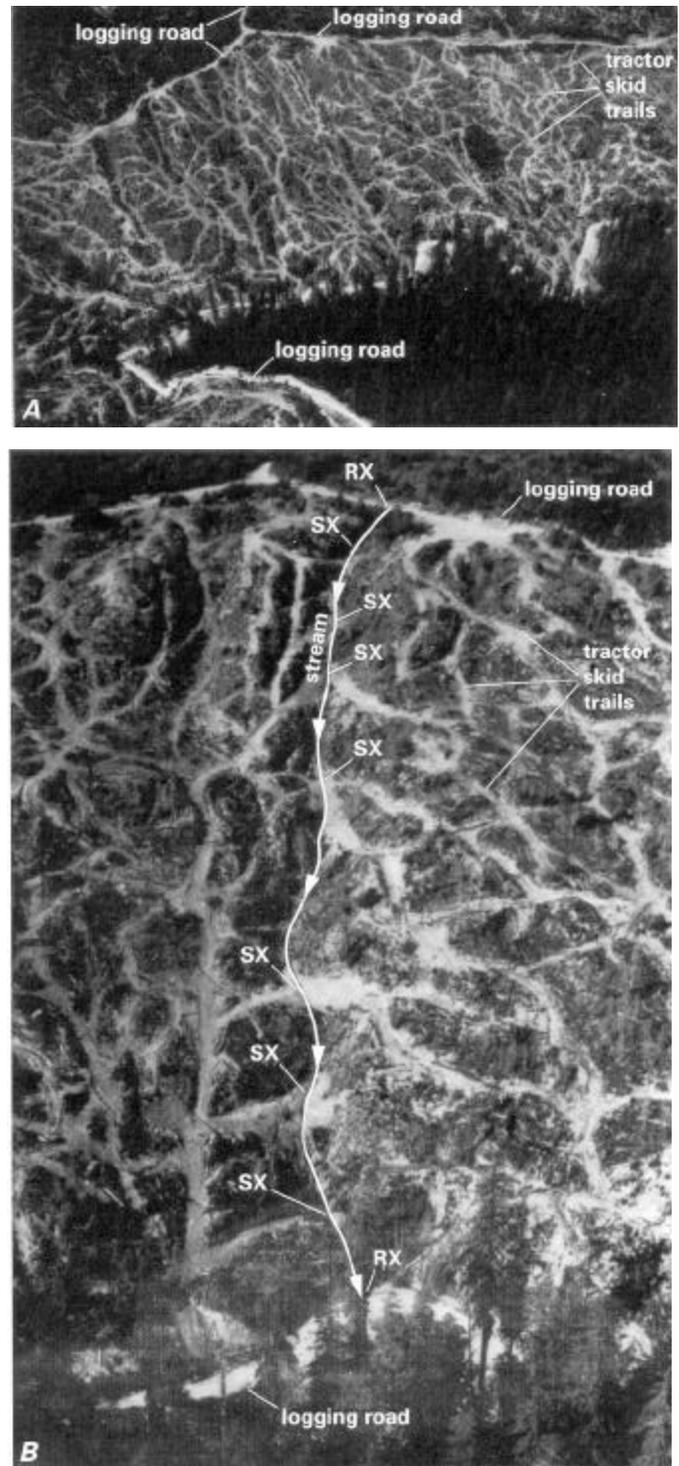
FIGURE 2. —Oblique aerial photographs of a portion of the Bond Creek study site (82-4). A, Top photograph taken in 1978, shows intricate web of tractor skid trails and associated haul roads on hillslope that was clearcut in 1975 and 1976. Areas between trails had already begun to revegetate. In contrast, the area at top of photograph was last logged in 1970. Old-growth forests remain at the base of the hill. B, Lower photograph shows two road crossings (RX) and at least seven skid-trail crossings (SX) of the intermittent stream that flows from top-center to bottom-center of the photographs.

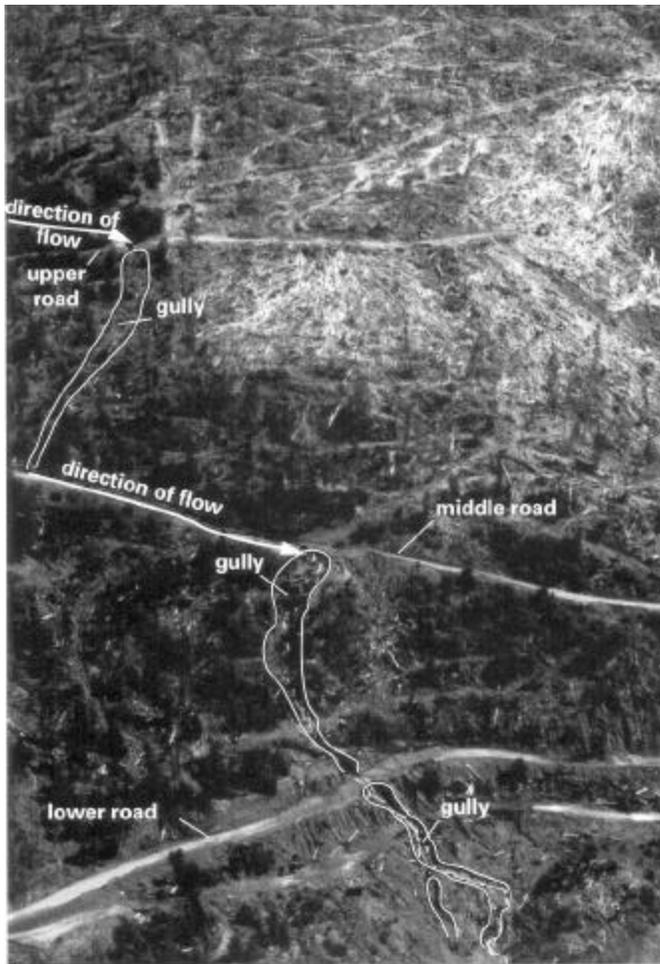
FIGURE 3.—Oblique aerial photograph of a roaded, clearcut hillslope in the lower Redwood Creek basin. Lack of culverts on the upper road resulted in large gully that extended from the end of switchback down to the middle road. The lack of a culvert at the stream crossing on the middle road caused diversion of flow down the ditch and across a road prism near center of the photograph, creating a large, visible gully extending down to and across the lower road system. Photograph was taken soon after the March 1972 storm.

The effect is a nearly total disruption of the microtopographic features of the site and obliteration of all but the major channels of the original drainage network. Compacted areas (roads, trails, and landings) promote rapid surface runoff during winter storms, and diverted streams find new paths over the disrupted landscape (fig. 3).

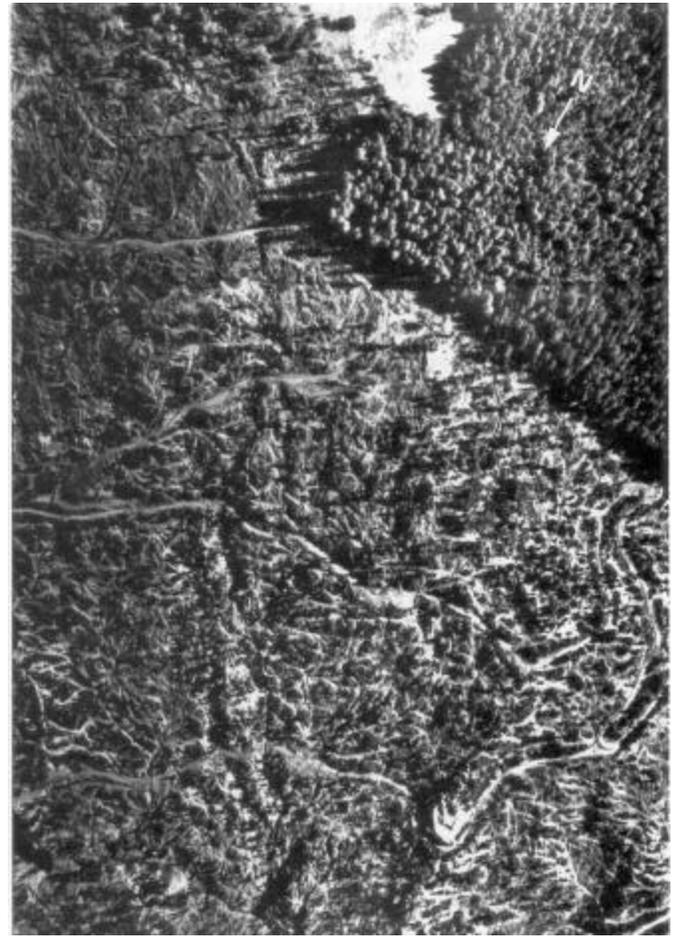
FIGURE 4.—Vertical aerial photograph taken March 7, 1972, of the western portion of the South Copper Creek study site. Note the degree of ground disturbance and the complex pattern of skid trails associated with clearcut tractor-yarding completed in 1971. Old-growth forest (upper right, outside study site) was logged the following year.

The sequence of harvesting in each of the nine study sites has generally consisted of (1) pioneer road construction and limited selective harvesting in the late 1950's and early 1960's and (2) reentry in the early 1970's (table 3), after a period of no activity, for additional road construction and clearcut tractor-yarding over virtually the entire forested portion of each site. For example, in South Copper the conifer forests were logged between 1959 and 1971, with 5 years of intermittent selective tractor logging from 1959 to 1963. The remaining residual timber was clearcut and tractor-yarded from 1970 to 1971. On all sites, this final phase of logging was marked by extreme ground disturbance that left approximately 80 percent bare soil in place of the forested portion of the study site (fig. 4). Road construction history paralleled

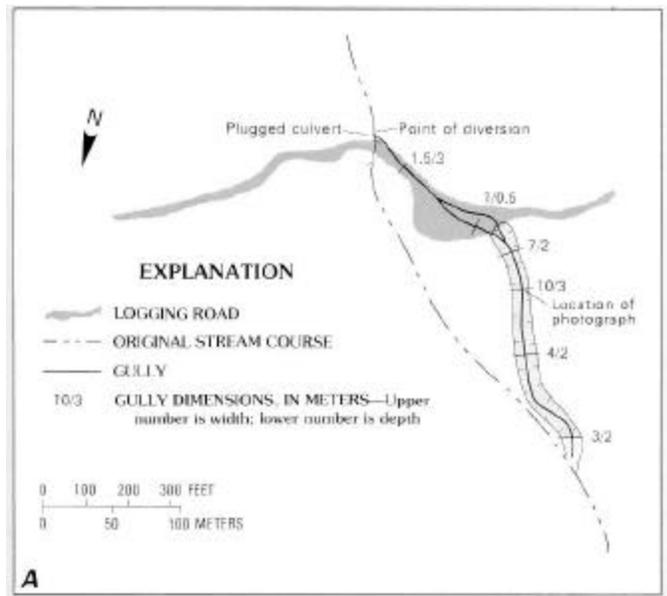
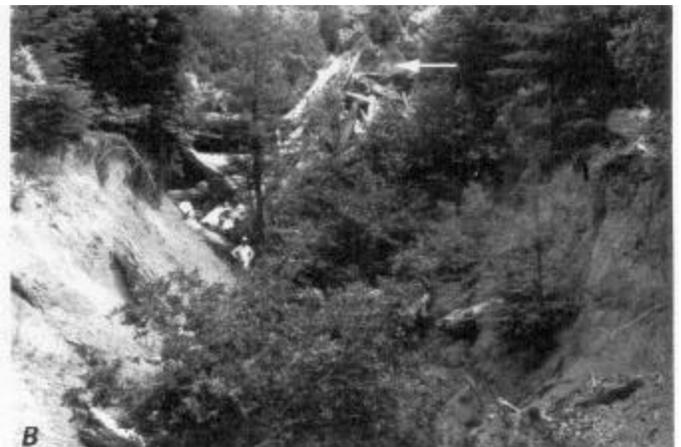
FIGURE 5.—Large gully created when a plugged gully diverted a perennial stream. A, Planimetric map of gully showing selected cross-sectional dimensions. Total measured volume of gully is 2,800 m³. B, Photograph of same gully. Scale is indicated by person standing in gully. Arrow indicates logging road at prominent headcut.

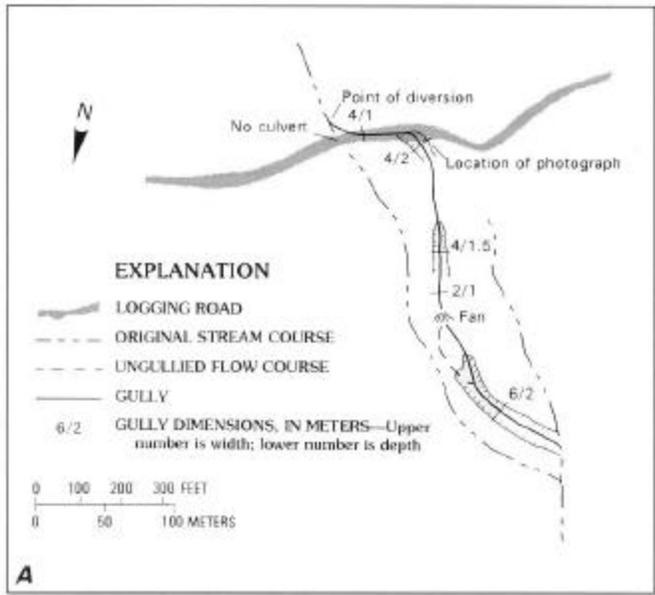
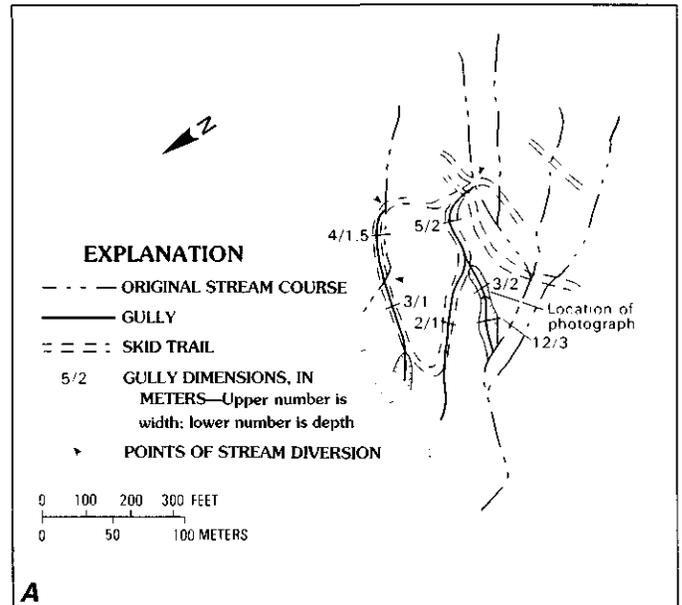
← FIGURE 6.— Gully attributed to lack of culvert on logging road. A, Planimetric map of gully showing diversion of stream down the roadside ditch, across road, and then down several hundred meters of hillslope before entering another stream channel. Total volume of gully system on map is 2,000 m³. B, Photograph taken where gully headcut has migrated across the road prism to a roadside ditch. Note coarse lag deposit that has accumulated in the bed of the gully.

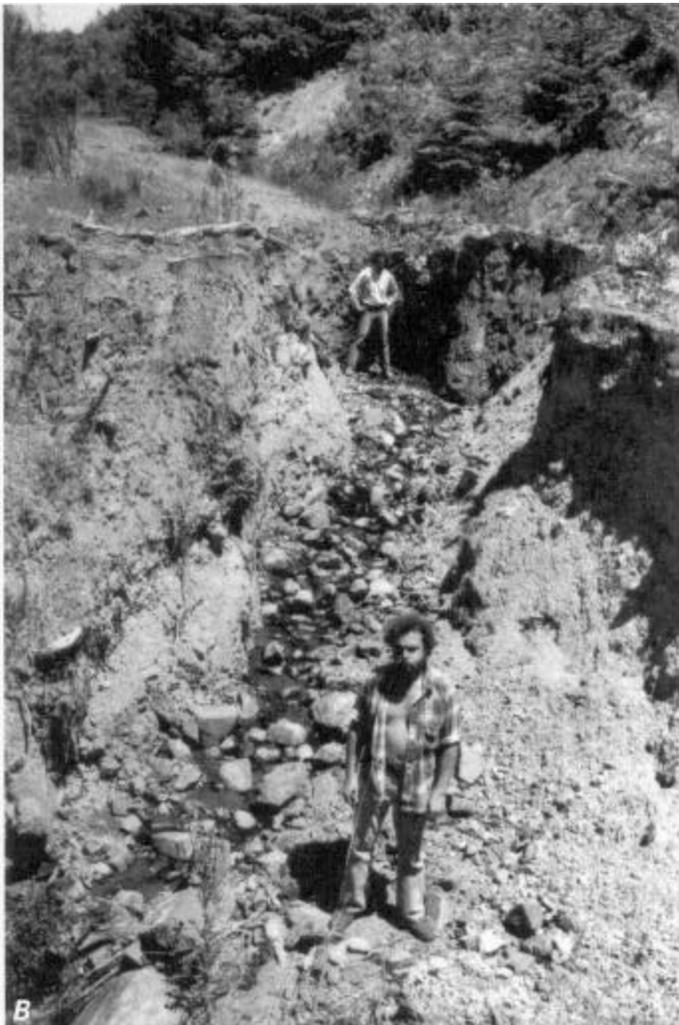
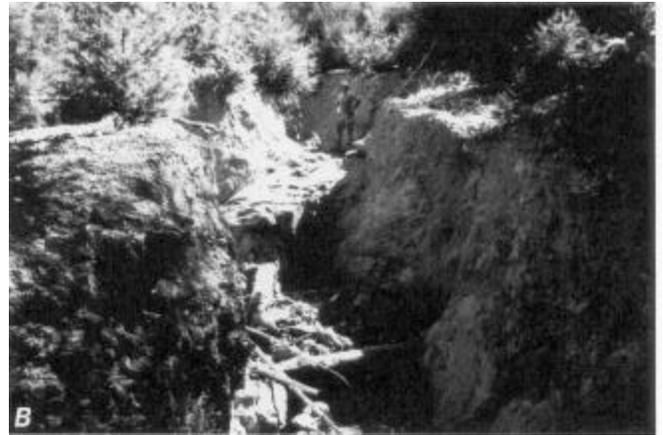
FIGURE 7.—Gullies created by channel obstruction where tractors crossed streams. A, Planimetric map of gully system showing selected cross-sectional dimensions. Most diverted streams followed skid trails. Total volume of gully erosion shown on the map is 4,700 m³. B, Photograph of typical gully in the system.

- (3) Channel obstructions, which caused hillslope stream diversions, occurred almost exclusively at locations where tractors had crossed streams or bulldozed soil and logging slash into shallow channels. Streamflow was then diverted across adjacent logged hillslopes and produced gullies that generally followed the network of skid trails (fig. 7).

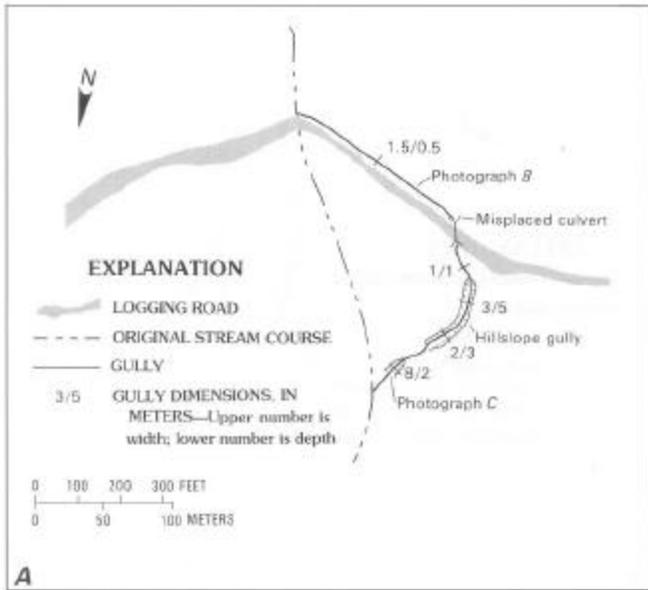
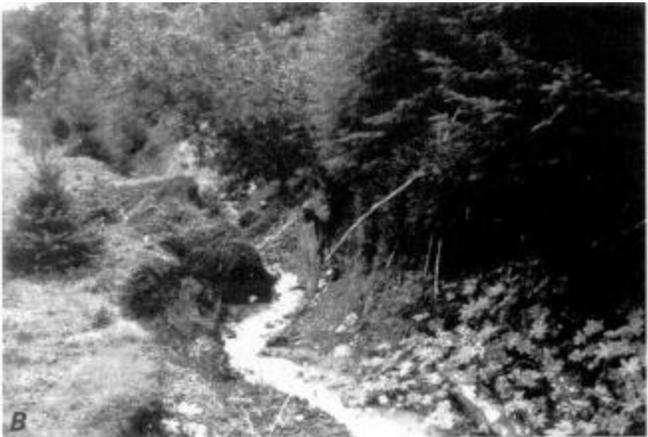
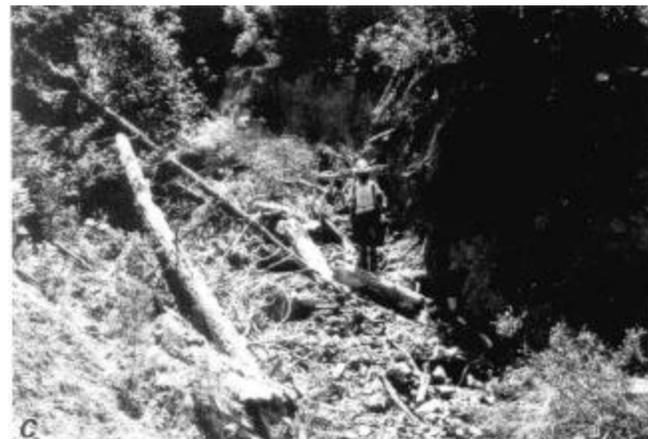
← FIGURE 8.—Gully attributed to misplaced culvert on logging road. A, Planimetric map showing diversion of a perennial watercourse down the roadside ditch for a distance of 150 m to the misplaced culvert, downslope from which a larger gully was formed. Cross-sectional dimensions of the gully are shown at selected intervals, and the computed gully volume is 1,200 m³. B, Photograph of a gullied roadside ditch on a logging road. C, Photograph of gully, which is much larger than gully in B above, on hillslope. Note the increase in the cross-sectional area of the gully as slope steepens.

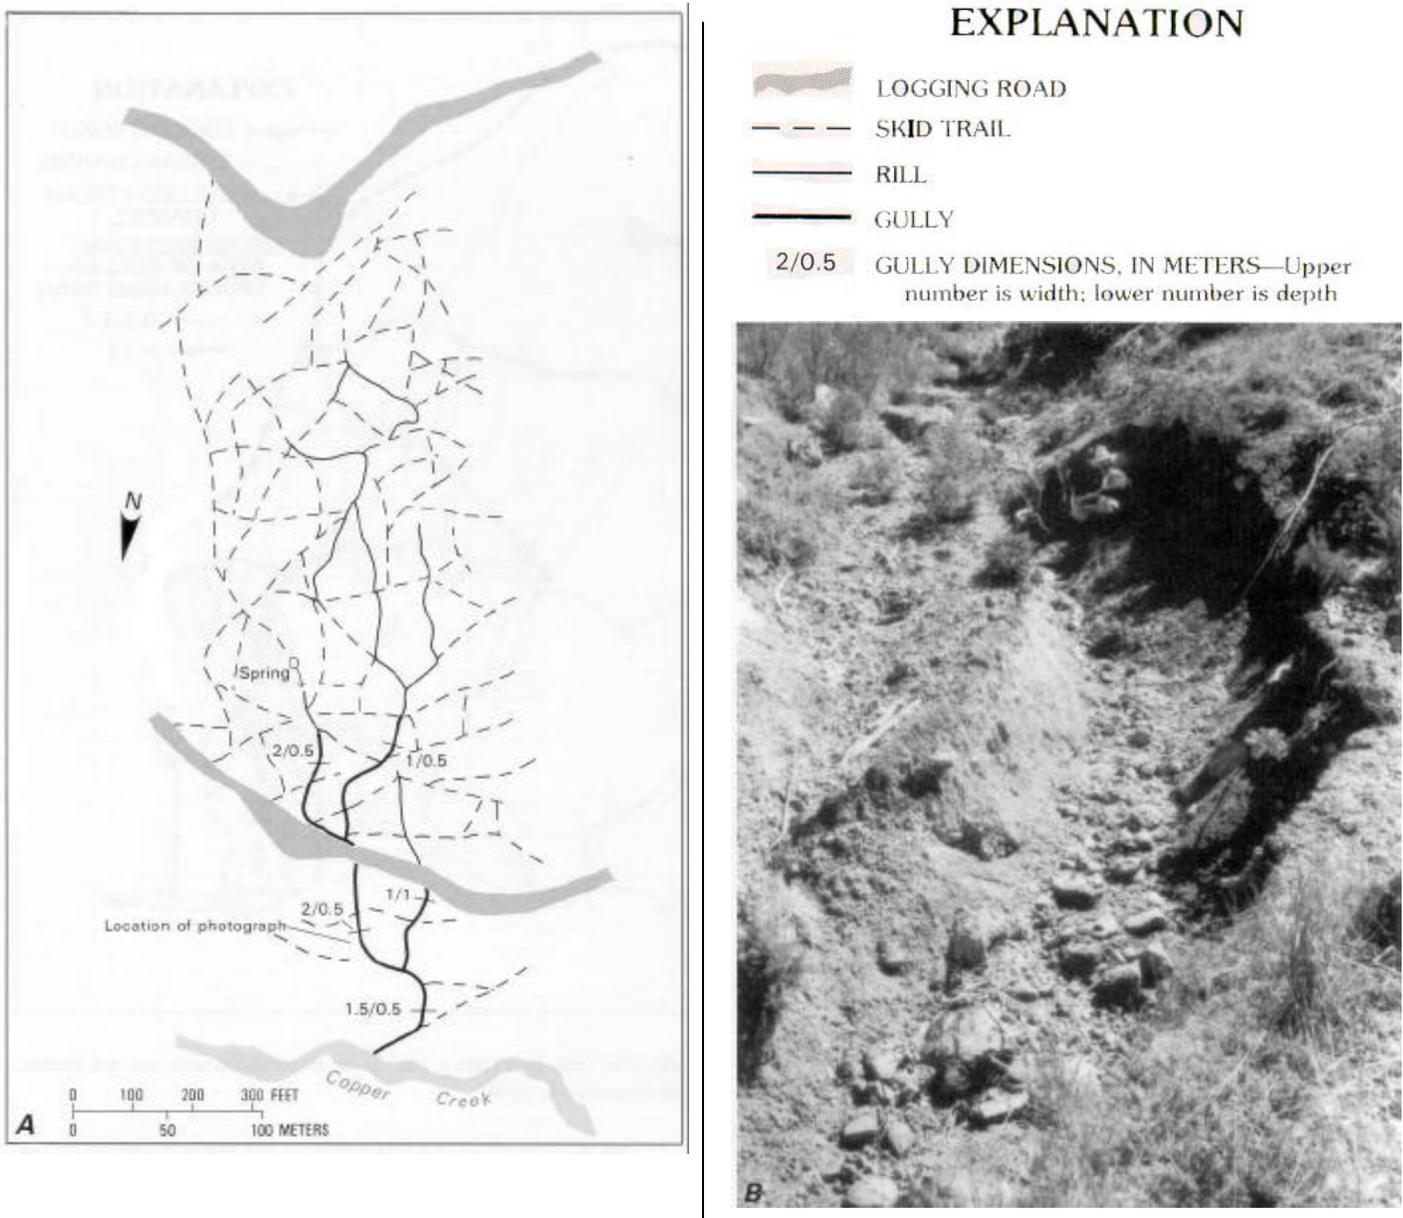
FIGURE 9.—Gullies created by increased surface runoff over the skid-trail network in a tractor-yarded area. A, Planimetric map showing gully system caused by concentrated runoff flowing on skid trails. Note the comparatively small gully dimensions shown on the map. Total gully erosion from the network was 350 m³. B, Photograph of typical gully caused by increased surface runoff.

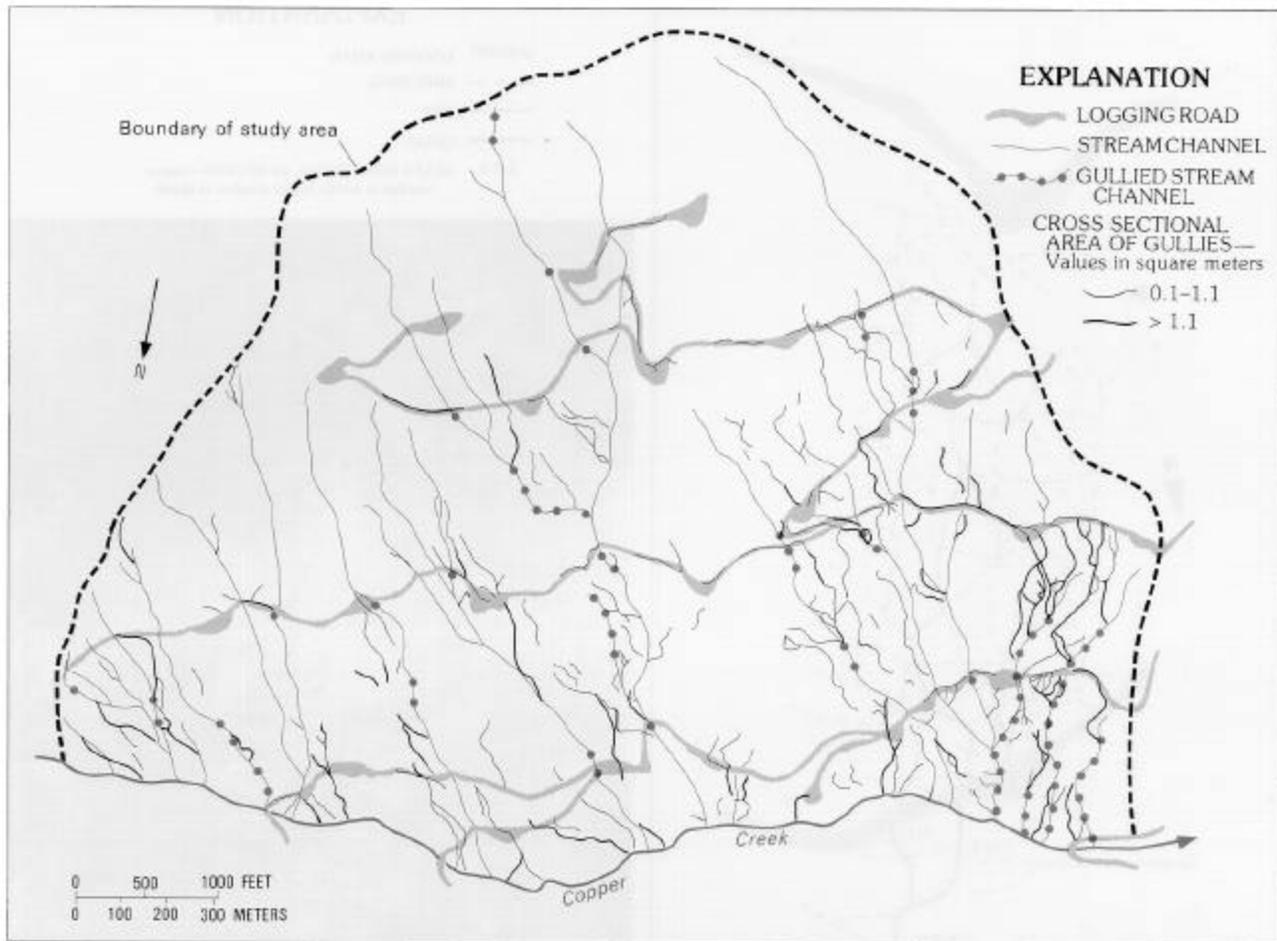
FIGURE 10.—Gully systems on the 246-hectare South Copper Creek study site. Rills less than 0.1 m² in cross-sectional area are not shown. Gullies were mapped and measured in 1979.

contributing to increased sediment yield in the study site (Weaver and others, 1981) (fig. 10). Most gullies were caused by diversions of low-order stream channels on the clearcut hillslopes (table 4). These diversions resulted from (1) widespread tractor disturbance in and adjacent to the natural channel system, (2) lack of maintenance of the 9.3-km logging road system between the initial selective harvest and subsequent reharvesting in the early 1970's, and (3) the lack of maintenance of the dead-end logging road system after clearcutting activities were completed in 1972. Culvert blockages led to either road washouts or stream diversions and the creation of large hillslope gullies. Water was also diverted onto adjacent bare hillslopes where logging roads and skid trails crossed ephemeral and intermittent streams without culverts. These diversions resulted in the development of extensive gully networks.

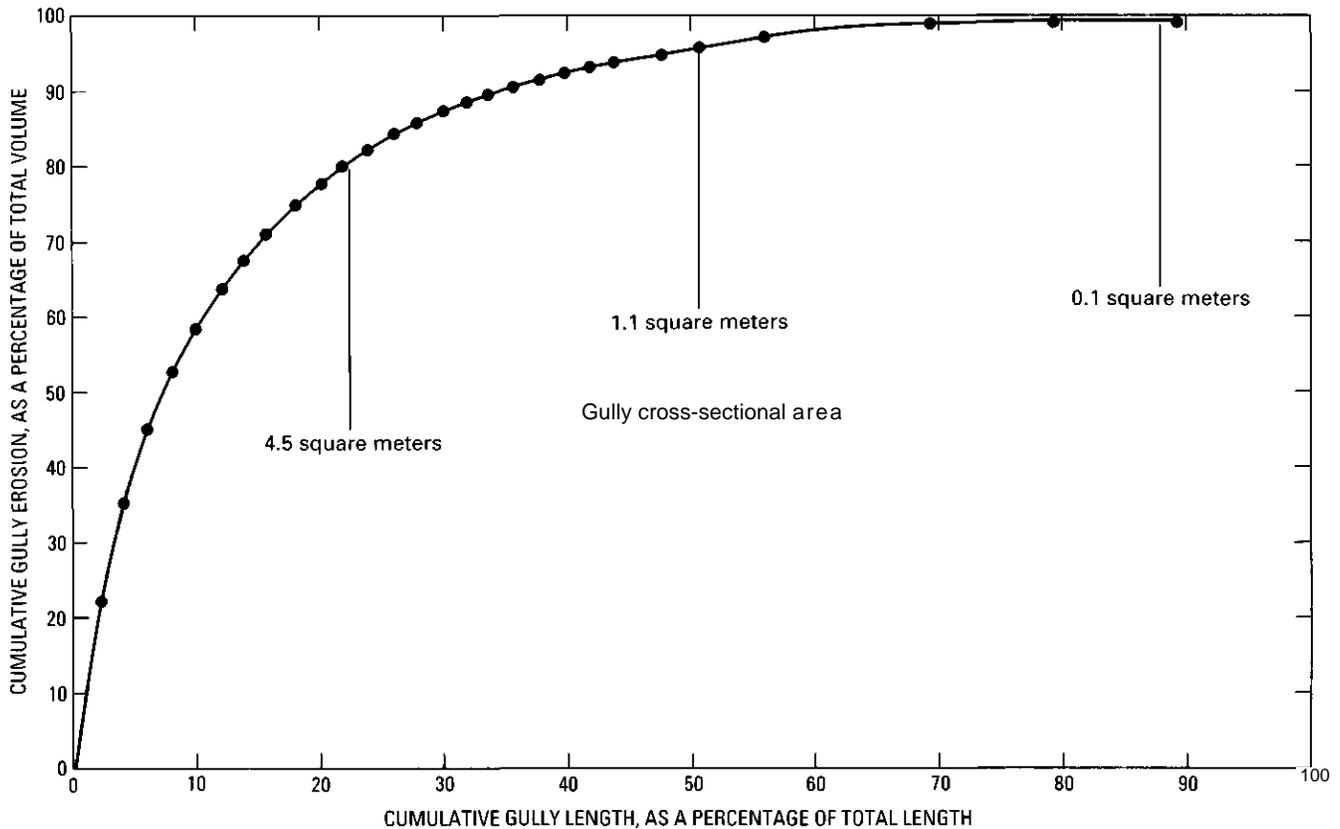
FIGURE 12.— Relations among cumulative gully length, gully cross-sectional area, and cumulative volume of gully erosion on the South Copper Creek study area. Gullies are plotted in order of descending cross-sectional area. (Largest cross sections are plotted first, followed by successively smaller sizes, and ending with the smallest

gullies.) The relationship indicates that the largest gullies (for example, those over 4.5 m² in cross-sectional area) accounted for the bulk of total erosion, yet constituted a relatively small proportion of the total gully network. Small gullies were abundant but produced comparatively little sediment.

Gully-derived sediment production from steep-land coastal terrain similar to that of the lower Redwood Creek basin can be closely determined by limiting sediment source inventories to gullies formed by stream diversions at road and skid-trail crossings. In forested or grassland basins that have been subjected to road building or timber harvesting, gullies produced by diversions will include, almost without exception, all the largest fluvial erosion features to be found in a basin. An accurate estimate of sediment production can then be made by measuring only the largest gullies. These account for a large percentage of the total volume of fluvial erosion but only a small portion of the cumulative length of the gully network (fig. 12).
