# Memorandum

SUBJECT : Kidd Creek, Sonoma County

On March 28, 1980, I met at the Cazanoma Lodge with Warden Don Jacobs, Forrest Reynolds of the Timber Harvest Review Team, and Jim Little of the Harwood Logging Company. The purpose of the meeting was to inspect the logging site on Kidd Creek (Code Section 1603 - III-234-79, THP No. 1-79 - 191S).

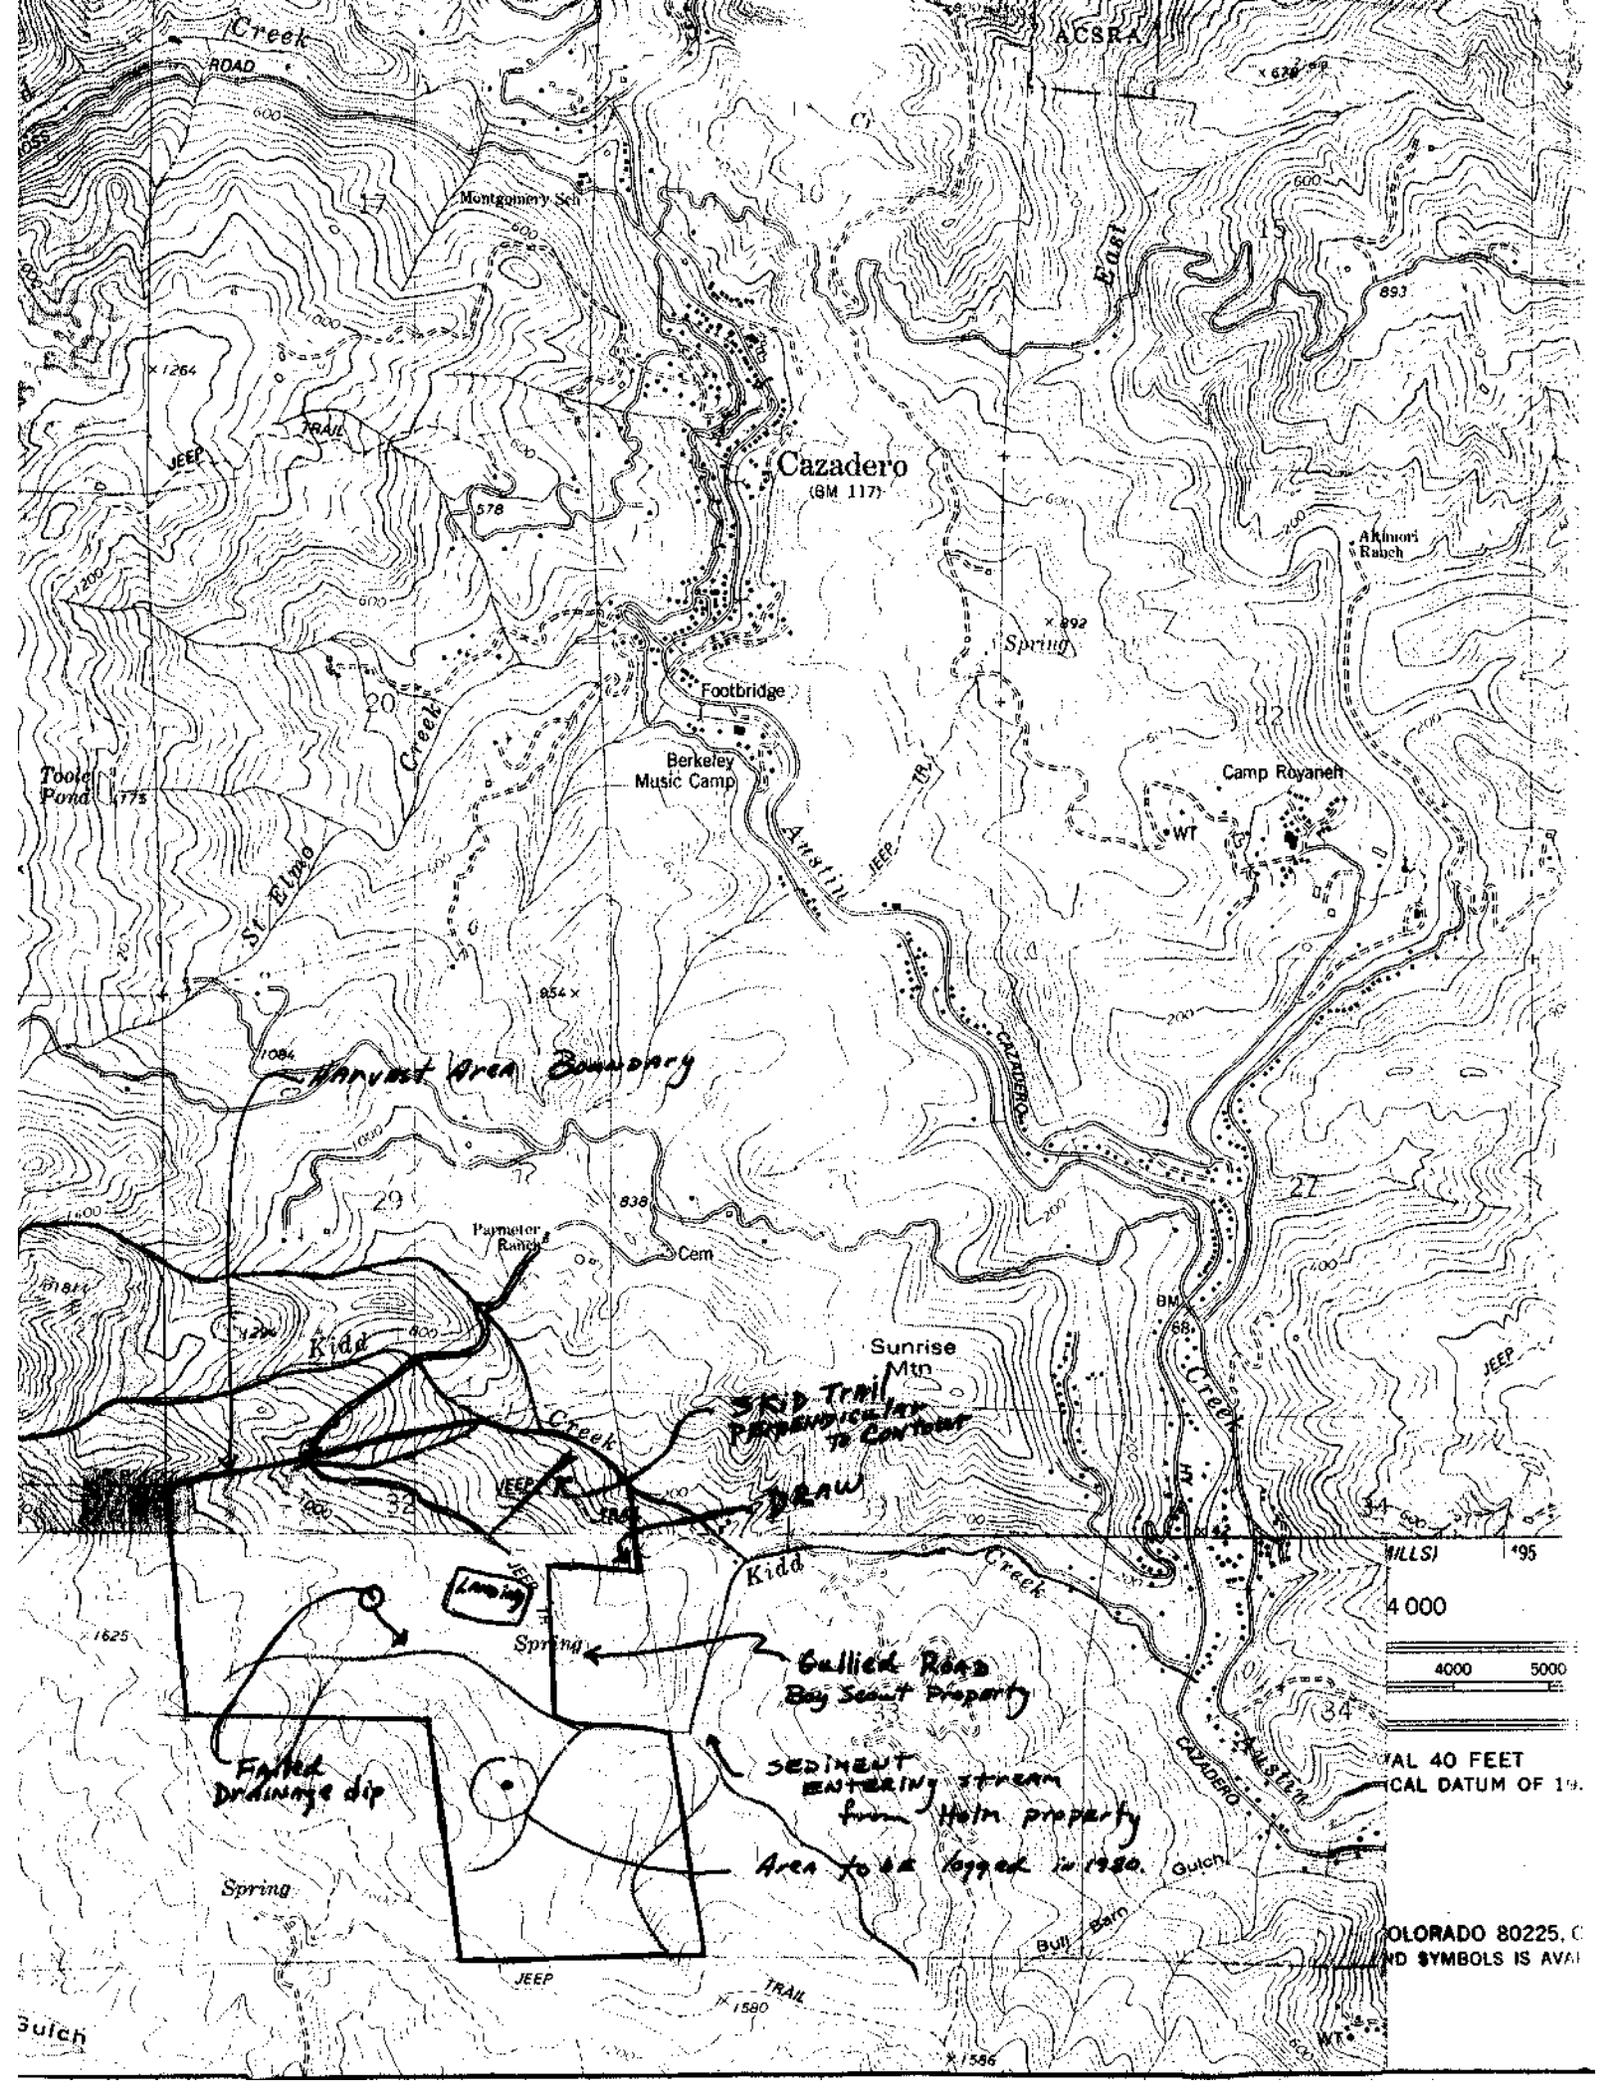
Near the headwater of the South Fork a skid road drainage dip had failed when it became clogged with debris. A sediment flow resulted, a small quantity of which reached the stream (perhaps 2 - 3 cubic yards). The gravel at the headwater of the stream is all well rounded material indicating that it has been in the stream for a long time. As we walked downstream the gravel changed to sharp, angular material; i.e., new material. The source of this material seemed to be natural, however, as even the hillsides on the unlogged Boy Scout property were covered with rock being rovelled from the soil.

At the forks of the South Fork the stream became clogged with new angular gravel. The material has come down the South Fork of the South Fork from a collapsed fire road on Holm Timber Industries property. Dave Ramsey of Holm reported this to Randy Neuman of the Cazanoma Lodge.

SKID TRAIL  
PERPENDICULAR  
TO CONTOUR

Gullied Road  
Big Scout Property

SEDIMENT  
ENTERING stream  
from Helm property

Failed  
Drainage dip
